## **Aircraft Accident Brief**

**EgyptAir Flight 990  
Boeing 767-366ER, SU-GAP  
60 Miles South of Nantucket, Massachusetts  
October 31, 1999**

**NTSB/AAB-02/01  
PB2002-910401  
Adopted March 13, 2002**

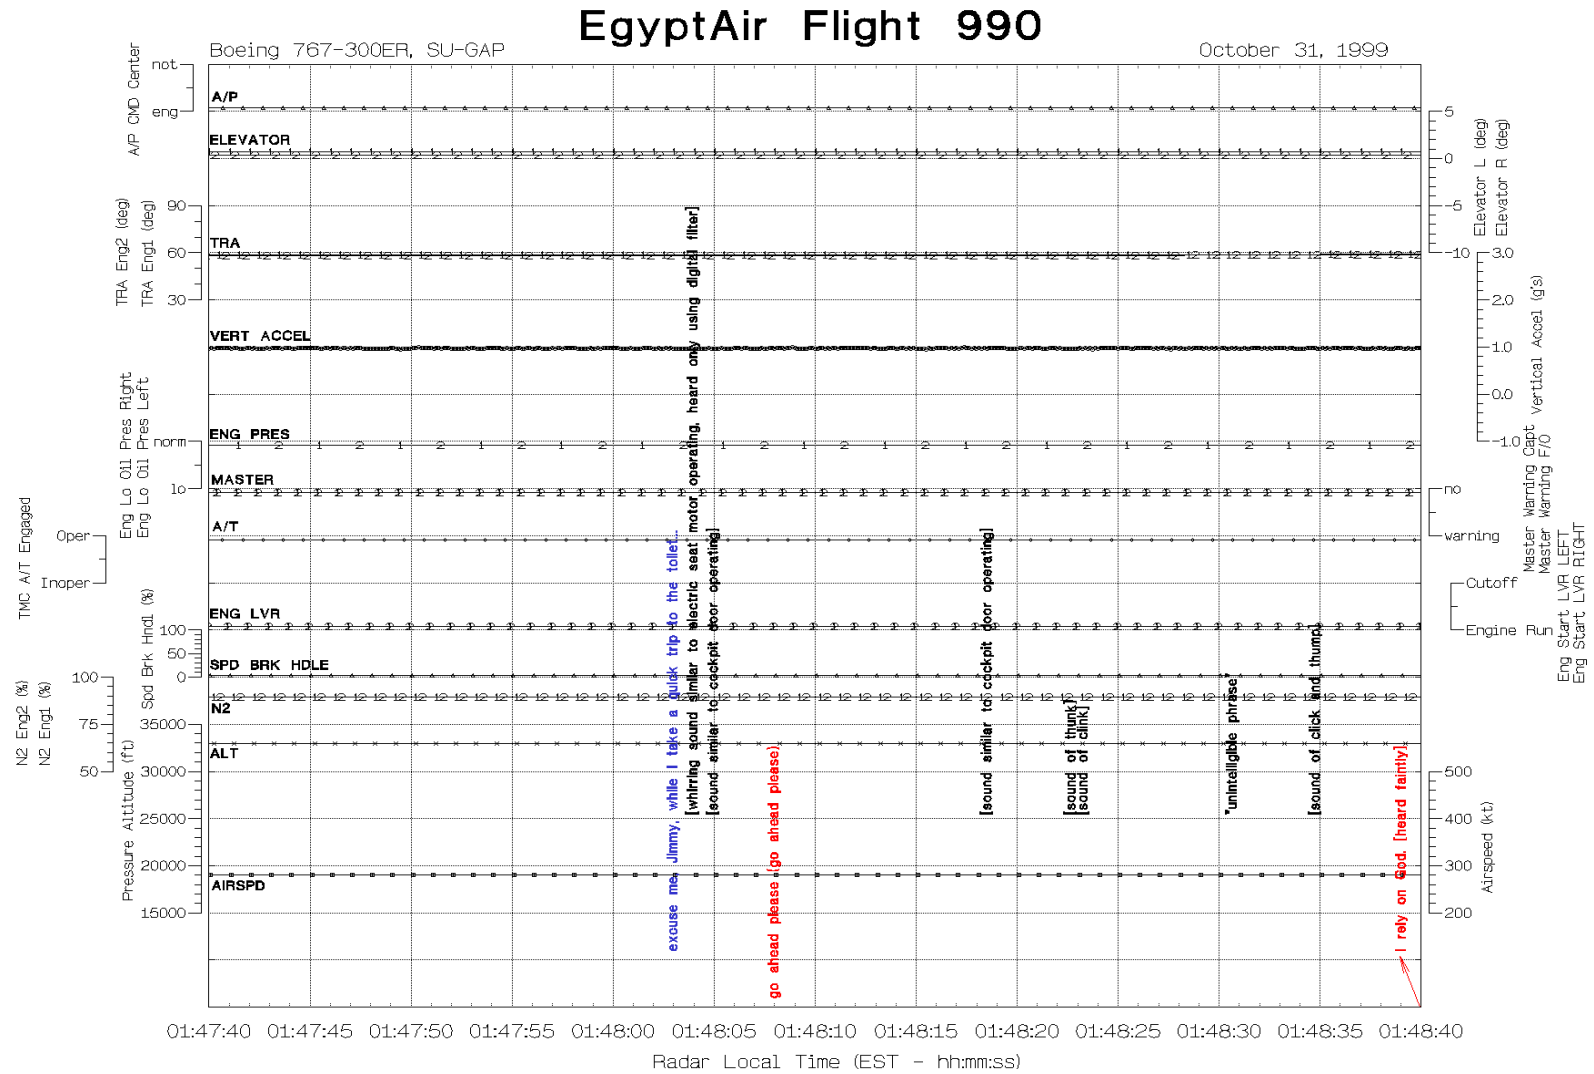
Figure 3a. A graph depicting selected FDR data from 1:47.40 to 1:48.40.

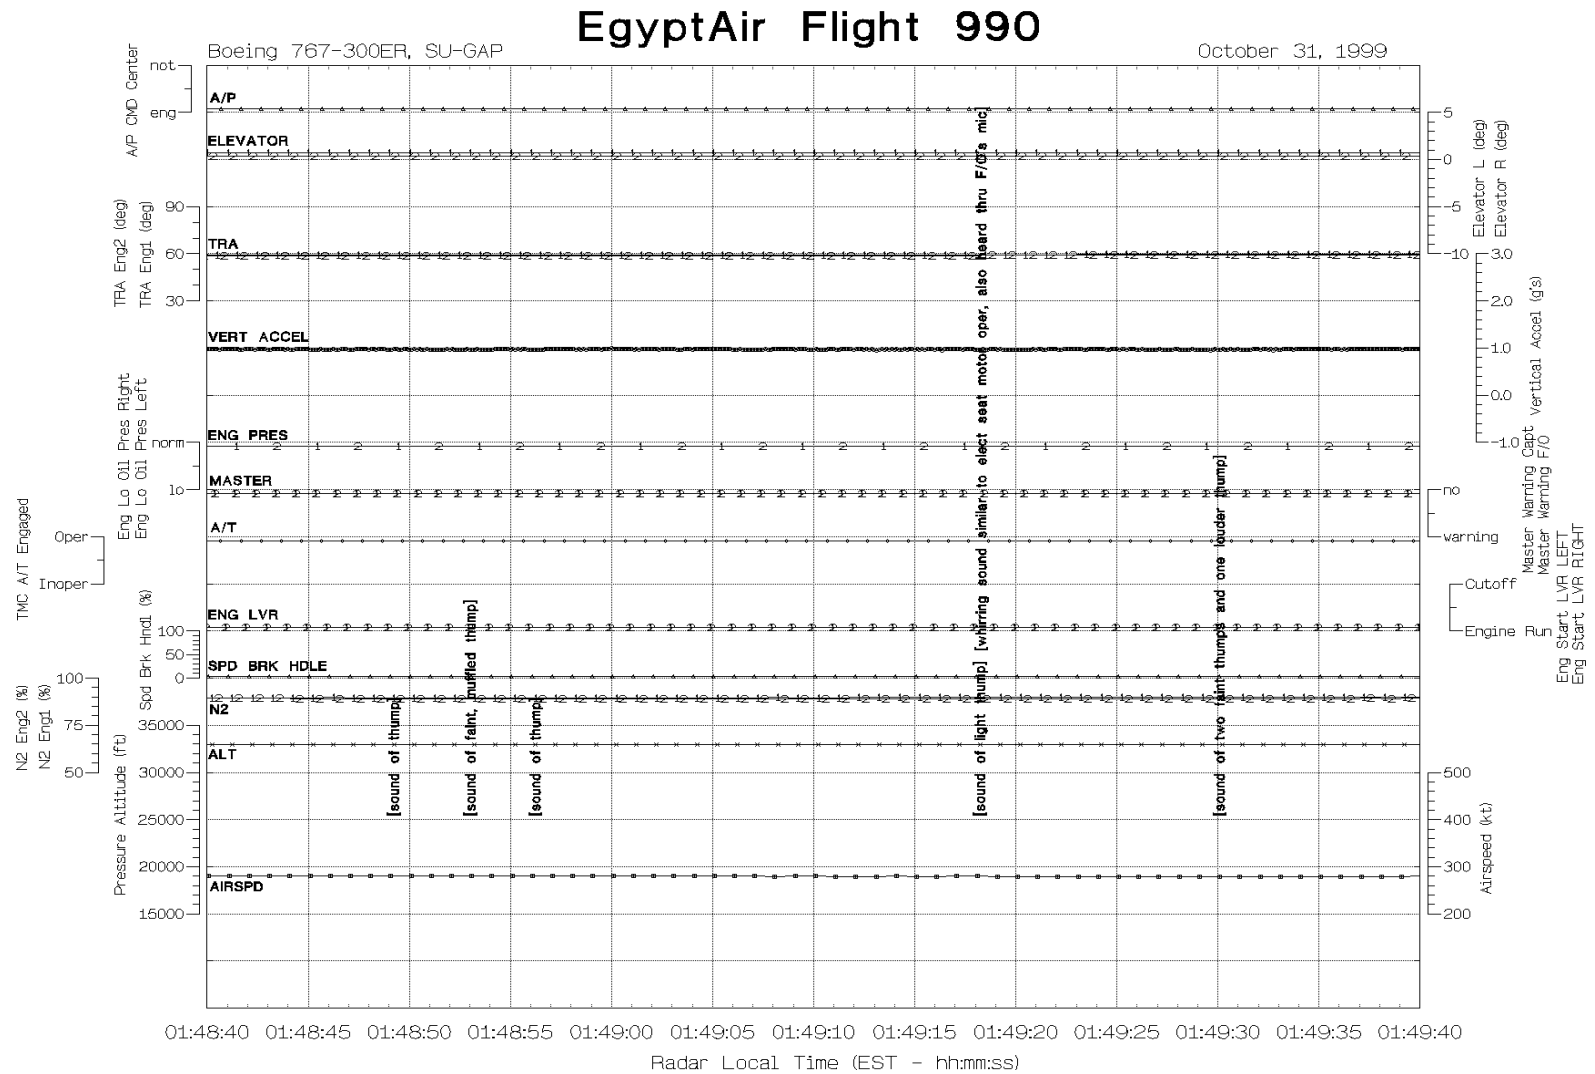
**Figure 3b.** A graph depicting selected FDR data from 1:48.40 to 1:49.40.

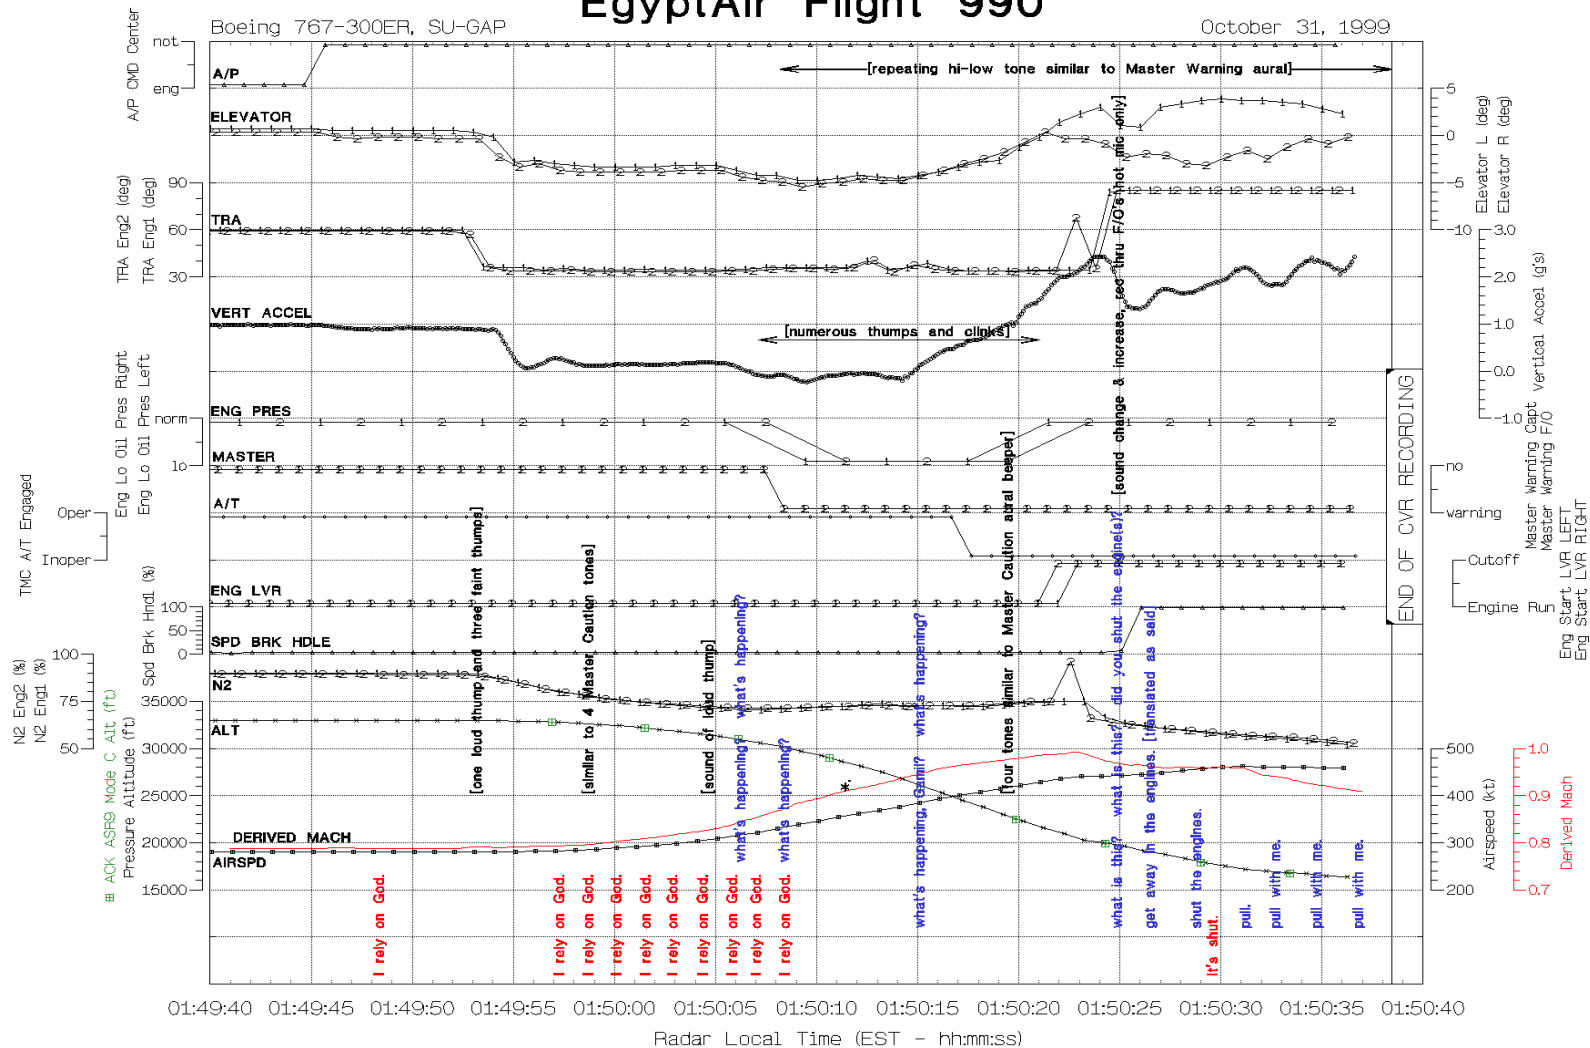
**Figure 3c.** A graph depicting selected FDR data from 1:49.40 to 1:50.40.

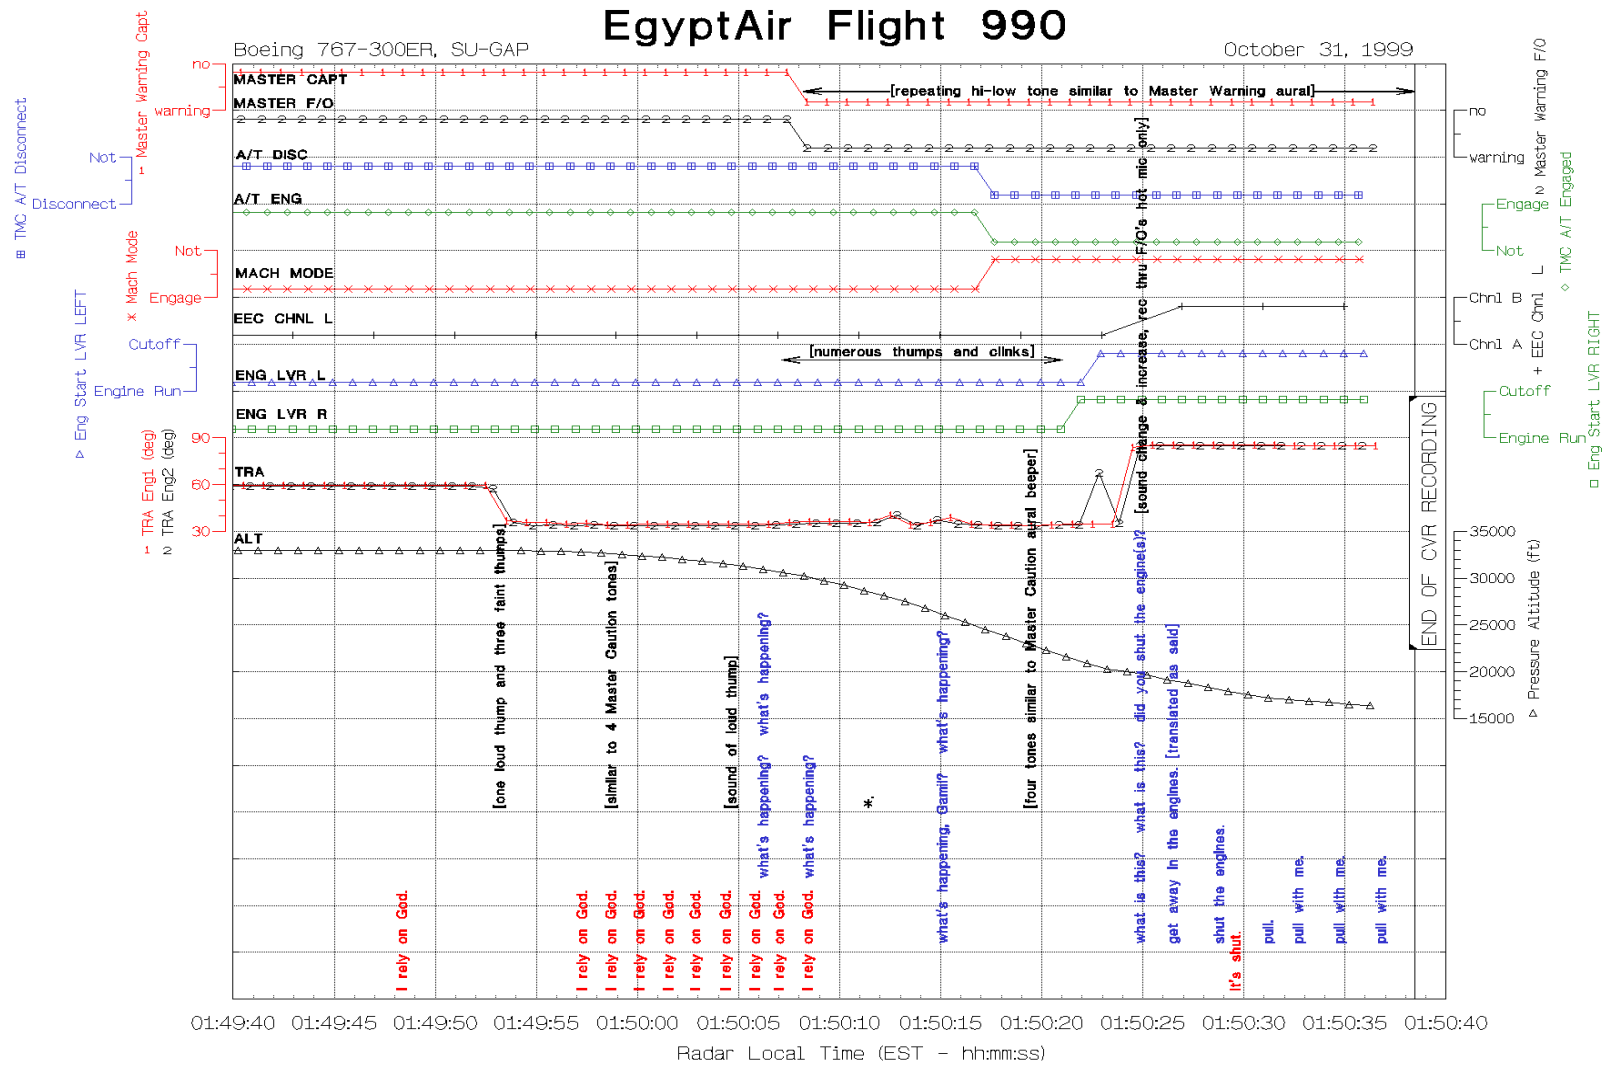
Figure 3d. A graph depicting selected FDR data from 1:49.40 to 1:50.40.

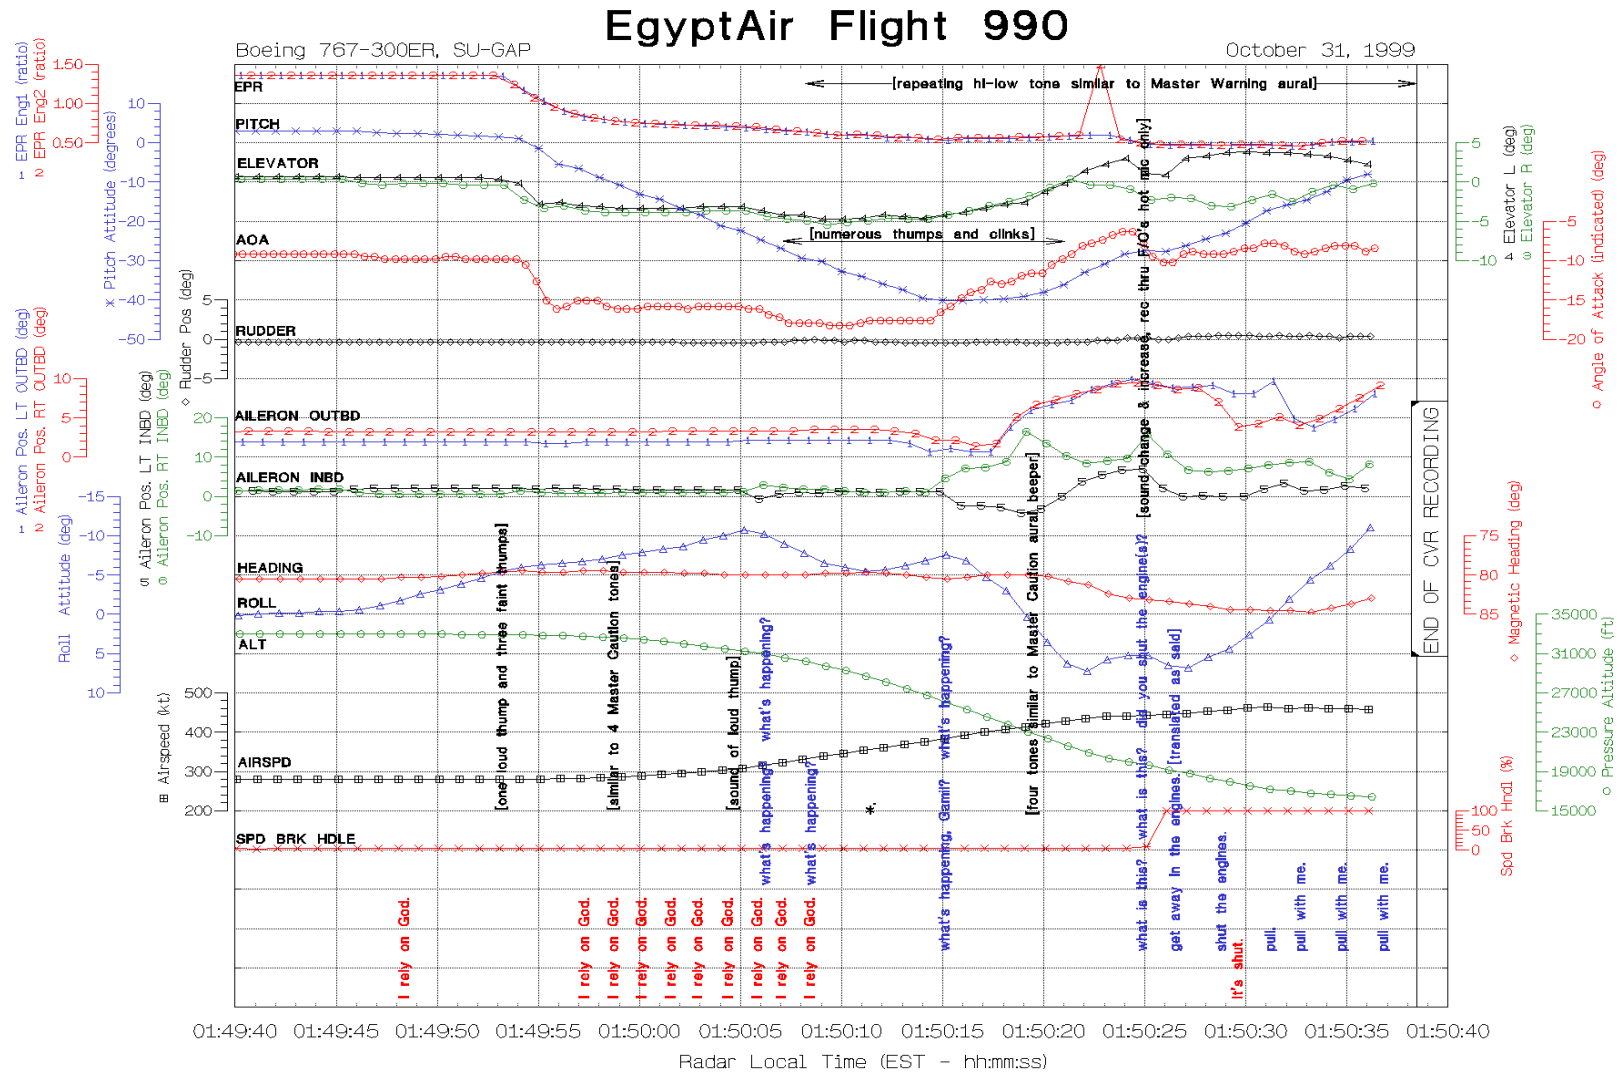
**Figure 3e.** A graph depicting selected FDR data from 1:49.40 to 1:50.40.

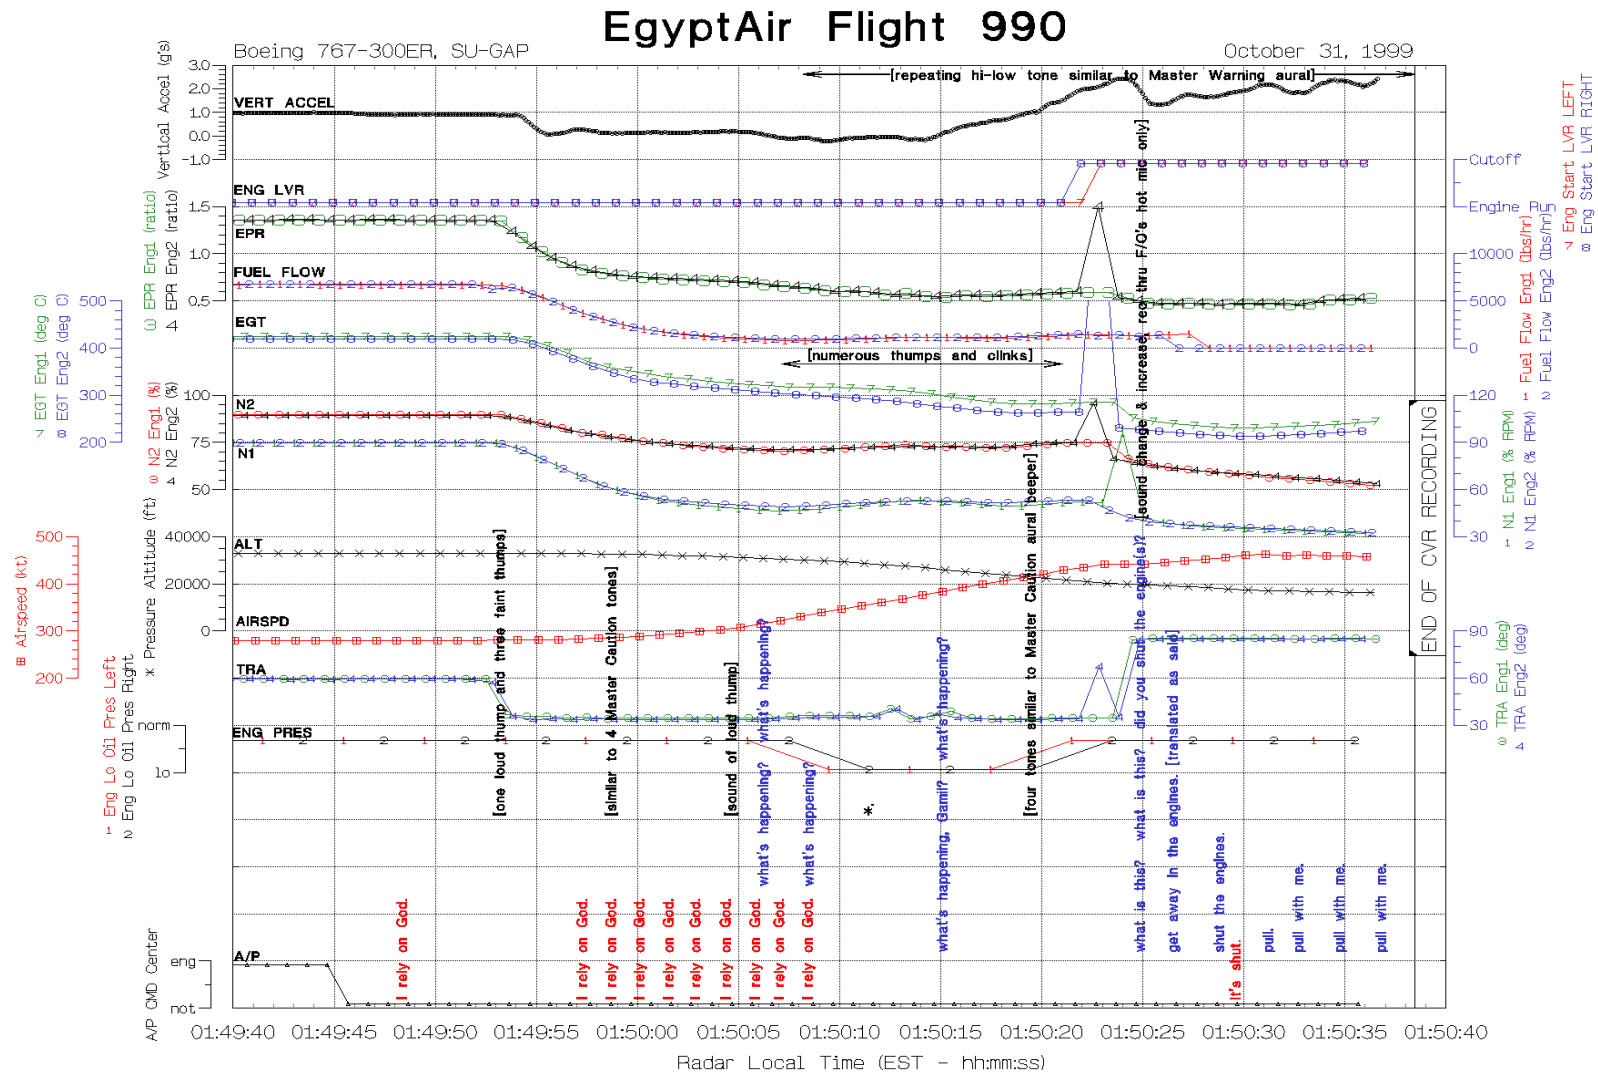
Figure 3f. A graph depicting selected FDR data from 1:49.40 to 1:50.40.

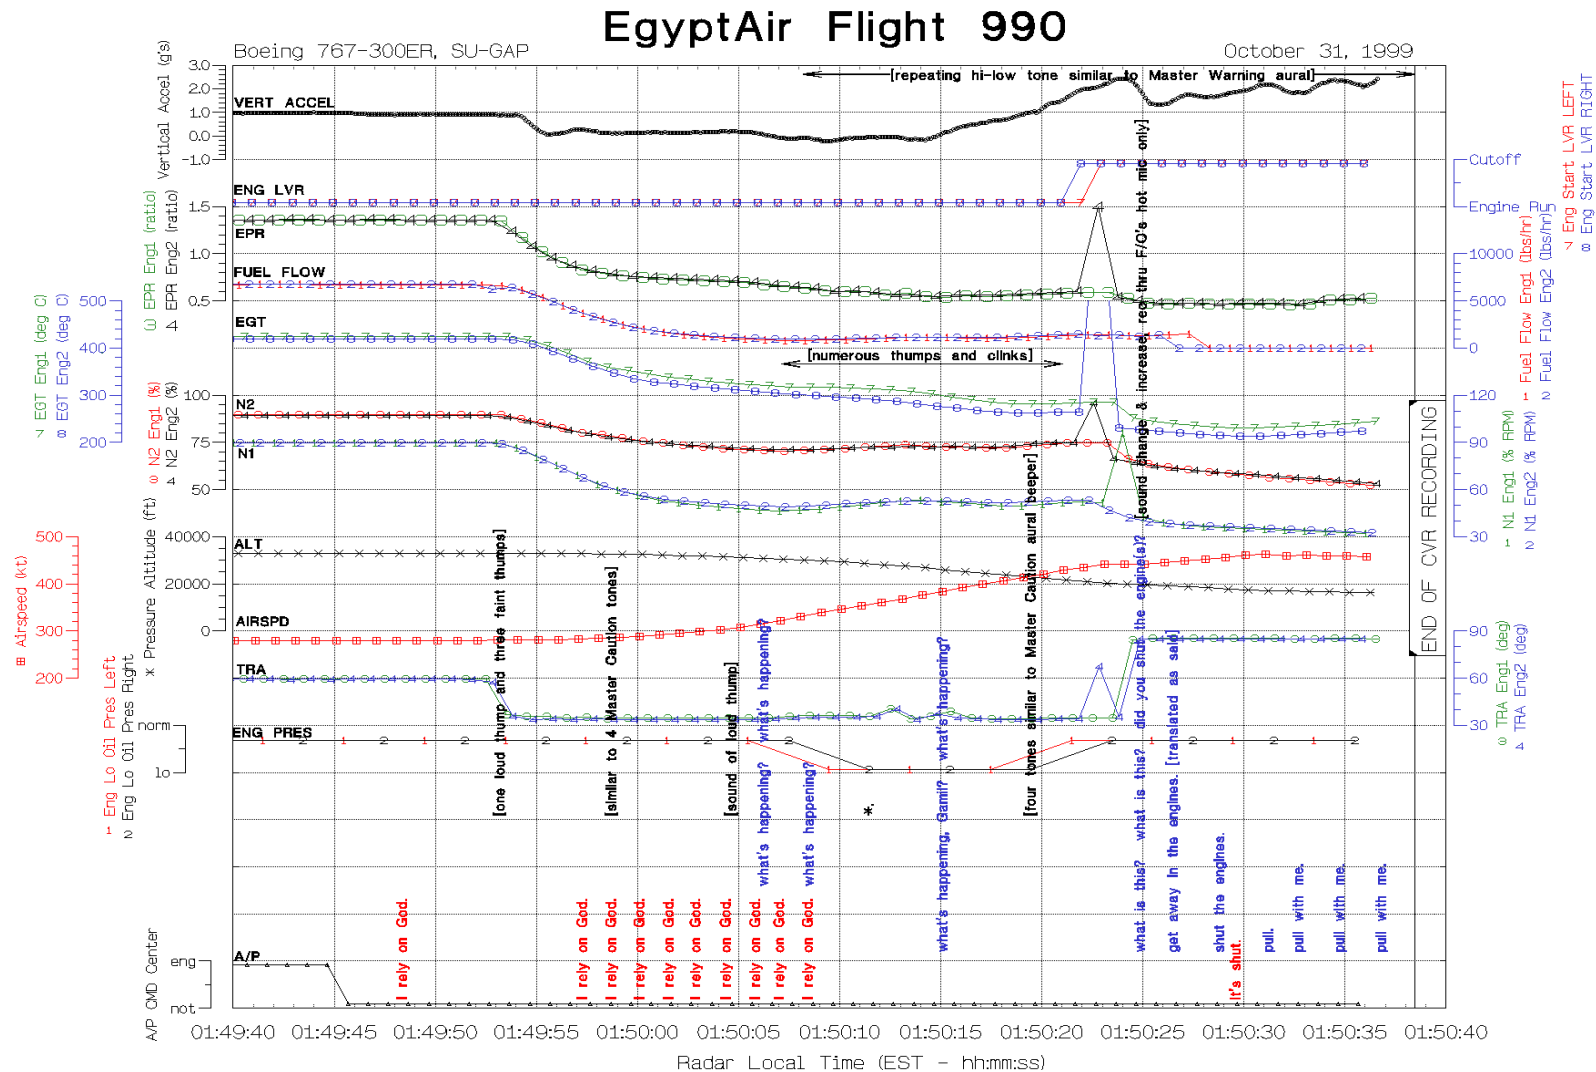
Figure 3g. A graph depicting selected FDR data from 1:49.40 to 1:50.40.

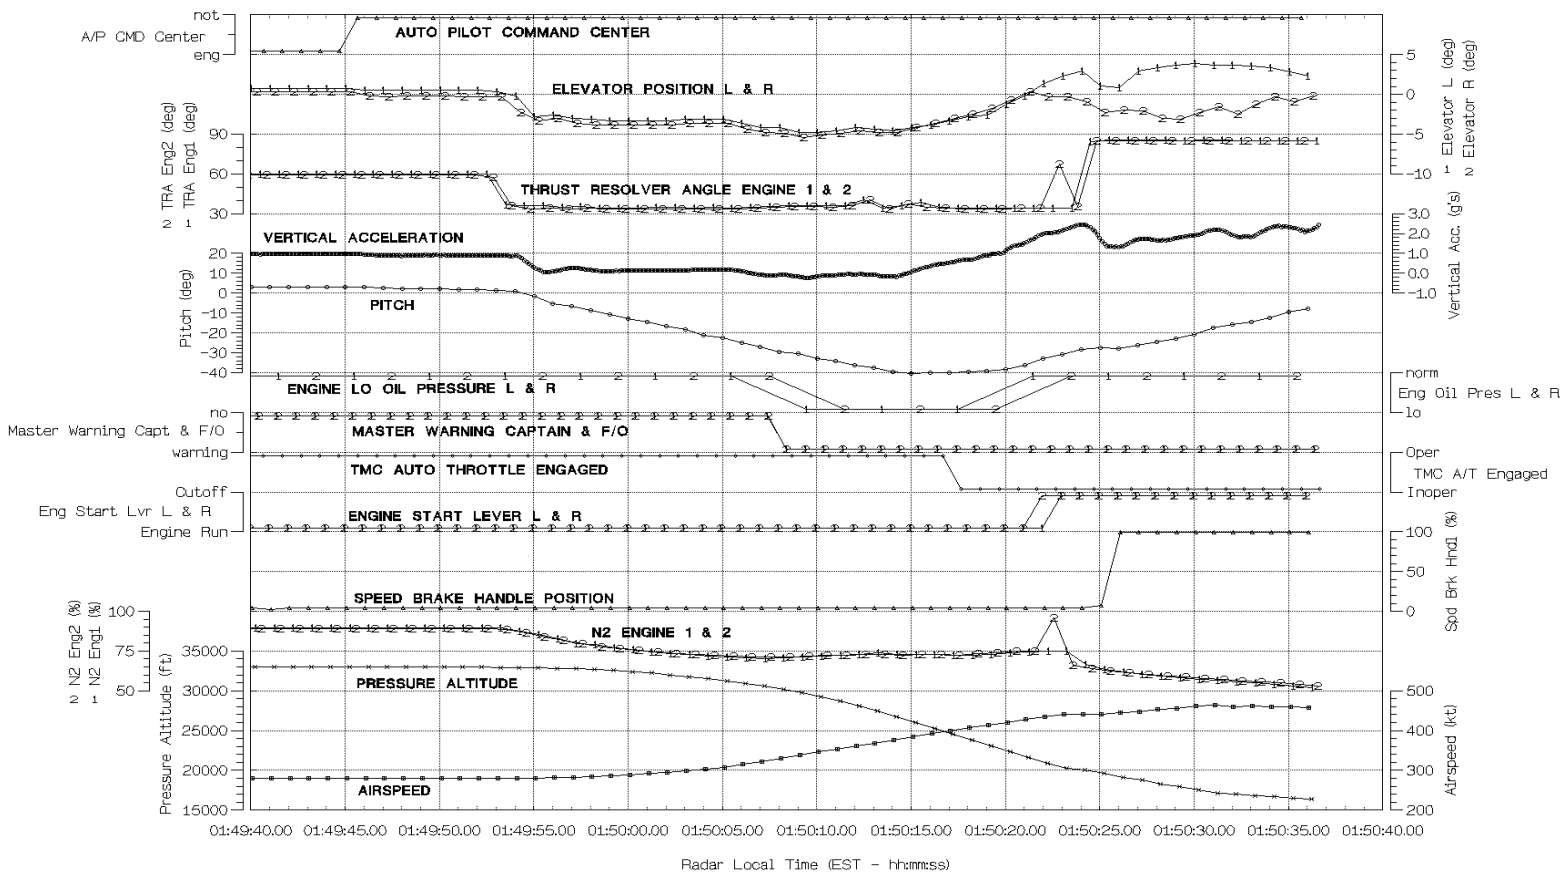
Figure 3h. A graph depicting selected FDR data from 1:49.40 to 1:50.40.

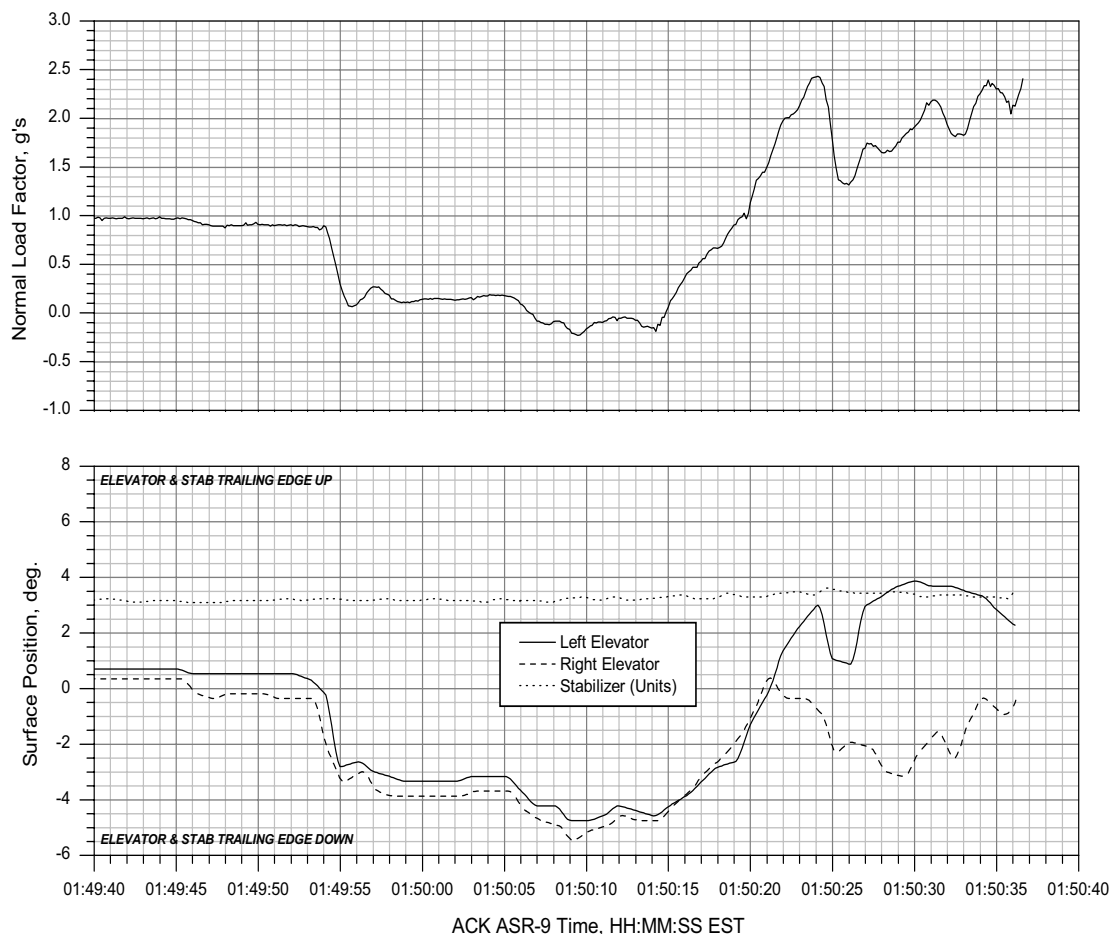
**Figure 4.** Graphs depicting the accident airplane's normal load factor response to elevator and stabilizer movement.
