National Transportation Safety Board

Aircraft Accident Brief

Accident No.:	DCA00MA052
Operator or Flight Number:	Executive Airlines
Aircraft and Registration:	British Aerospace J-3101, N16EJ
Location:	Bear Creek Township, Pennsylvania
Date:	May 21, 2000

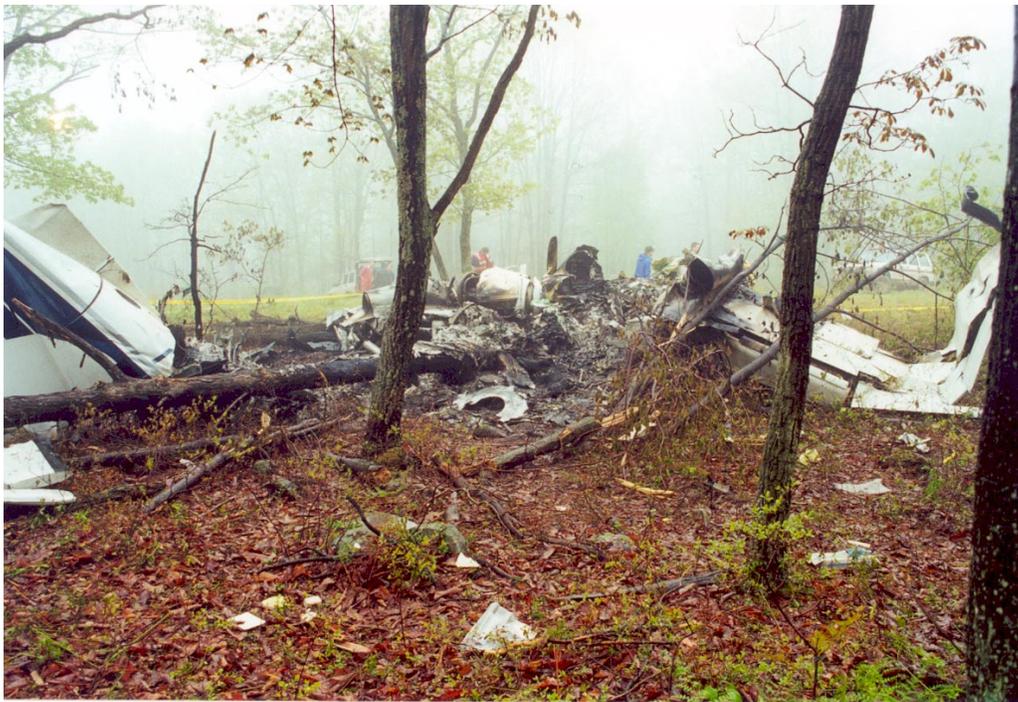
The airplane wreckage was found on the top of a mountain on the east side of a pipeline clearway on state-owned property. Ground and tree impact marks indicated that the airplane impacted terrain at a steep angle and in an extreme bank angle. Witness marks on the attitude indicator, ground witness marks, airplane crushing, and other damage indicated that the airplane impacted the ground at a 60° nose low attitude and in a 135° left bank. Ground scars indicated that the airplane impacted the ground on a 40° heading. All of the airplane's primary structure was located at the accident site. All recovered primary and secondary flight control surfaces were found at the accident site. As shown in figure 2, fire damage was confined to the immediate impact area, with little fire damage to surrounding trees and foliage.

Figure 2. Photo of the accident site illustrating the lack of fire damage to the surrounding area.
