National Transportation Safety Board
Washington, D.C. 20594

Aircraft Accident Brief

Accident Number:	LAX01MA272
Aircraft and Registration:	Eurocopter AS350-B2, N169PA
Location:	Meadview, Arizona
Date:	August 10, 2001
Adopted On:	June 3, 2004

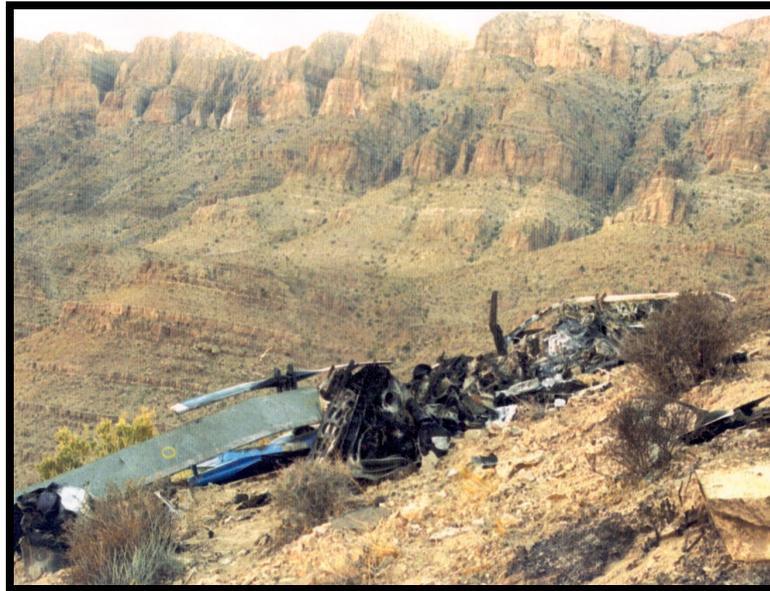
Figure 3. Profile view of the accident site. Note downsloping terrain.

The accident site was located at an elevation of 4,041 feet msl. The average elevation of the top of the mesa formed by Grand Wash Cliffs is about 5,500 feet msl. The accident site was just outside the SFAR 50-2 (Green Route 4) area of the Grand Canyon National Park.

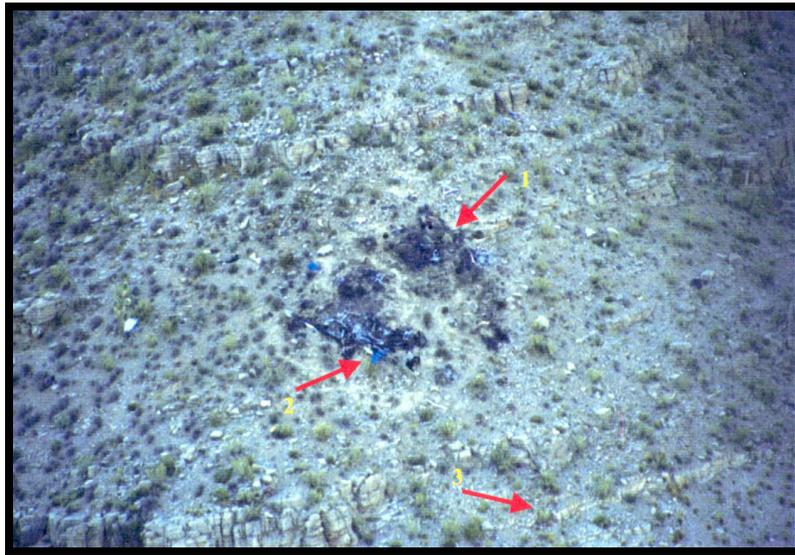
The main wreckage area distribution, including helicopter debris, tree strikes, and ground impressions, were contained in an area approximately 40 feet in diameter. See figure 4 for an aerial view of the crash site.

Figure 4. Aerial view of the crash site. Top arrow denotes first identified point of contact (IPI). Middle arrow denotes resting point of main wreckage. Lower arrow denotes right door. Note that the crash site is compact.

The first identified point of impact (IPI) contained an outcropping of boulders. Various portions of the center fuselage belly panel, canopy glass, and all of the landing gear with the exception of the aft cross tube were found on and immediately around the boulder outcropping.

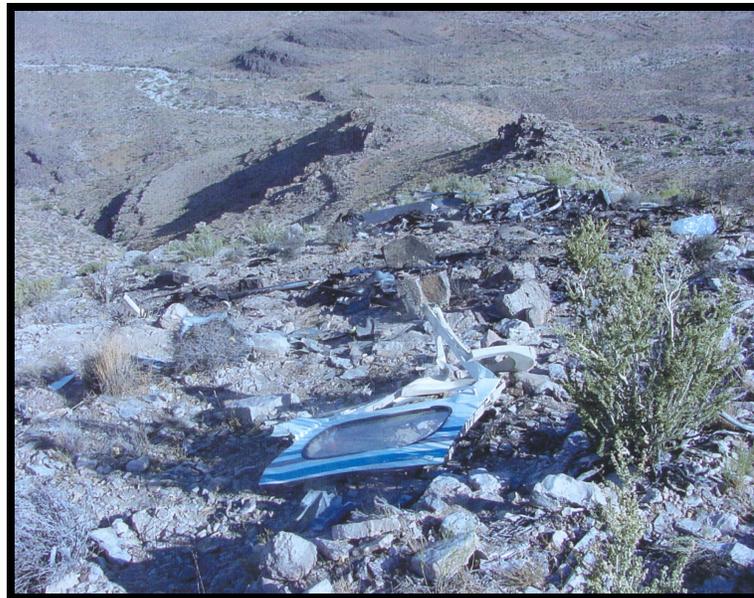
The left front door was found up slope from the IPI. (See figure 5.) It had separated from the fuselage with a portion of the forward fuselage doorpost attached to the upper and lower hinges. The doorpost section was torn from the fuselage structure. The lower hinge was bent and distorted, whereas the upper hinge was intact and undamaged. The hinge pins were fully seated in their corresponding gudgeons and also remained attached to the door jettison arm and rod mechanism, with the internal cockpit-side jettison handle in a near normal position. The door-operating handle was found in the closed and latched position.

Figure 5. View of crash site showing left door (in foreground) found upslope from IPI.

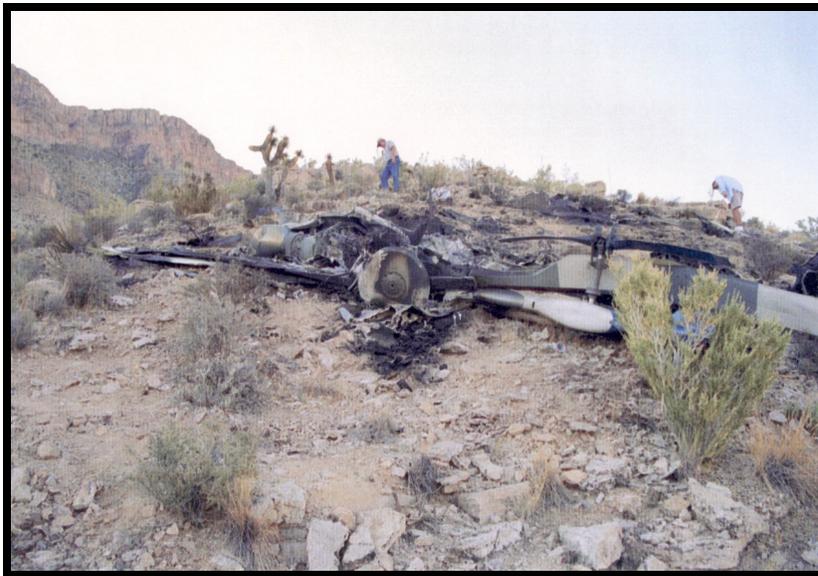
Figure 6. View looking upslope from IPI. The tail rotor blade is shown in right half of photograph.

The tail rotor blades were bowed and had minor leading edge damage. One strike tab was bent aft and exhibited chordwise scratching. The other strike tab was bent inboard and also exhibited chordwise scratching.
