National Transportation Safety Board

Aircraft Accident Brief

Accident Number:	FTW03MA160
Operator and Flight Number:	Southwest Airlines Flight 2066
Aircraft and Registration:	Boeing 737-300, N343SW
Location:	Amarillo, Texas
Date:	May 24, 2003

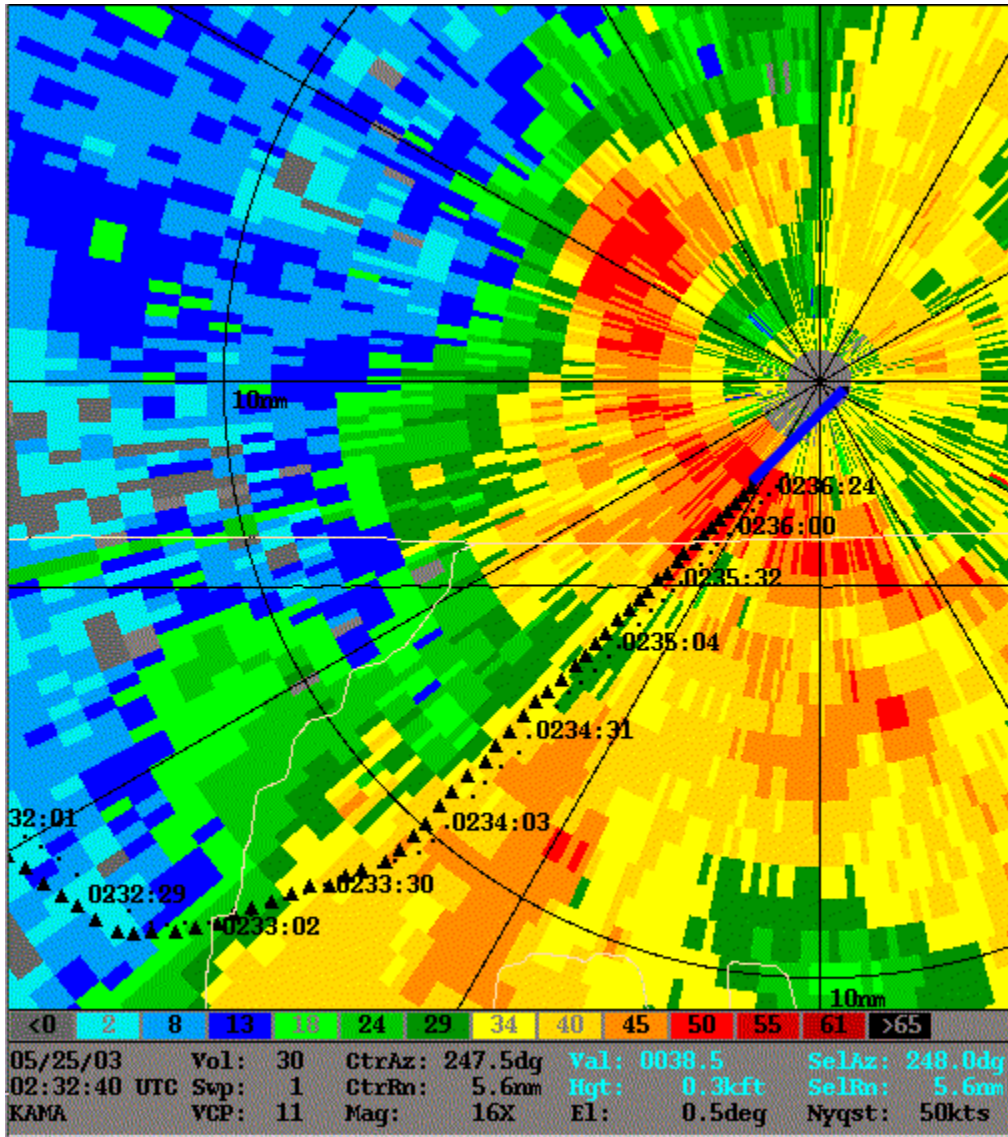
For the 0232:40Z scan, the base reflectivity image indicates that very strong to intense weather radar echoes were detected along the approach to runway 4 (see figure 2).

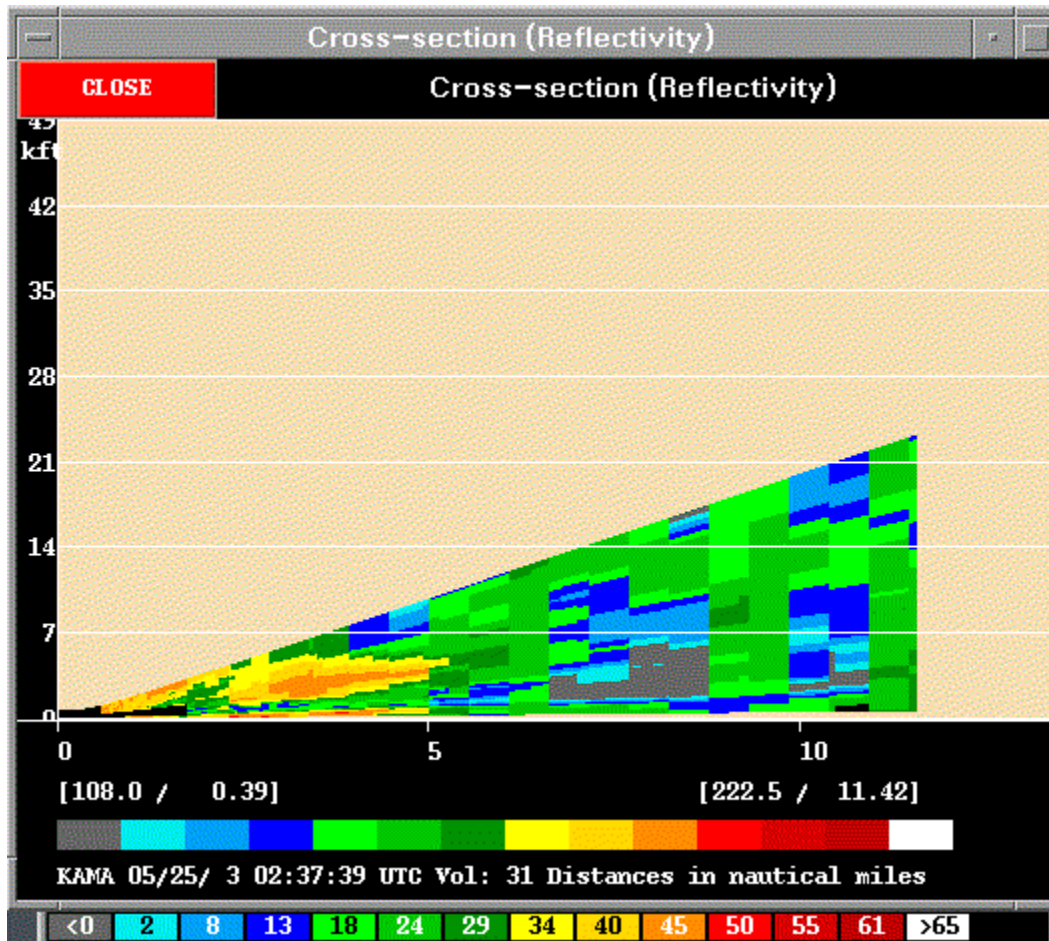
Figure 3. Weather Echo Intensity Cross-Section for 0237:39Z.

For the 0237:39Z scan, the cross-section reflectivity image indicates that very strong weather echoes were detected in the approach area of runway 4 (see figure 3).

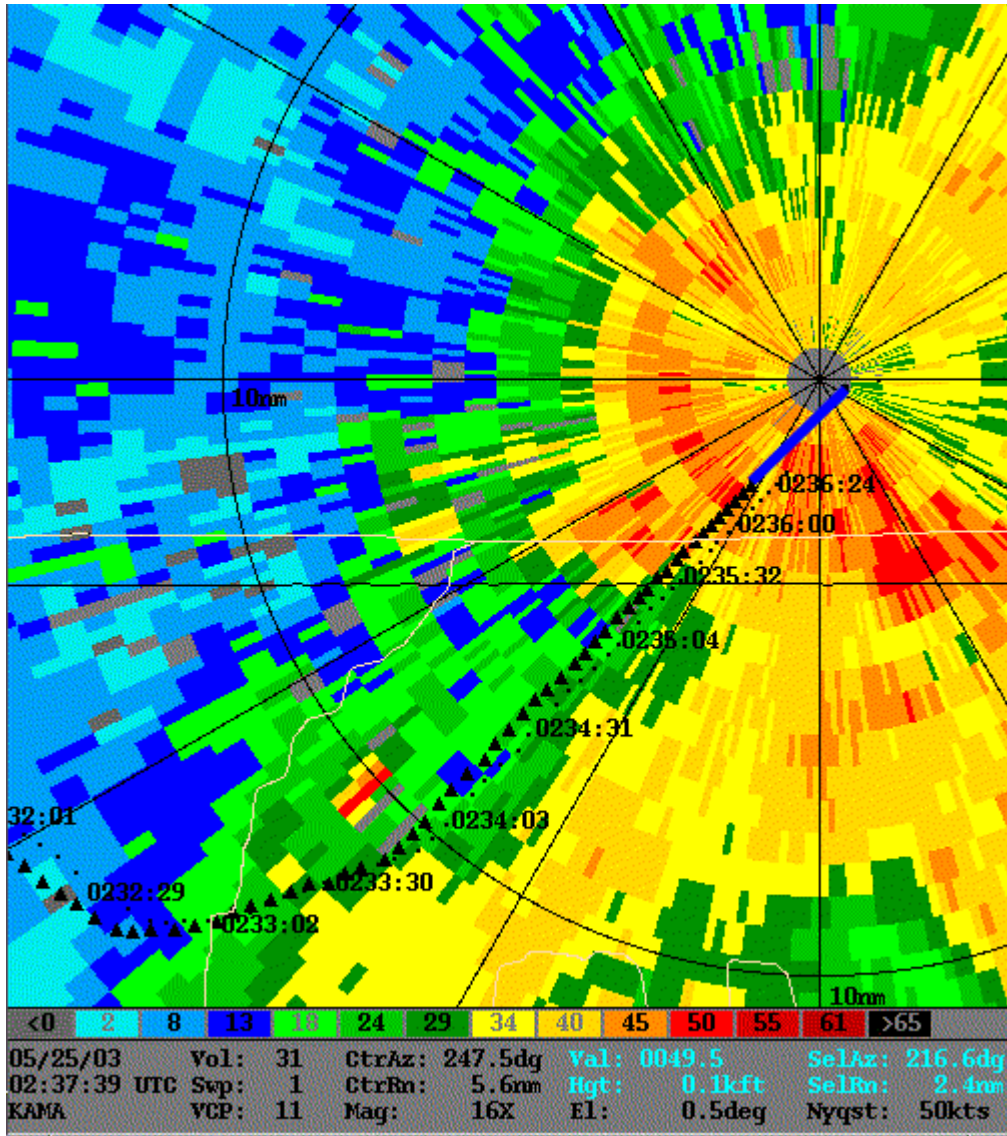
Figure 4. Base Reflectivity Image for 0237:39Z (0.5° elevation angle).

For the 0237:39Z scan, the base reflectivity image indicates that very strong weather radar echoes were detected in the approach area to runway 4. Strong or greater weather echoes were detected from about 3 nm southwest of the runway 4 threshold to the runway threshold (see figure 4).

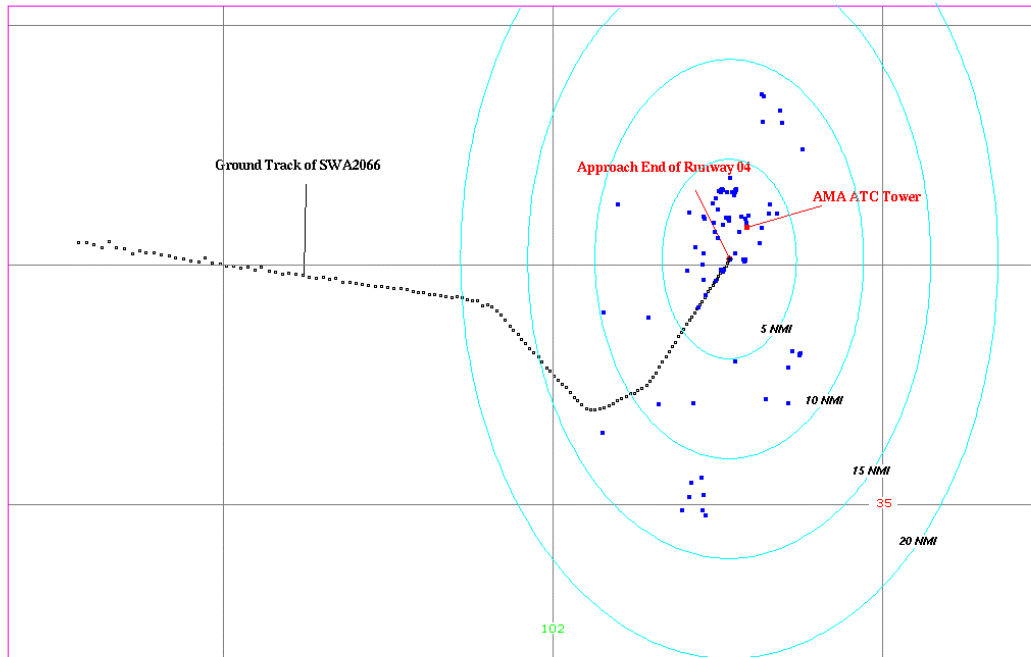
Figure 5. Cloud-to-Ground Lightning Strikes From 0233Z to 0237Z.

According to the National Lightning Detection Network (NLDN),¹⁴ 505 cloud-to-ground strikes were recorded within a 15-mile radius of the runway 4 threshold between 0225Z and 0240Z. A cloud-to-ground lightning strike was recorded near the runway 4 threshold at 0233:23Z. About seven cloud-to-ground lightning strikes were recorded near or along the airplane's flightpath from 0233Z to 0237Z (see figure 5).

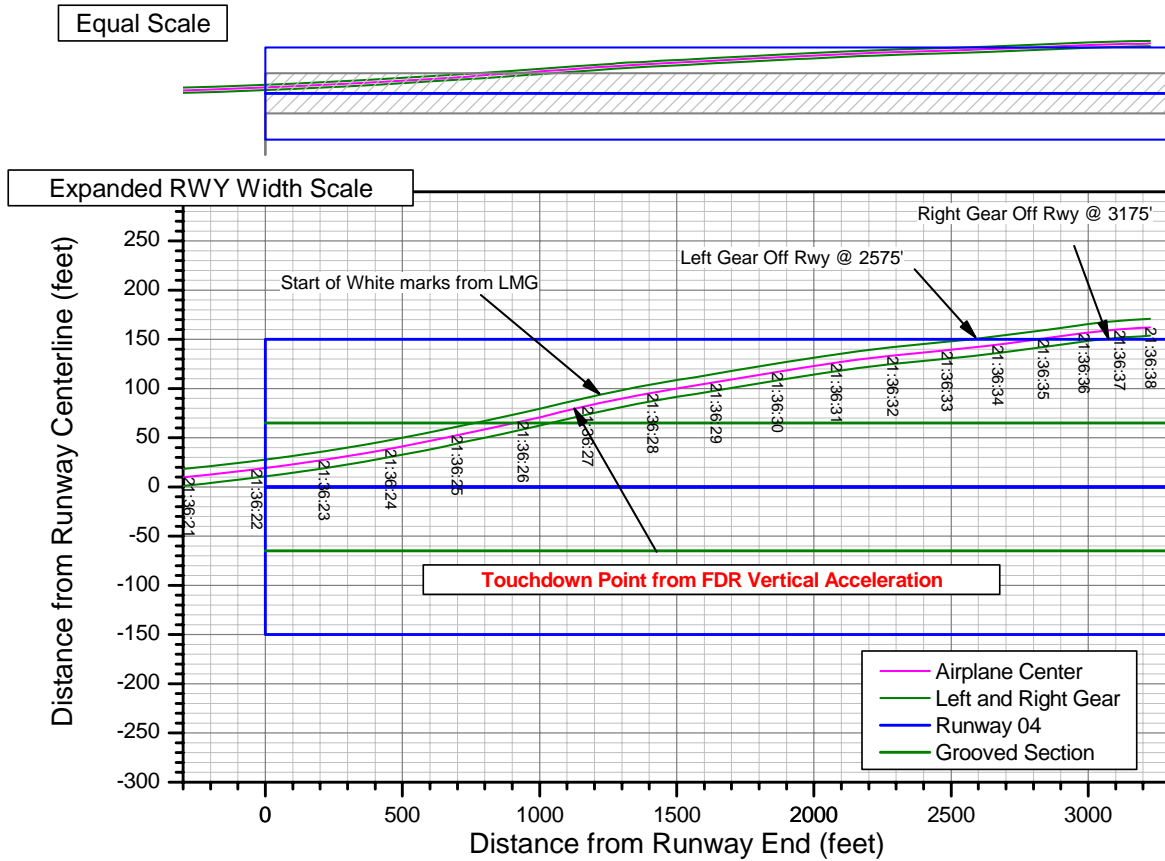
Figure 6. Integrated Ground Track During Approach and Landing.

consistent with tire marks²¹ were found about 1,250 feet from the threshold and 60 feet from the runway's left edge. Ground scarring indicated that the left main landing gear's outboard tire went off the left edge of the runway 2,575 feet from the threshold, followed by the left gear inboard tire at 2,700 feet. The nosewheel went off the runway at 3,000 feet, and nosewheel ground tracks ended at 3,475 feet, which was consistent with the collapse of the nose landing gear. Ground scarring also indicated that the right main landing gear was off the runway 3,175 feet from the threshold. Ground and runway markings indicated that the right main landing gear was back on the runway 3,750 feet from the threshold, followed by the left main landing gear at 3,837 feet.

FDR data, CVR data, and ground scar information were examined to determine the airplane’s flightpath and ground track before touchdown and the airplane’s ground roll after touchdown. The Safety Board conducted an FDR data flightpath integration study to calculate the airplane’s flightpath and ground track. In addition, the Aircraft Performance Group completed a kinematics study of the airplane’s motion during the approach and landing. The study used FDR data and kinematic extraction techniques to derive wind speeds, wind directions, and the ground track for the accident airplane. The ground tracks calculated by both methods were consistent with the markings on the runway (see figure 6 for integration results).
