Pilot/Race 177, *The Galloping Ghost*  
North American P-51D, N79111  
Reno, Nevada  
September 16, 2011

**Accident Brief**

NTSB/AAB-12/01  
PB2012-916203

# Aircraft Accident Brief

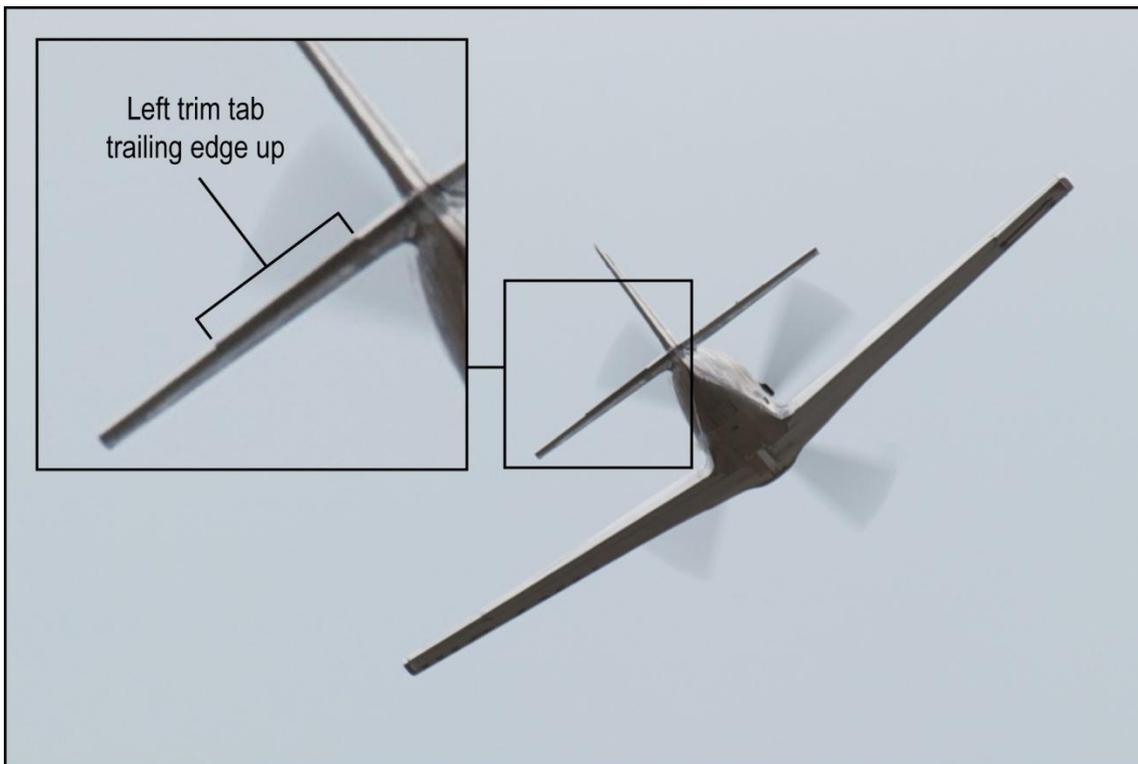
edge down when the right aileron was faired with the wing. Photographs of the airplane during flights on the race course 3 days before the accident showed that the airplane's left elevator trim tab was deflected trailing edge up; image study calculations determined that, in one photograph, the deflection was 5° trailing edge up, and in another photograph, it was 8° trailing edge up. Available telemetry data showed that, at the time that the photograph showing 8° trailing edge up was taken, the airplane was in a section of the race course between pylons 6 and 7 and had a ground speed of about 360 to 380 knots (see figure 4).

**Figure 4.** Left trim tab deflection of 8° trailing edge up during a previous flight.

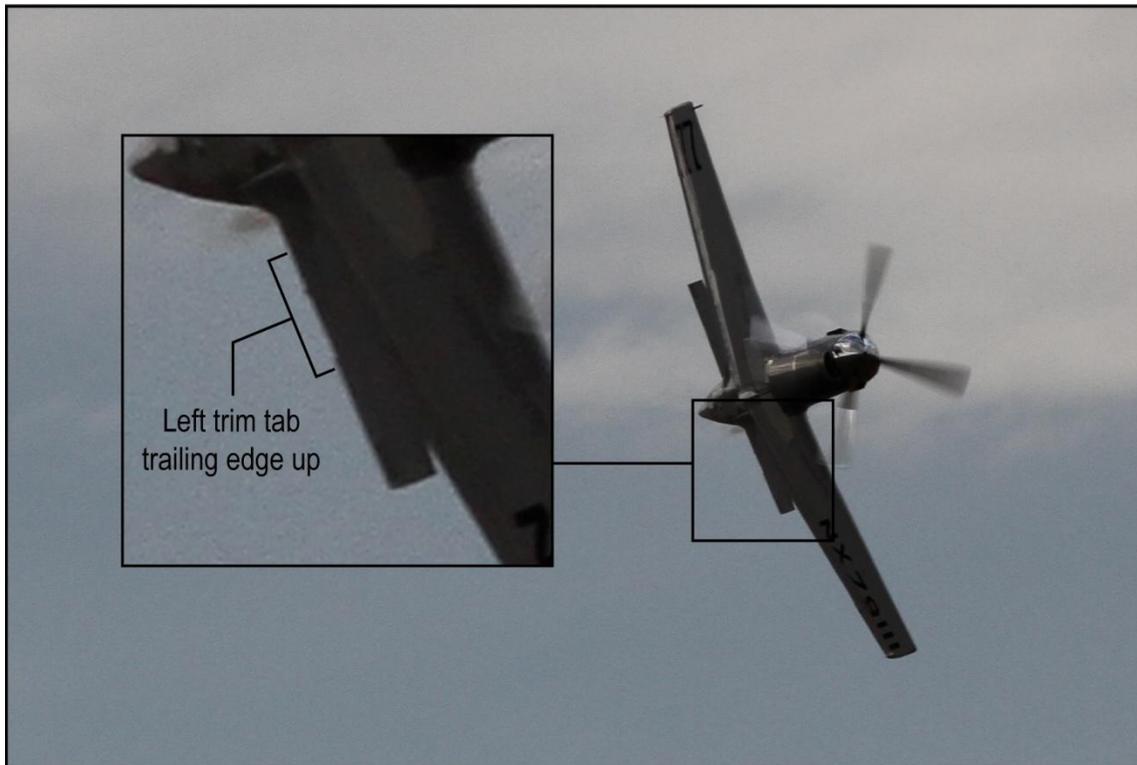
Trailing-edge-up left elevator trim tab deflection was also evident in photographs of the airplane during the accident race. One photograph showed that, as the airplane began to round pylon 8 at 1624:28.65<sup>29</sup> during the accident lap, the left elevator trim tab was trailing edge up, consistent with the position observed during previous laps (see figure 5).

**Figure 5.** Airplane rounding pylon 8 during accident lap before the left roll upset at 1624:28.65.

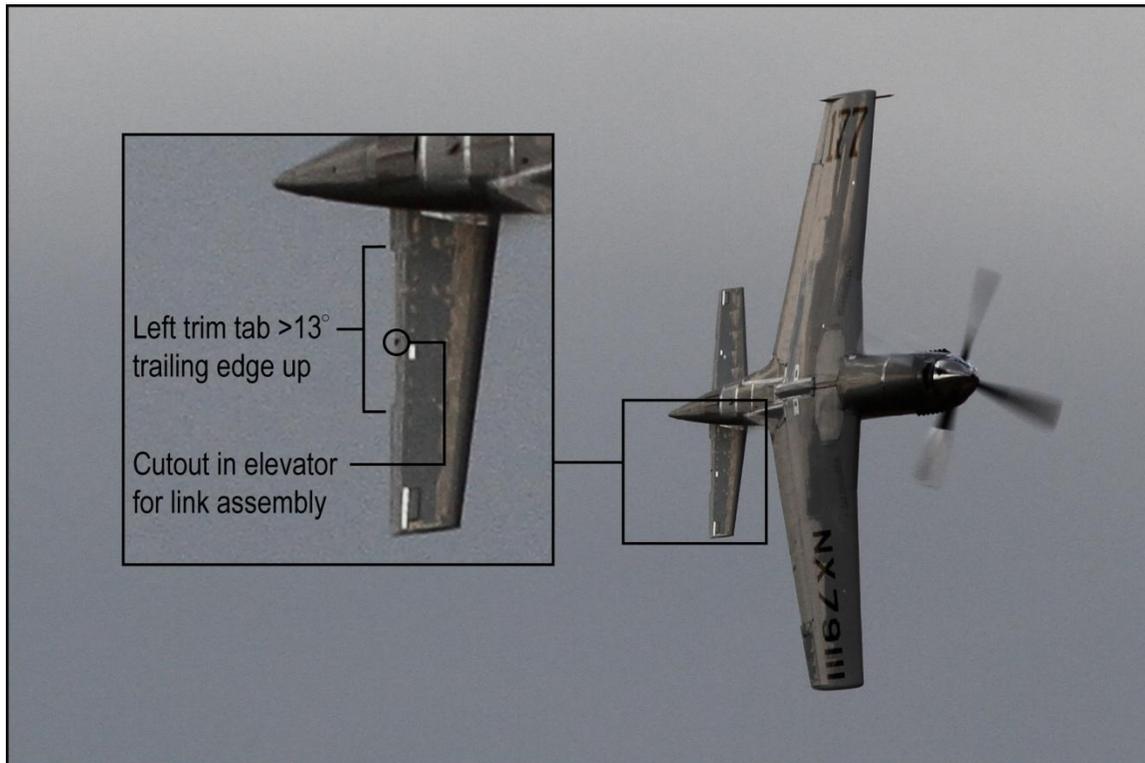
**Figure 6.** Airplane during left roll upset at 1624:29.46, before it reached maximum left bank angle. Inset shows detail of left elevator trim tab and the cutout in the elevator for the trim tab link assembly.

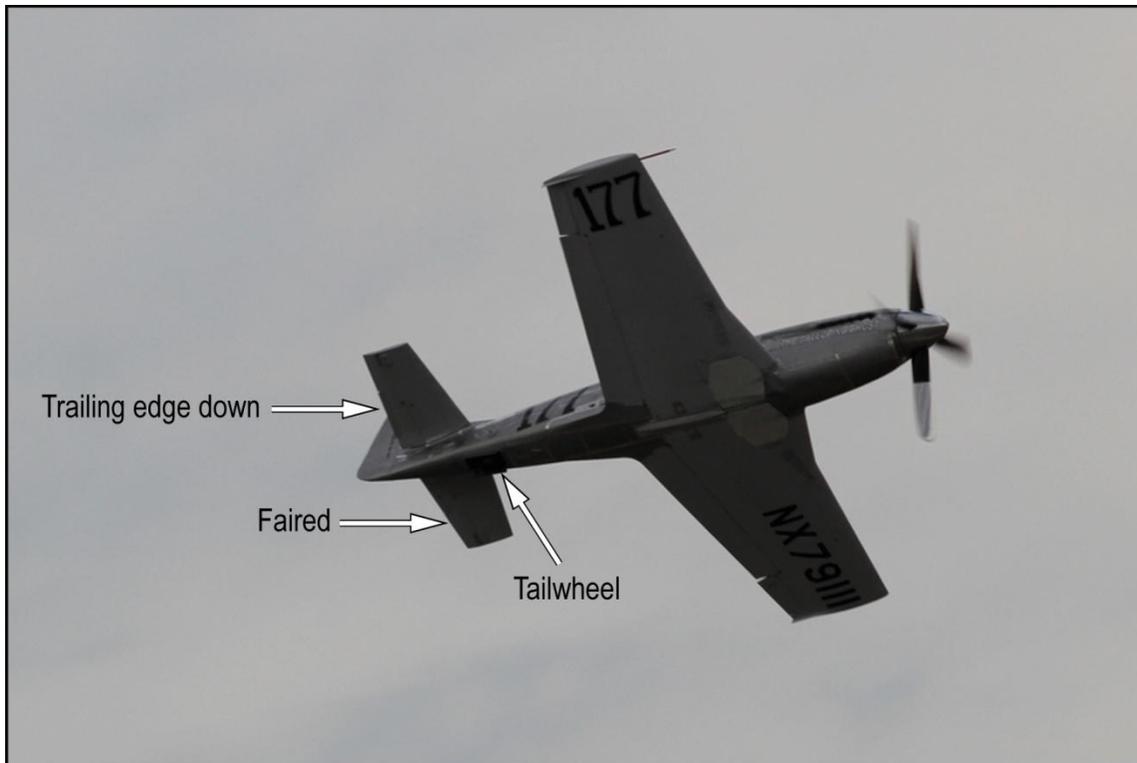
A subsequent photograph showed the airplane at 1624:30.20 as it rolled back to the right and pitched up. Examination of the photograph showed that the left elevator trim tab was faired with the elevator, and the right elevator trim tab was trailing edge down (see figure 7). The deflection of the right trim tab from its fixed, faired position indicates that the right elevator trim tab link assembly had also broken by this time in the flight. This image, which was captured about the time that the airplane sustained its maximum vertical load factor of 17.3 G, also showed that the tailwheel had begun to extend from its housing.

**Figure 7.** Airplane rolling right and pitching up at 1624:30.20, about the time it sustained its maximum vertical load factor.

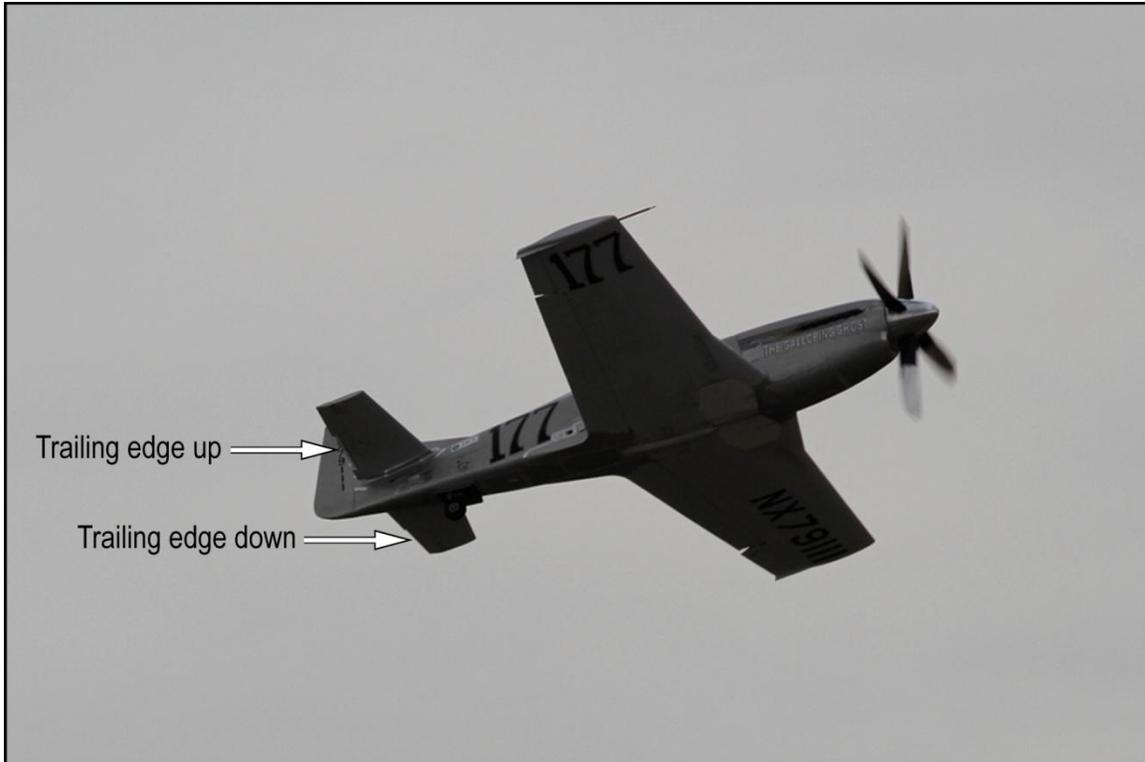
A photograph captured about 0.14 second later, at 1624:30.34, showed that the left elevator trim tab was trailing edge down, and the right elevator trim tab was trailing edge up. Nearly full right-wing-down aileron deflection (right aileron trailing edge up, left aileron trailing edge down) was also evident (see figure 8).

**Figure 8.** Airplane pitching up with left elevator trim tab trailing edge down at 1624:30.34, right elevator trim tab trailing edge up, and nearly full right-wing-down aileron deflection.

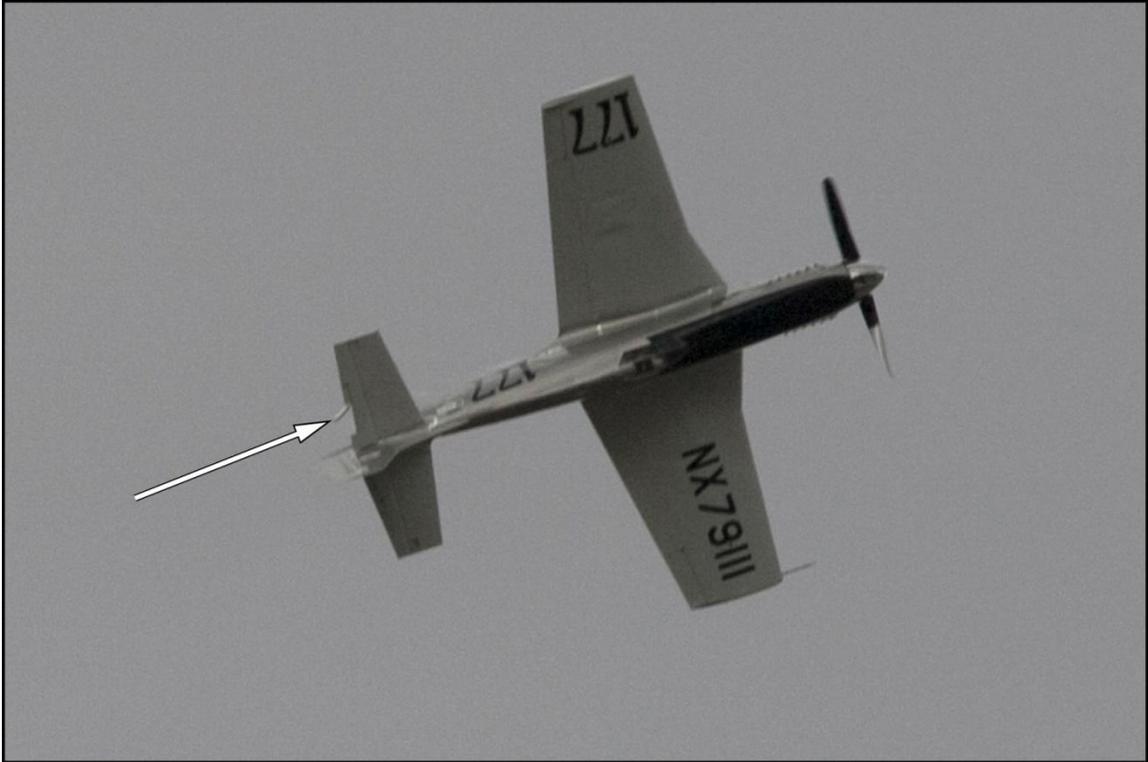
A photograph taken about 1624:32 showed that, as the airplane reached the apex of the climb, the left elevator trim tab was detached from its inboard hinge (see figure 9). Another photograph showed that, about 1624:33.5 (about 4.6 seconds after the left roll upset began), the inboard piece of the left elevator trim tab was separated from the airplane (see figure 10).

**Figure 9.** Inboard piece of left elevator trim tab detached from inboard hinge.

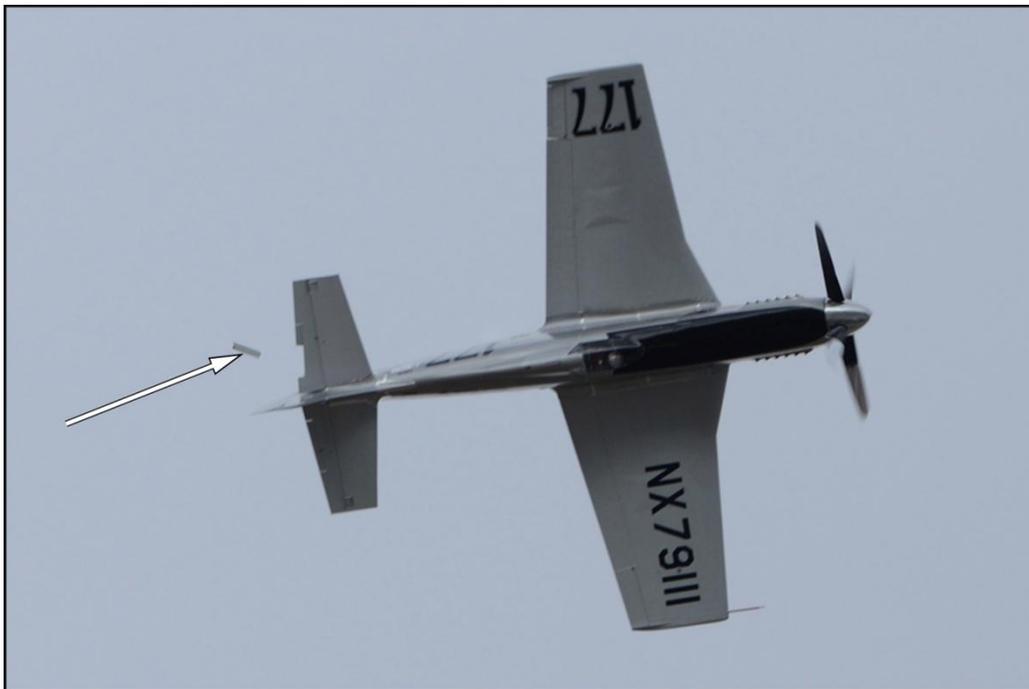
**Figure 10.** Inboard piece of left elevator trim tab separated.

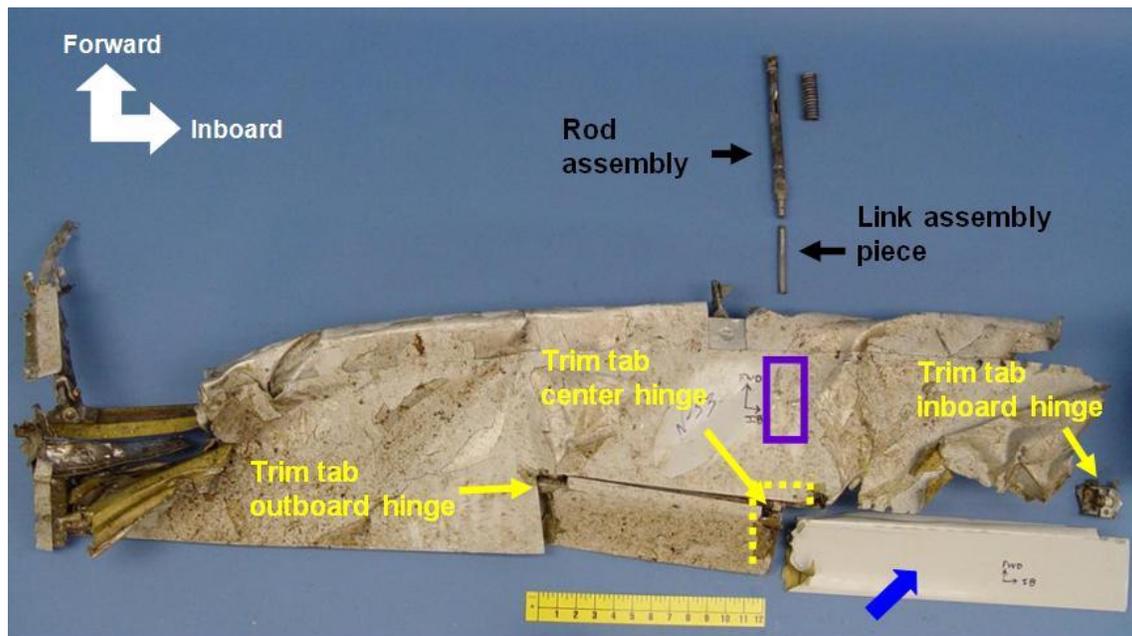
**Figure 12.** Left elevator showing the relative installed locations of the recovered trim tab pieces, trim tab hinges, trim tab rod assembly, and trim tab link assembly piece.

The blue arrow points to the piece of the tab that separated in flight, and the purple box shows a long, upward bulge in the upper elevator skin.

The left elevator trim tab link assembly was buckled and fractured in bending overload in the threaded portion of the clevis with the bending process producing an upward bulge in the upper skin of the elevator (indicated by the purple box in figure 12). Evidence of subsequent oscillations of the free trim tab was indicated by scoring on the elevator's lower skin material, and on the fracture of the link assembly's tubing section, which showed notched fracture faces from repeated contact.

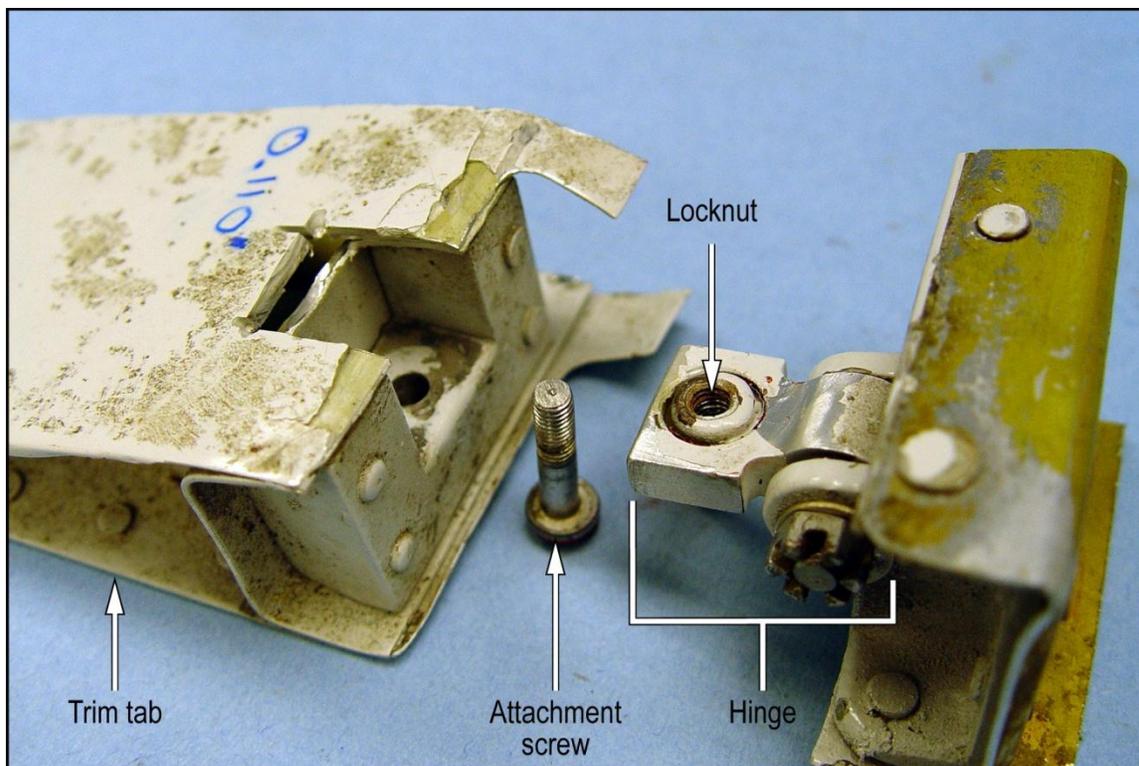
Each elevator trim tab is attached to three hinges on the elevator, with one screw per hinge (see figure 13). Examination of the left elevator trim tab pieces and the right elevator trim tab revealed that each had two intact screws (the center and outboard screws for the left tab, and the inboard and outboard screws for the right tab).

**Figure 13.** Section of right elevator trim tab (view of underside) showing the inboard hinge, attachment screw, and locknut.

All of the intact elevator trim tab attachment screws were loose with negligible resistance from their respective locknuts. The locknuts showed evidence of yellow paint beneath the uppermost coat of paint; records show that the airplane had been painted yellow before the 1985 NCAR. For each intact screw, the fiber locknut insert material applied little to no clamping pressure on the screw threads, and all of the inserts showed evidence of age and reuse<sup>37</sup> (see figure 14). The mating surfaces between each trim tab and its respective outboard, center, and inboard hinges displayed varying degrees of missing paint and exposure of bare metal, consistent with relative motion due to the loose screws. The left trim tab's outboard trim tab screw was slightly shorter than specified, and the center trim tab screw was significantly shorter than specified and its tail was flush with the end of the locknut.

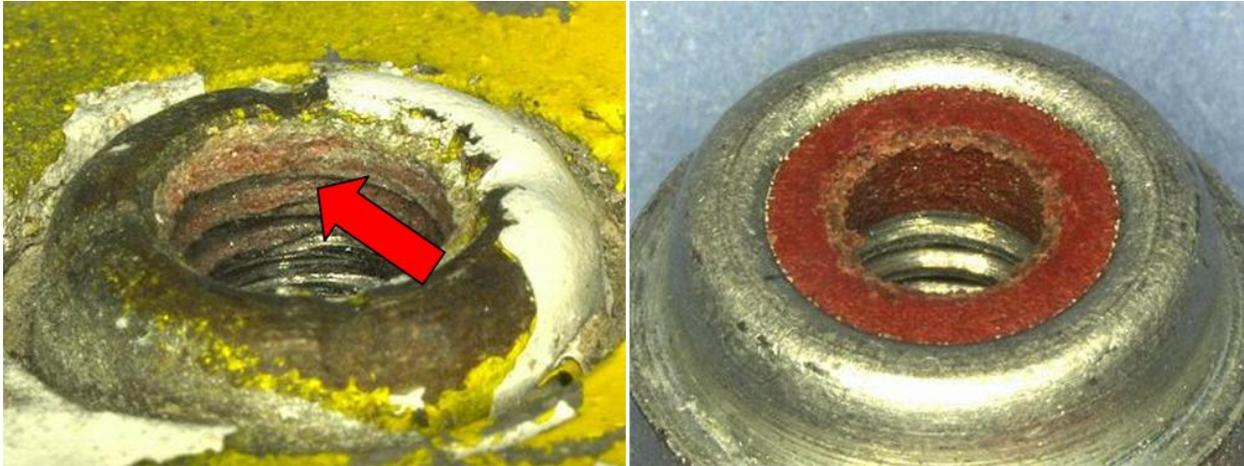
<sup>37</sup> Common maintenance guidance indicates that a locknut with a fiber or nylon insert should not be reused if it cannot meet the minimum prevailing torque values. See AC 43.13-1B, "Acceptable Methods, Techniques, and Practices – Aircraft Inspection and Repair," chapter 7, paragraph 64 (f).

**Figure 14.** Locknut in the left elevator trim tab outboard hinge.

Red arrow indicates red insert material (left) and an exemplar new locknut shows intact fiber insert material (right).

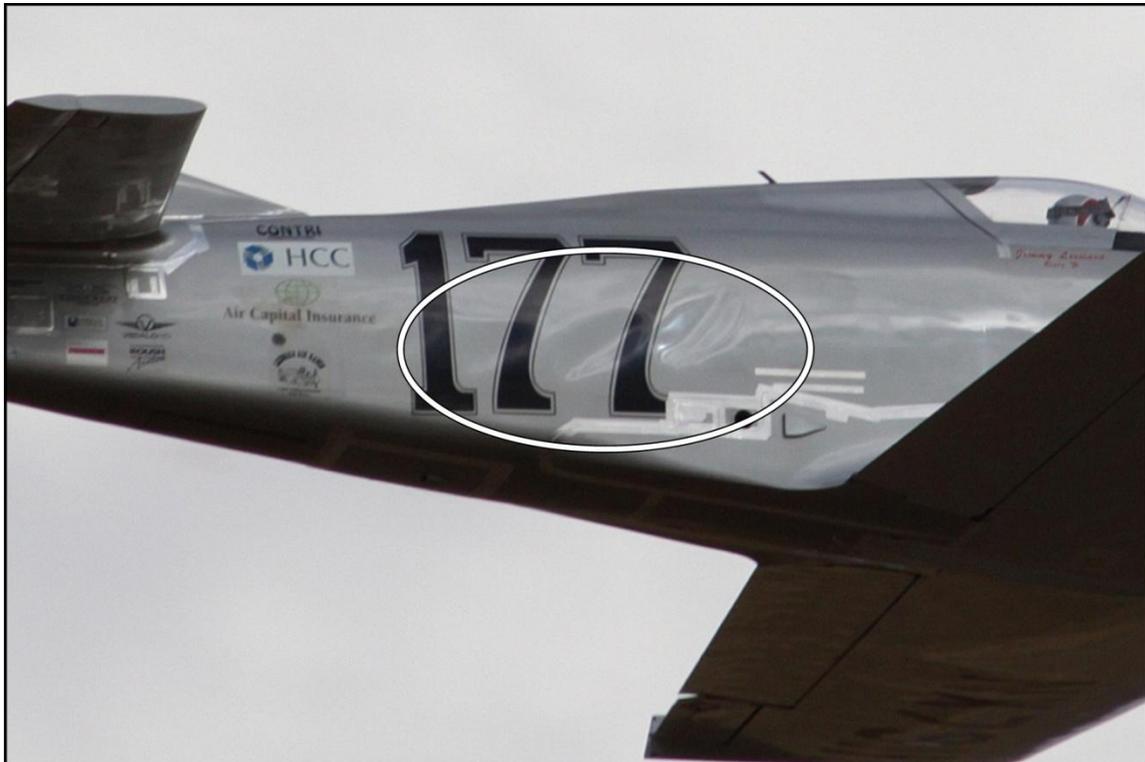
Photographs of the airplane taken during the accident race showed that structural deformation was visible in flight. Figure 15, which was cropped from a photograph taken during the race's second lap, shows that diagonal wrinkles were evident on the right side of the aft

**Figure 15.** Diagonal wrinkles on right side during accident race.

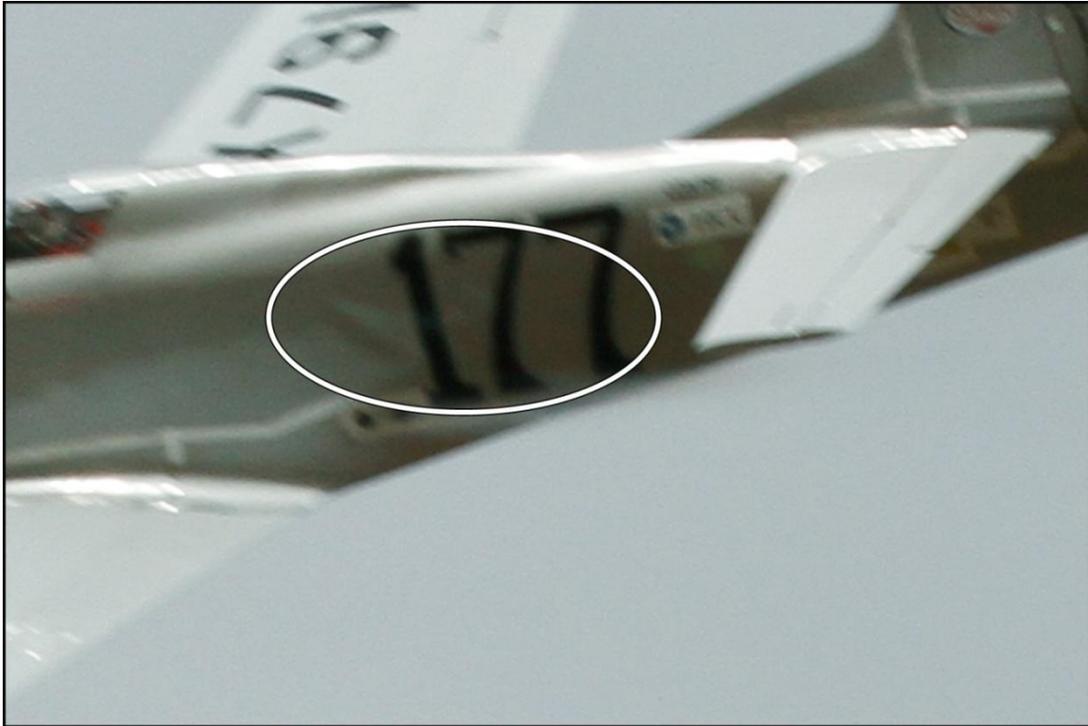
fuselage. Figure 16, which is a photograph that was taken as the airplane passed pylon 2 during the accident lap, shows that similar (although less pronounced) diagonal wrinkles were evident on the airplane's left side; photographs showed that this deformation was evident during all three laps of the accident race and during qualifying flights performed on September 13, 2011. Figure 17, which was taken during the first lap of the accident race, shows that deformation was evident along the canopy and windscreen, such that a gap was visible; this deformation was also evident in photographs taken during the third lap of the accident race but was not evident in prerace photographs of the airplane on the ground.

**Figure 16.** Diagonal wrinkles on left side during accident race.

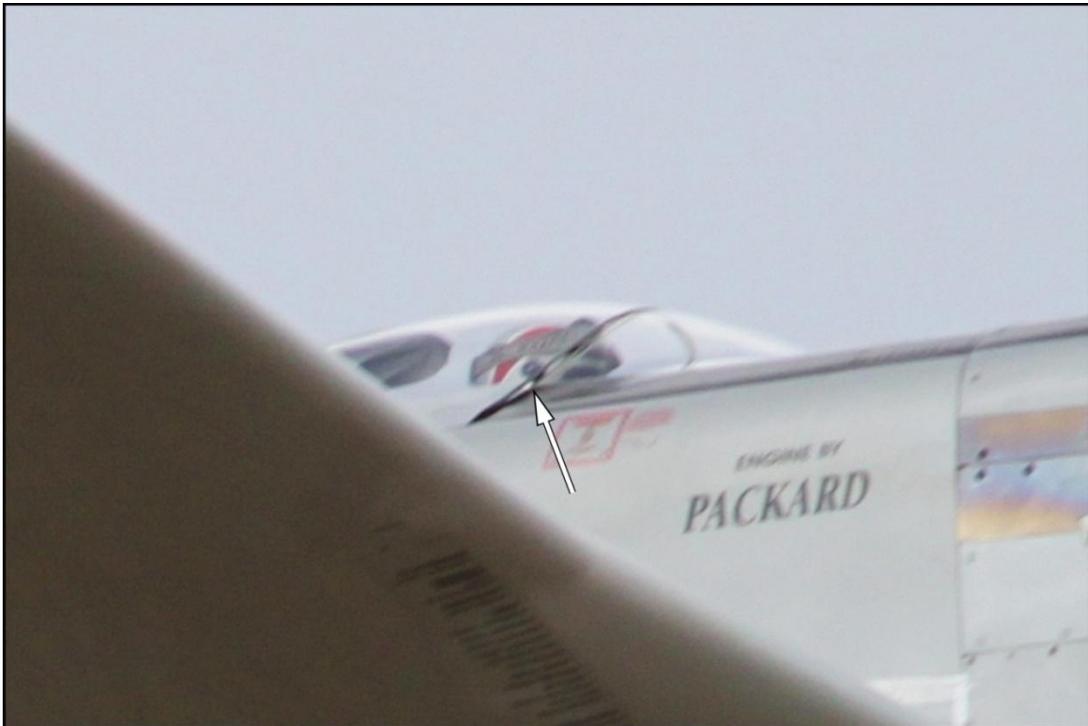
**Figure 17.** Gap between canopy and windscreen in flight.
