# National Transportation Safety Board

## Aircraft Accident Brief

**Accident Number:** DCA11PA075  
**Operator/Flight Number:** Omega Aerial Refueling Services, Flight 70  
**Aircraft and Registration:** Boeing 707, N707AR  
**Location:** Point Mugu Naval Air Station, California  
**Date:** May 18, 2011  
**Adopted:** January 2, 2013

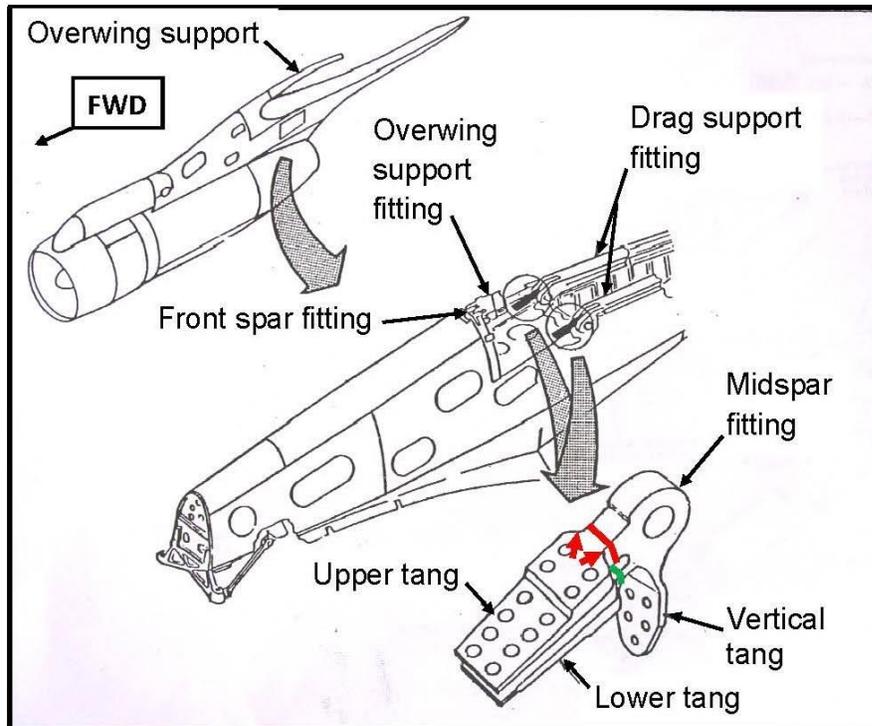
The No. 2 engine nacelle strut attaches to the wing at four primary locations: an upper connection, which consists of the overwing support fitting and the front spar fitting; lower connections, which consist of the lower spar fitting, diagonal brace (thrust link), and the wing aft drag fitting; and two middle connections, which consist of the midspar and wing drag support fittings and the vertical attach fittings. As shown in figure 1, the midspar fitting is of a right-angle configuration in which the vertical tang attaches to the pylon bulkhead and the horizontal upper and lower tangs sandwich the midspar of the pylon. The lug at the center of the fitting is attached to the forward drag support fitting on the underside of the wing. Fractures of the midspar fitting were observed at the upper and lower horizontal tangs (as indicated by the red and green lines in figure 1) at the radius (indicated by the red arrows), where the tangs merge with the lug at the fitting's center.

**Figure 1.** Diagram of a Boeing 707 engine nacelle strut, showing the fracture area on the midspar fitting.

The Nos. 1 and 2 engine pylon fitting components were brought to the NTSB Materials Laboratory for examination. Metallurgical examination revealed that the No. 1 pylon-to-engine bolts, the No. 1 engine pylon-to-wing fittings, and the No. 2 engine pylon-to-wing fittings all failed in an overload event with the exception of the upper and lower tangs of the inboard midspar fitting on the No 2. pylon, which failed due to fatigue.

The upper tang of the No. 2 pylon inboard midspar fitting failed in the reduced section between the lug where the drag support fitting was normally attached and the chromium-coated radius, with the fatigue initiating at its upper inboard corner and occupying approximately 15 percent of the fracture surface. Corrosion product covered the fatigue fracture surface, consistent with it being exposed to the atmosphere for a significant time. Chemical cleaning of the fatigue fracture surface revealed that mechanical damage had obliterated any fatigue fracture features that may have been generated in the upper inboard corner and the corrosion product had obliterated any fine fatigue features, such as striations, leaving only vestiges of crack arrest marks. The lack of striations prevented a striation count analysis. The cleaning procedure also revealed surface fissures on the fatigue fracture surface that were oriented parallel to arc-shaped crack arrest marks and are consistent with high-stress, low-cycle fatigue propagation.

The lower tang of the No. 2 pylon inboard midspar fitting failed in the inboard chromium-plated radius with the fatigue initiating at multiple locations in the upper portion of the inboard edge and occupying approximately 1 percent of the fracture face.

The plated radii in the No. 2 pylon midspar fittings were measured at a nominal 0.38 inch, identifying them as the older style fittings that should have been replaced in accordance with the effective AD. The new midspar fittings have radii of 1.0 inch.

The No. 2 engine pylon midspar fitting had a preexisting fatigue crack that had propagated to a critical length before or during the accident flight takeoff. The fatigue crack initiated at the upper inboard corner of the reduced section between the lug where the drag support fitting is normally attached and the chromium-coated radius. Corrosion product covered the fatigue fracture surface, consistent with it being exposed to the atmosphere for a significant time. The reduced section radius was measured and found to be a nominal 0.38 inch. The 0.38-inch radius is consistent with an older fitting design that was subject to a series of Boeing SBs and FAA ADs calling for repetitive visual inspections and eventual replacement with a more fatigue-resistant design incorporating a 1.0-inch radius. Replacing the older fitting design was a terminating action for the repetitive inspections.

Boeing Alert Service Bulletin (ASB) 707-00A3537-00, issued on January 30, 2012, gives instructions to inspect for the correct engine No. 2 and 3 nacelle strut midspar fittings and to perform immediate replacement if the wrong fitting is found. The ASB also calls for application of a droop stripe, inspection of the engine Nos. 1, 2, 3, and 4 nacelle struts for droop, and a high-frequency eddy current inspection for any crack of the visible lug area of the inboard and outboard strut midspar fittings (new design) on the No. 2 and 3 engines. A drooped nacelle strut indicates that a midspar fitting may have fractured. Installation of an incorrect midspar fitting can result in a fatigue crack, which can cause the fitting to fracture. A fractured midspar fitting can result in a separation of the nacelle strut and engine from the airplane in flight. On August 17, 2012, the FAA published AD 2012-16-12, effective September 21, 2012, requiring the provisions of ASB 707-00A3537-00.

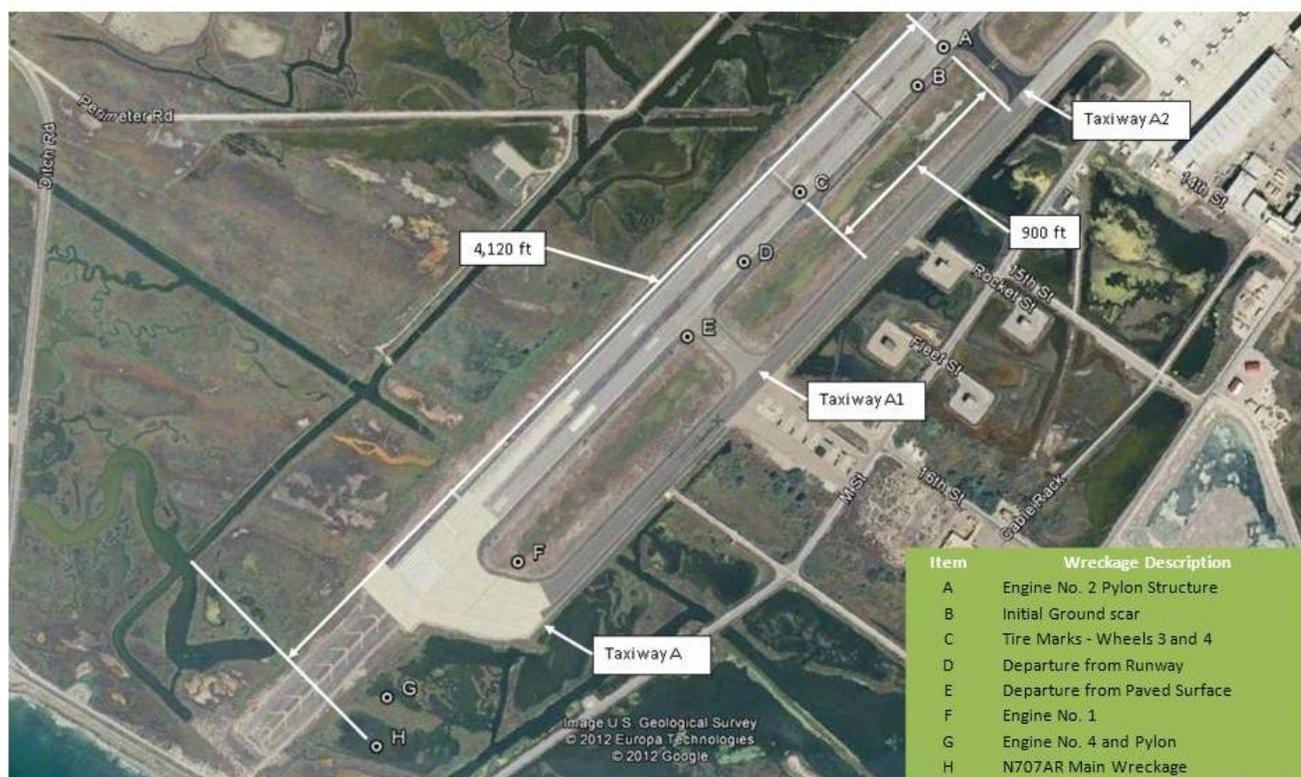
As shown in figure 2, a 4,120-foot debris field began about 7,500 feet from the approach end of runway 21, near taxiway A2. Main landing gear tire marks indicated that the airplane regained contact with the runway about 900 feet into the debris field, departed the runway on a 218° heading near taxiway A1, and continued across the grass infield and taxiway A before coming to rest in a saltwater marsh where it caught fire. The first pieces of wreckage found along the debris path were a fragment of the No. 2 engine pylon torque bulkhead and a piece of the No. 2 pylon overwing fitting, located just past taxiway A2. The No. 1 engine nose cowl was found in the grass infield near taxiway A about 450 feet further into the debris field and left of the runway surface; it exhibited crush damage consistent with contact with the No. 2 engine. The No. 2 engine nose cowl was located near the runway arresting gear on the left side of the runway at the 8,500 foot point. The No. 2 engine was found about 230 feet further, on the left side of the runway surface. Intermittent scrape marks leading to the No. 2 engine were observed on the runway beginning about 7,800 feet, consistent with the engine tumbling after separating from the wing.

**Figure 2.** Aerial photograph of the debris field.

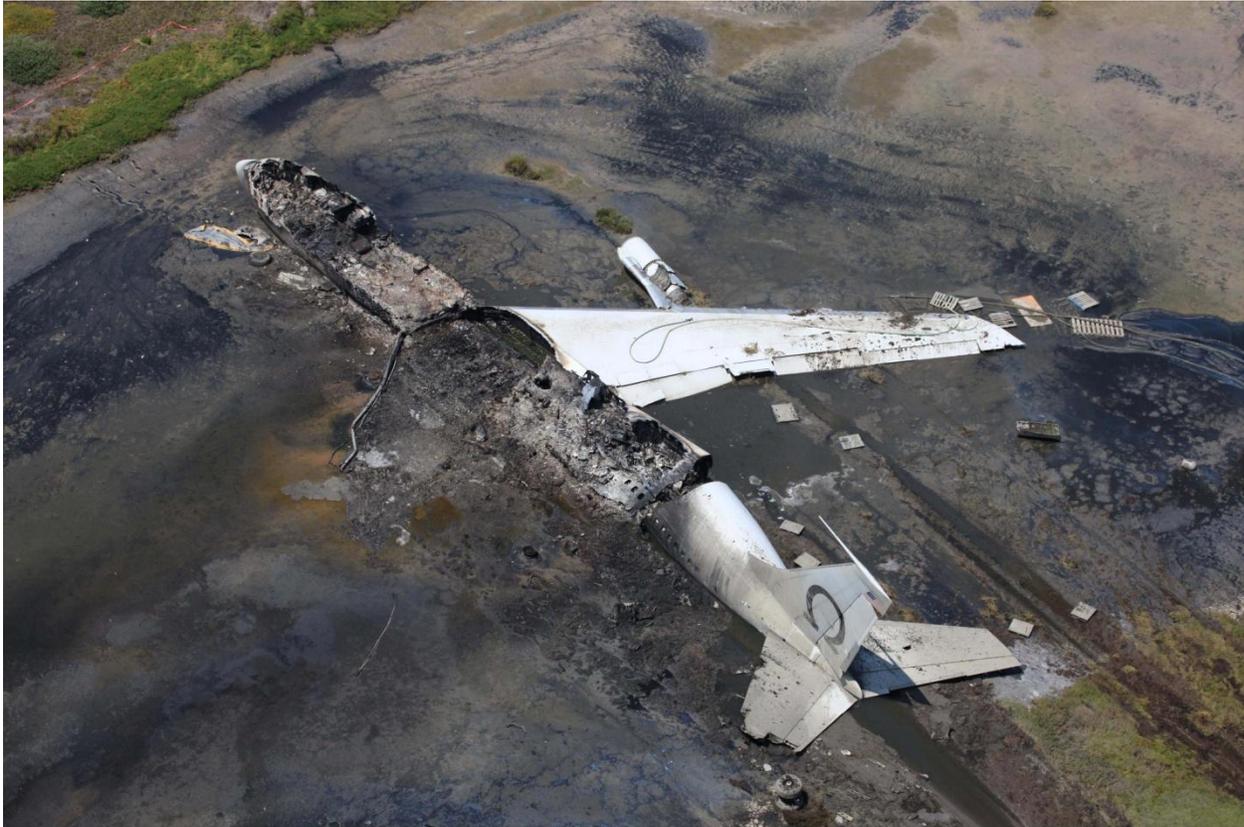
Fire consumed the top of the cabin and the cockpit (see figure 3). The main wreckage, which came to rest in the wetland marsh, consisted of the cockpit and cabin; the right wing with the No. 3 (right inboard) engine partially attached; the empennage; and the inboard half of the left wing, which sustained thermal damage and was submerged in water. Scattered debris aft of the main wreckage included the nose gear, remnants of the burned outboard left wing, right main landing gear truck, and No. 4 (right outboard) engine.

**Figure 3.** Aerial photograph of airplane wreckage.
