National Transportation Safety Board

Accident Number: DCA11MA039
Operator/Flight Number: Southwest Airlines, Flight 812
Aircraft and Registration: Boeing 737-3H4, N632SW
Location: Yuma, Arizona
Date: April 1, 2011
Adopted: September 24, 2013

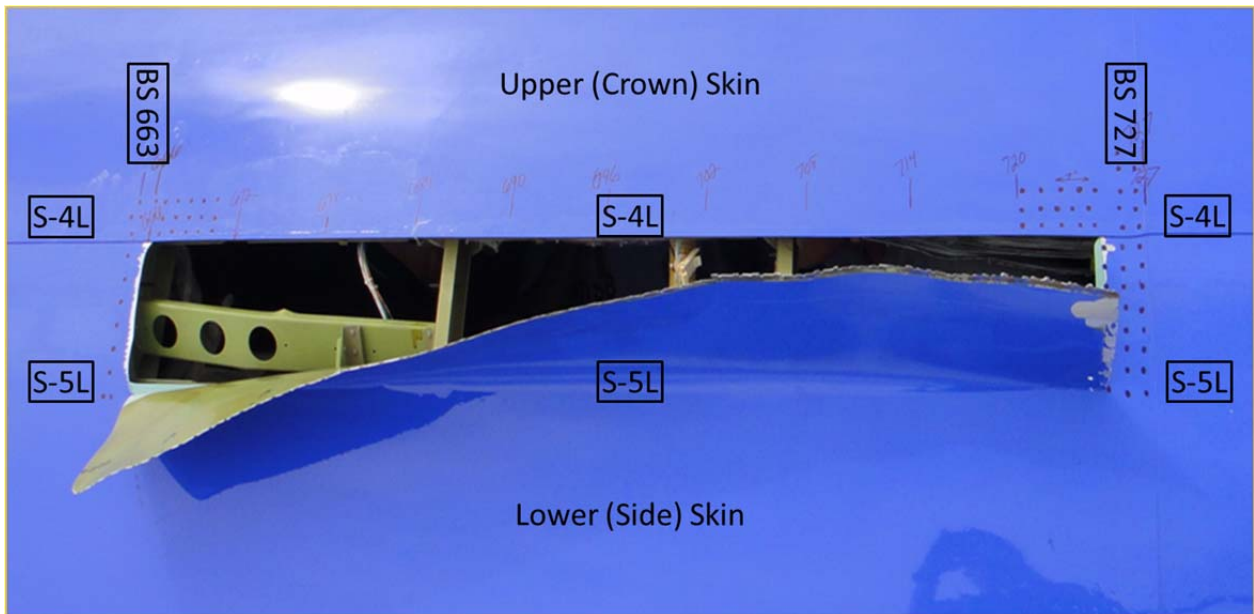
Figure 2. Close-up photograph of hole in fuselage side skin on N632SW.

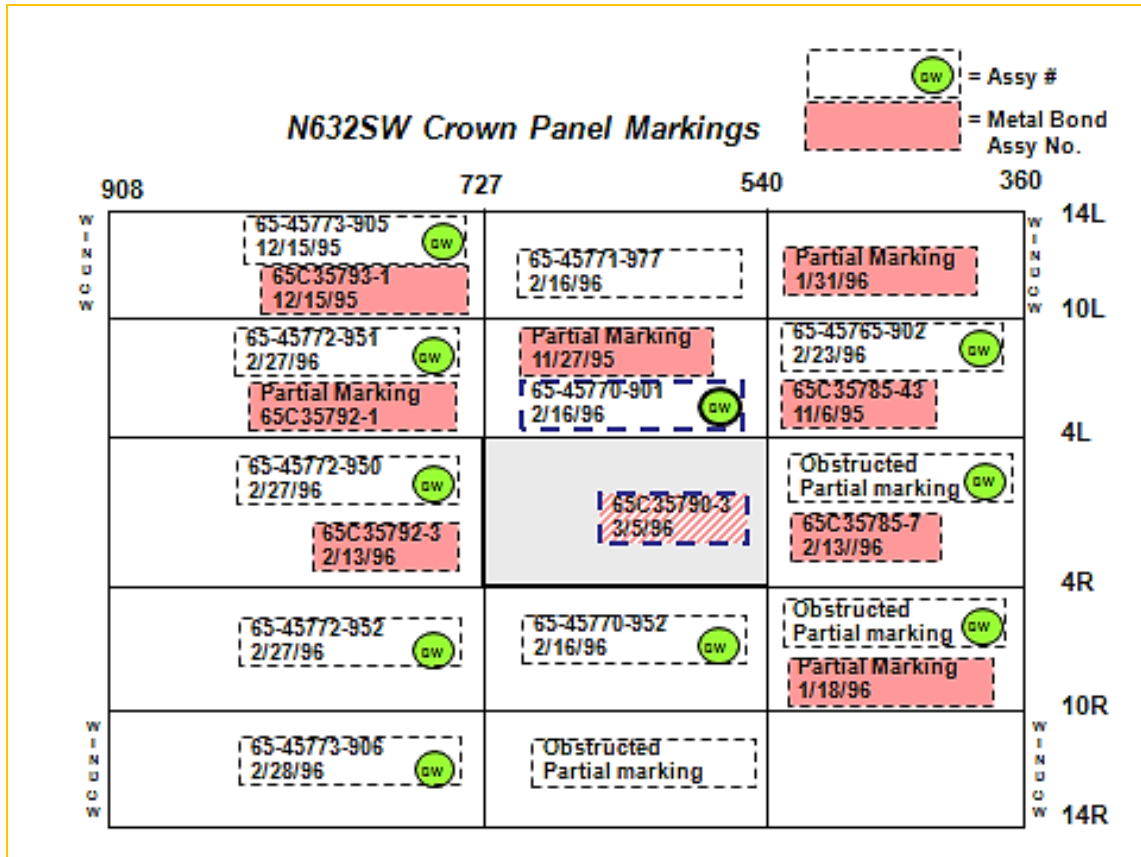
After the accident, all of the airplane’s interior components and insulation were removed, allowing examination of the interior surface of the fuselage skins. The visible markings on the skin panels⁵ surrounding the crown skin panel (BS 540 to BS 727, S-4L to S-4R) immediately above the fractured skin panel were documented. Typically, a skin panel should have two markings: one for the manufacture of the skin panel itself and one for the manufacture of the built-up panel assembly. Additionally, the built-up panel assembly should have a marking to indicate that the assembly had been approved by the QA process. Figure 3 shows the markings on the accident airplane. The three-panel crown assembly from S-10L and S-10R that included the fracture had QA stamps dated February 16, 1996, with the exception of the grey panel in figure 2. The panel assemblies aft of the accident crown panel had QA stamps dated February 27, 1996. One of the three panel assemblies forward of the accident crown panel had a QA stamp dated February 23, 1996, while the other two markings were obstructed. The accident crown skin panel above the fracture and coincident with the lap joint where the fracture occurred only had a stamp for the skin panel manufacture and was dated March 5, 1996.

Figure 3. Documented markings on the accident airplane skin panels.

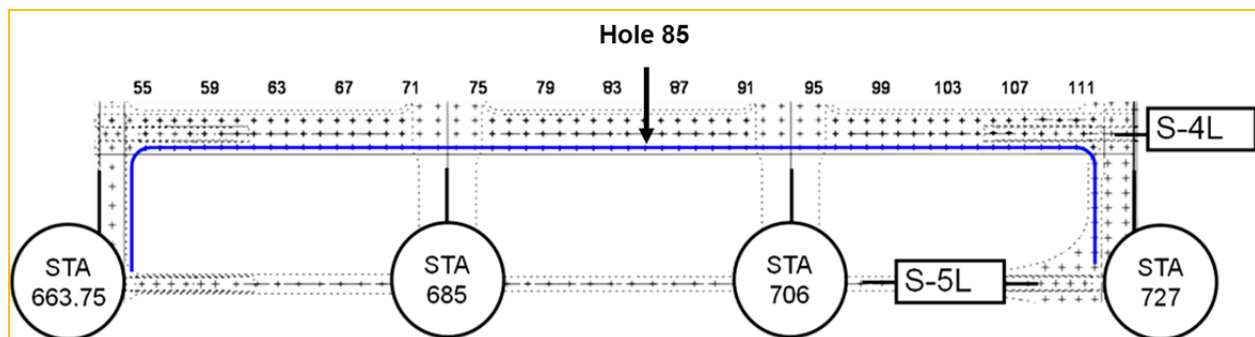
Microscopic examination of the longitudinal portion of the fracture surfaces revealed thumbnail fracture features consistent with fatigue cracking that originated from 54 out of 58 rivet holes. The fatigue cracks emanated from the outer surface of the lower skin. This surface is not visible from the interior or exterior of the airplane. In nine adjoining rivet holes (81 through 89), fatigue cracking occurred through 100% of the skin thickness. The depth of each fatigue crack varied along its length. The two longest fatigue cracks were found on the forward and aft side of rivet hole 85. The crack on the forward side of the rivet hole measured 0.55 inch, and the crack on the aft side measured 0.60 inch. The fatigue cracks propagated forward and aft with respect to each rivet hole. Figure 5 shows a drawing of the fuselage skin in the area of the fracture. As the distance from rivet hole 85 was increased, the length of a fatigue crack on each side of a rivet hole for each successive rivet hole decreased. The fracture face in the areas located outside of the fatigue crack regions showed rough texture features consistent with overstress separation. The remaining 4 of the 58 rivet holes (69, 71, 97, and 98) contained no evidence of fatigue cracking. The fracture intersected two tear straps⁶ at BS 685 and BS 706. The face of the fracture for the tear straps contained no evidence of fatigue cracking.

Figure 5. Drawing of the lap joint in the area of fracture (blue line represents the fracture).
