# **In-Flight Engine Failure and Subsequent Ditching**

**Air Sunshine, Inc., Flight 527**

**Cessna 402C, N314AB**

**NTSB/AAR-04/03**

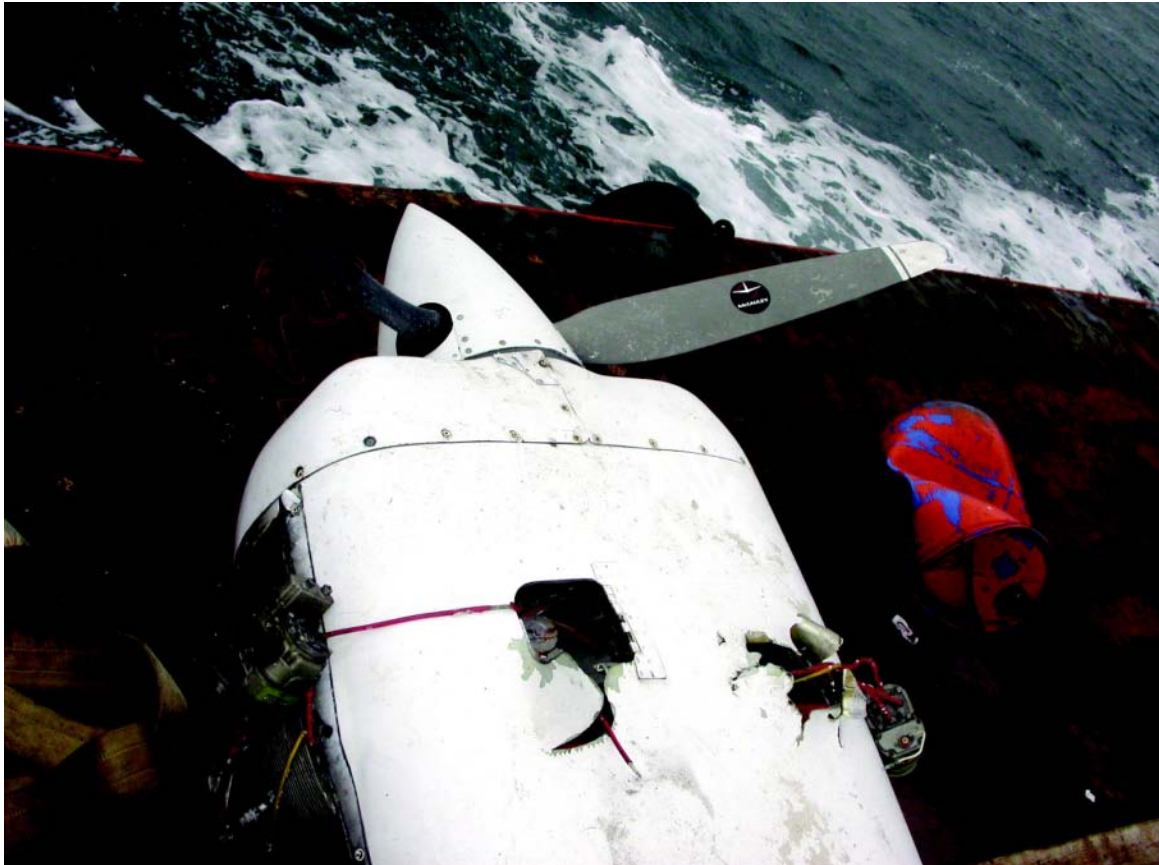
The right engine was attached to the airframe in its normal position, and the propeller was attached to the engine. Damage was noted on the leading edge skin from the engine outboard to the wing tip; the leading edge skin from the engine nacelle inboard of the wing root was crushed up and aft. The lower inboard engine cowling was separated and was not recovered; the lower outboard engine cowling was in place.

**Figure 3.** Exterior of the upper outboard engine cowling.

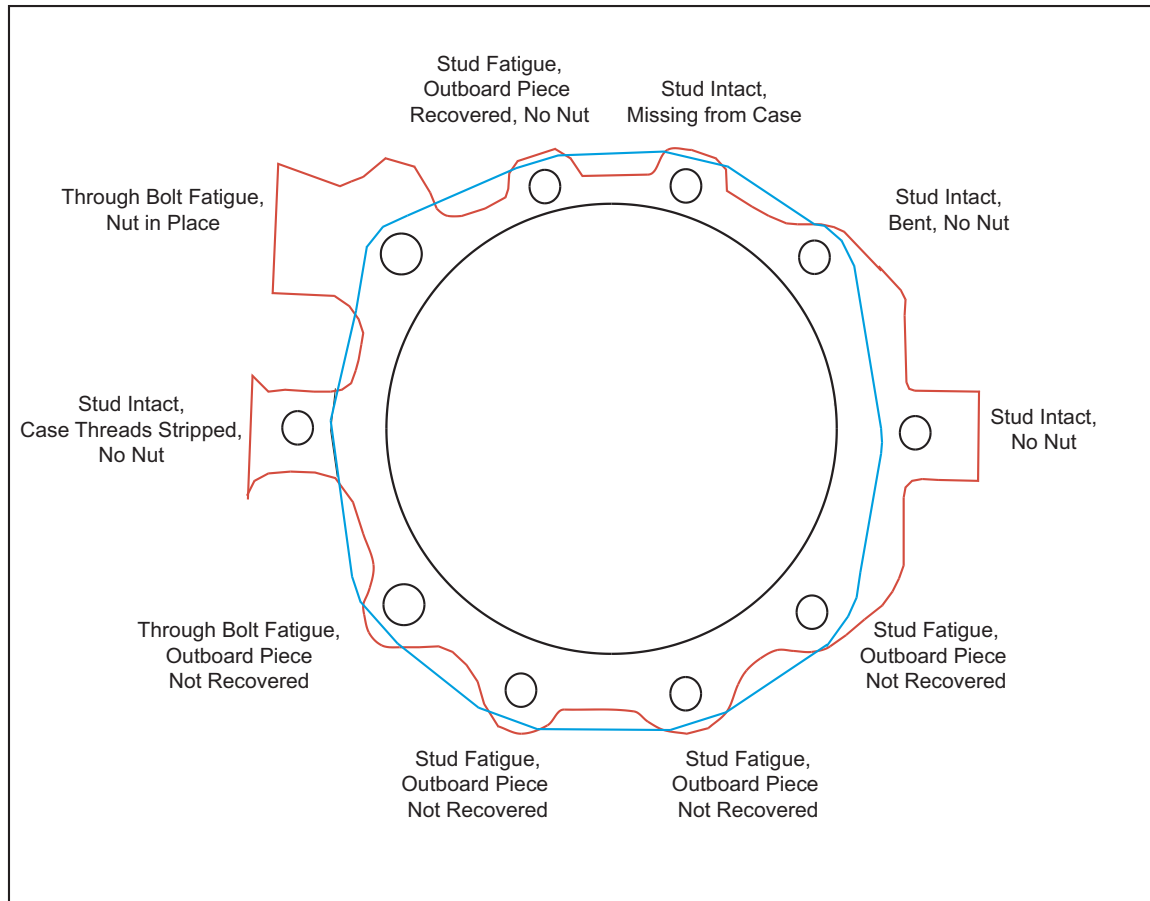
The right engine No. 2 (inboard aft) cylinder was found separated from the engine crankcase, exposing a portion of the crankshaft, and held onto the engine by the exhaust pipe tubing and by an electrical cable that was secured to the cylinder assembly by an adel clamp. The two magnetos were found protruding through the upper outboard engine cowling but remained attached to the engine by ignition leads. (See figure 3.) Two 6-point flanged nuts, one 12-point flanged nut with a fractured threaded piece, and a nonfractured connecting rod were recovered from the engine compartment area. Piston ring pieces were found in the partially separated No. 2 cylinder assembly.

The outboard portions of one of the fractured hold-down studs and one of the fractured through bolts were recovered. The stud piece was found without a nut attached,

and the through bolt piece was found with a nut attached. The outboard portions of the other three fractured studs were not recovered. The other fractured through bolt, which is where the nut would normally be, was not recovered. Figure 4 shows the condition in which the right engine No. 2 cylinder retention system components were found.

**Figure 4.** The condition in which the right engine No. 2 cylinder retention system components were found.

Note: The cylinder base flange is outlined in blue, and the mounting surface is outlined in red.
