In-flight Fire, Emergency Descent
and Crash in a Residential Area
Cessna 310R, N501N
Sanford, Florida
July 10, 2007

Aircraft Accident Summary Report

NTSB/AAR-09/01/SUM
PB2009-910401

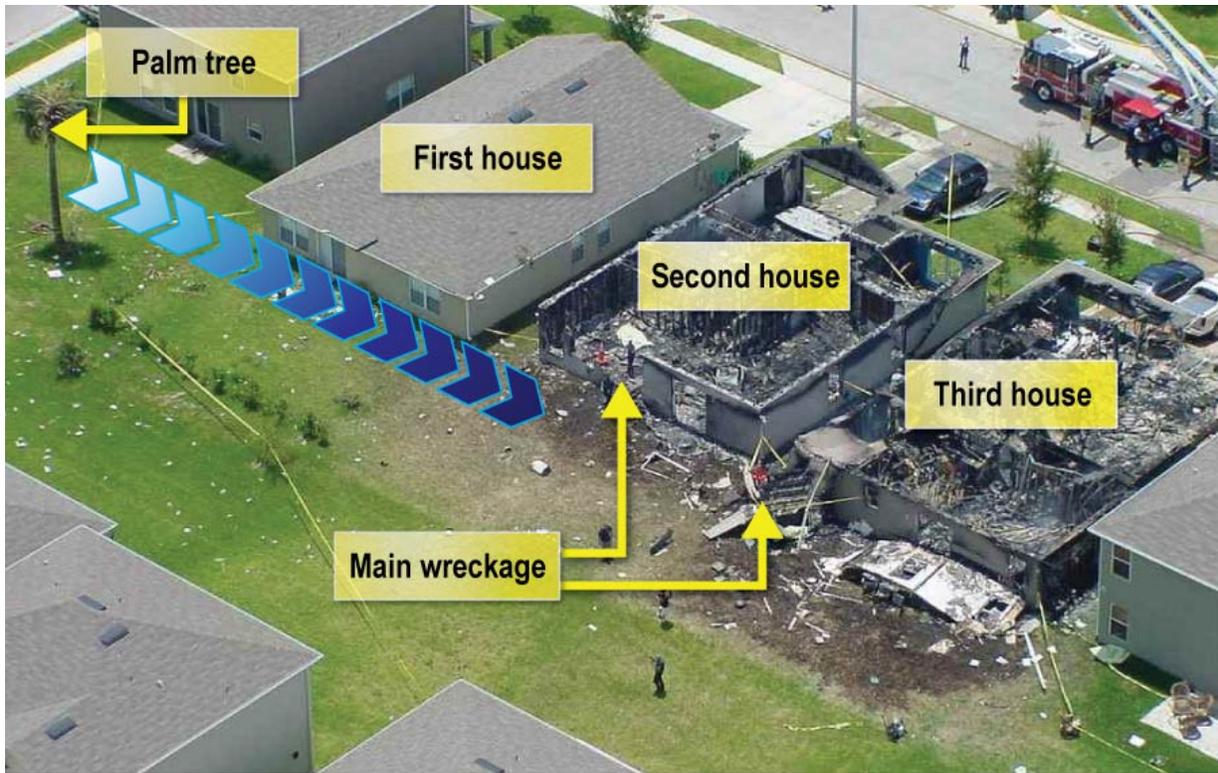
Airplane debris was found along the wreckage path, beginning near the impacted north-south line of trees and continuing to the impacted houses. (See figures 1 and 2.) The instrument panel glare shield⁶ was located on the roof of the first house. Most of the fuselage, the wings, the instrument panel, some avionics, seats, and the right engine were found in and around the second- and third-impacted homes.

Figure 1. Aerial photograph of main wreckage and impacted homes. The blue arrows show the general westerly direction of the airplane's travel at impact.

Further, the cabin door was found about 60 feet away from the main wreckage, as illustrated in figure 1, unburned and with latching pins undamaged. However, numerous soot deposits were noted on the interior side of this door, again consistent with an in-flight fire. These soot deposits trailed across the lower portion of the door from an area that would have been near the lower edge of the instrument panel on the intact airplane to the aft edge of the door. The undamaged latching pins and the location and existence of the observed trailing soot deposit are consistent with the pilots having opened the cabin door to vent smoke during an in-flight fire.

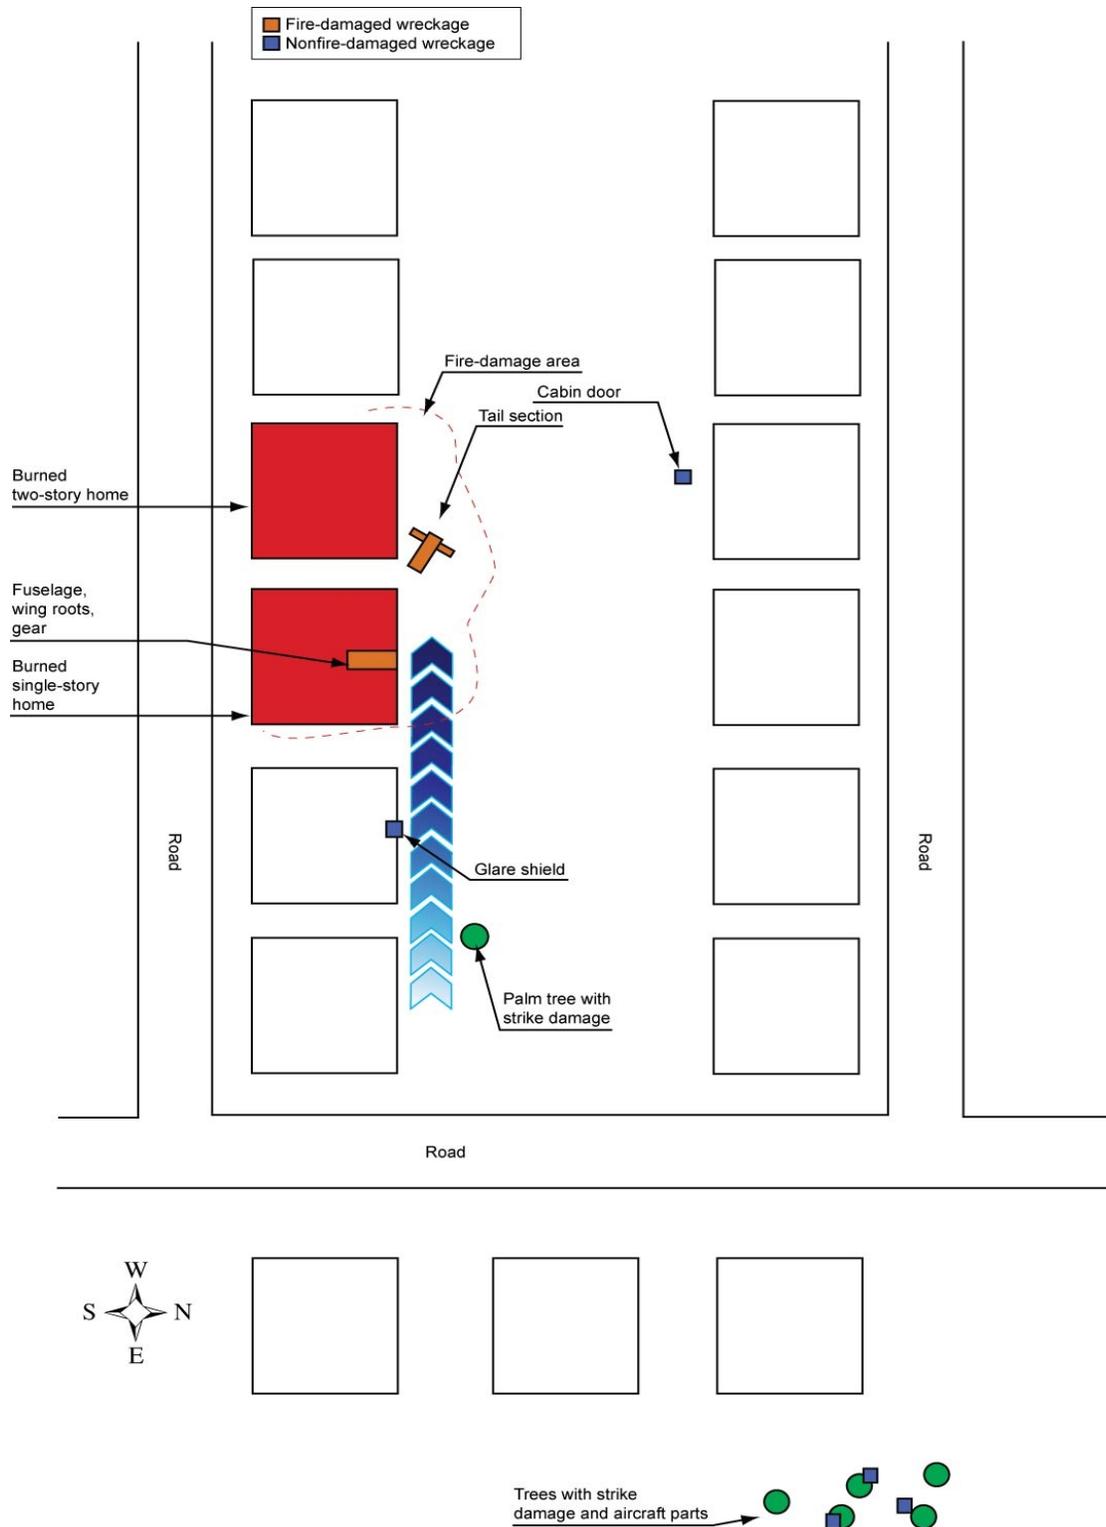
Figure 2. Diagram showing the location of impacted homes and trees and pertinent wreckage. The blue arrows show the general westerly direction of the airplane’s travel at impact. (Diagram not to scale.)
