Crash of Cessna 500, N113SH
Following an In-Flight Collision with Large Birds
Oklahoma City, Oklahoma
March 4, 2008

NTSB/AAR-09/05
PB2009-910405

Crash of Cessna 500, N113SH,
Following an In-Flight Collision with Large Birds,
Oklahoma City, Oklahoma,
March 4, 2008

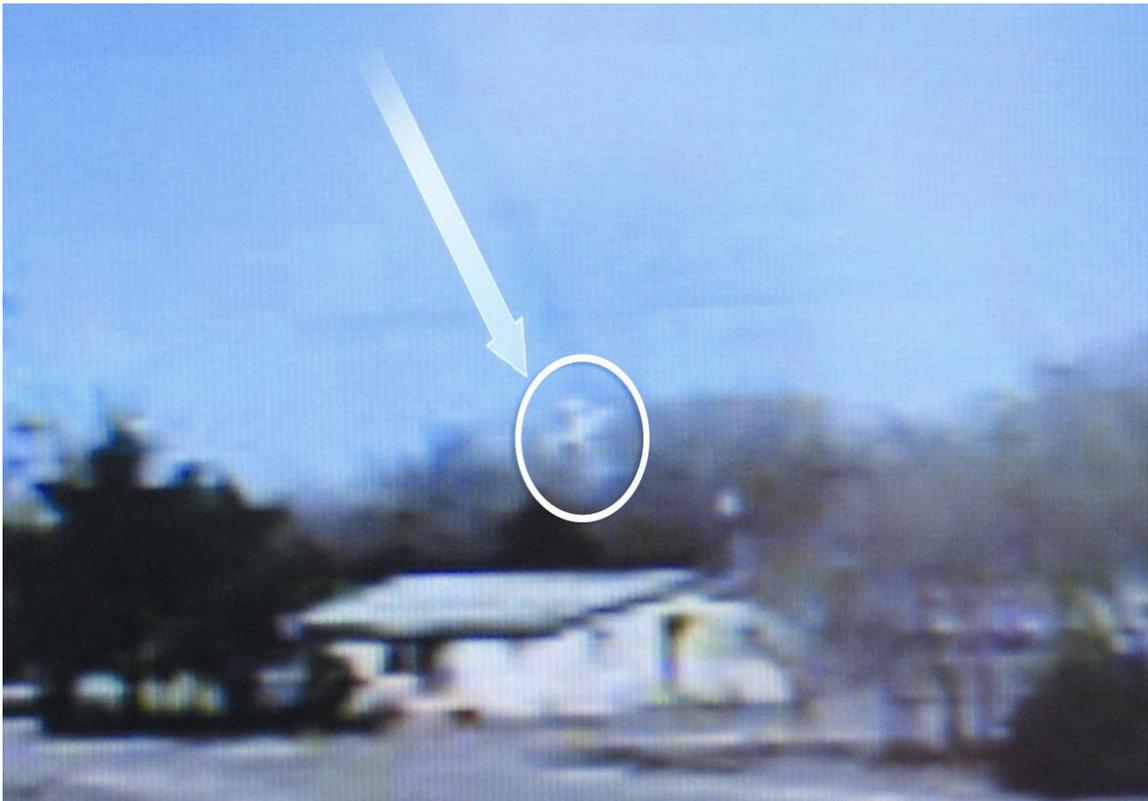
A security camera located about 1/2 mile southwest of the accident site captured images of the accident airplane descending steeply, nose down to the ground while emitting a visible trail. (See figure 1.) The video also showed that a large fireball followed the airplane’s impact.

Figure 1. Screen capture of a video image showing the accident airplane (circled) and the visible trail behind it (to the right of and approximately parallel to the arrow) before ground impact.

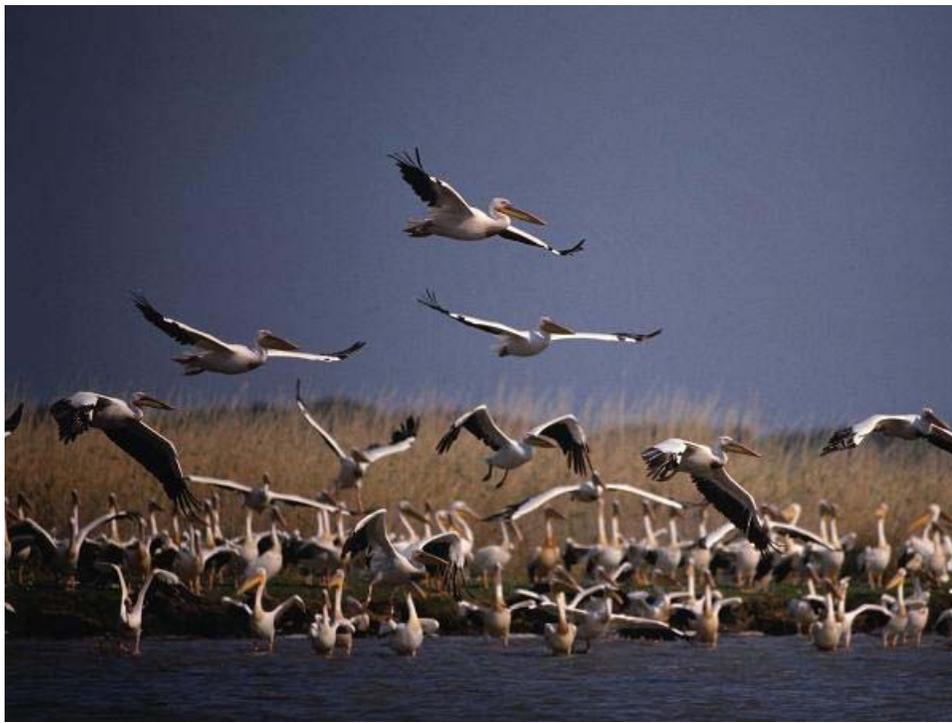
114 in.³² (See figure 2.) The examination of a preserved American white pelican at the Smithsonian Institution's ornithology collection showed that the bird's body could be about 30 in long with a 12- to 15-in diameter.

Figure 2. American white pelicans.

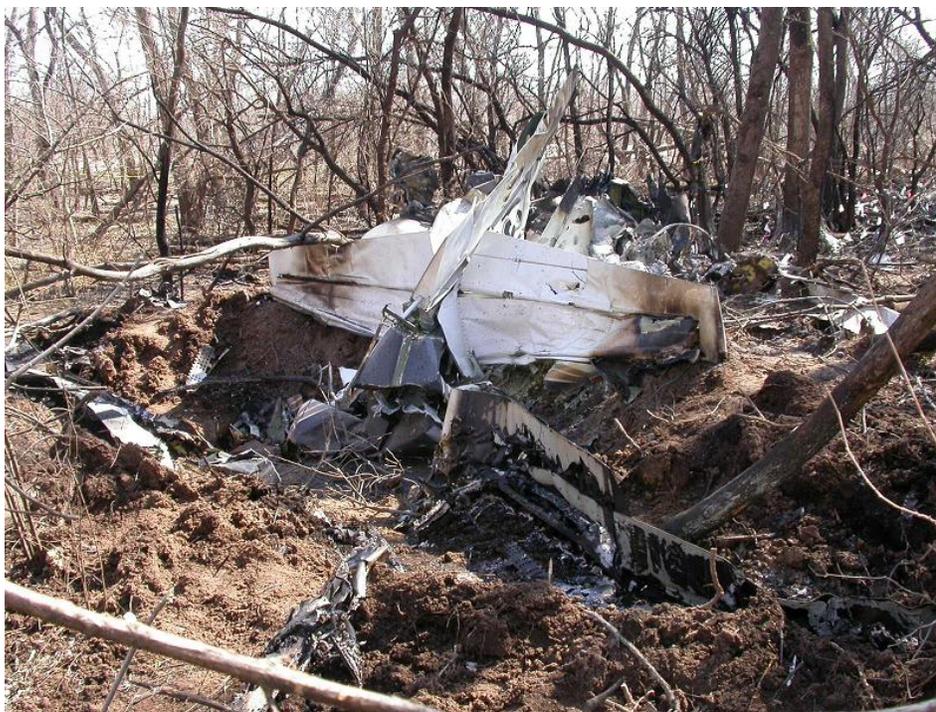
Examination of the airplane’s horizontal stabilizer at the accident site revealed that it was oriented leading-edge down on top of a ground crater that contained fire-damaged wreckage debris. Dark brown to black soot patterns on the left and right horizontal stabilizers and elevators corresponded to the location of fire-damaged wreckage in the crater below. Soot patterns that extended into crush-damage folds on the trailing edge of the left elevator skin corresponded to an area where a damaged tree or tree limb came to rest on top of the wreckage. (See figure 3.)

Figure 3. Horizontal stabilizers and elevators with fire-damaged wreckage below.
