Crash During Approach to Landing of
Maryland State Police
Aerospatiale SA365N1, N92MD
District Heights, Maryland
September 27, 2008

NTSB/AAR-09/07
PB2009-910407

**CRASH DURING APPROACH TO LANDING OF
MARYLAND STATE POLICE AEROSPATIALE SA365N1, N92MD,
DISTRICT HEIGHTS, MARYLAND, SEPTEMBER 27, 2008**

Aircraft Accident Report

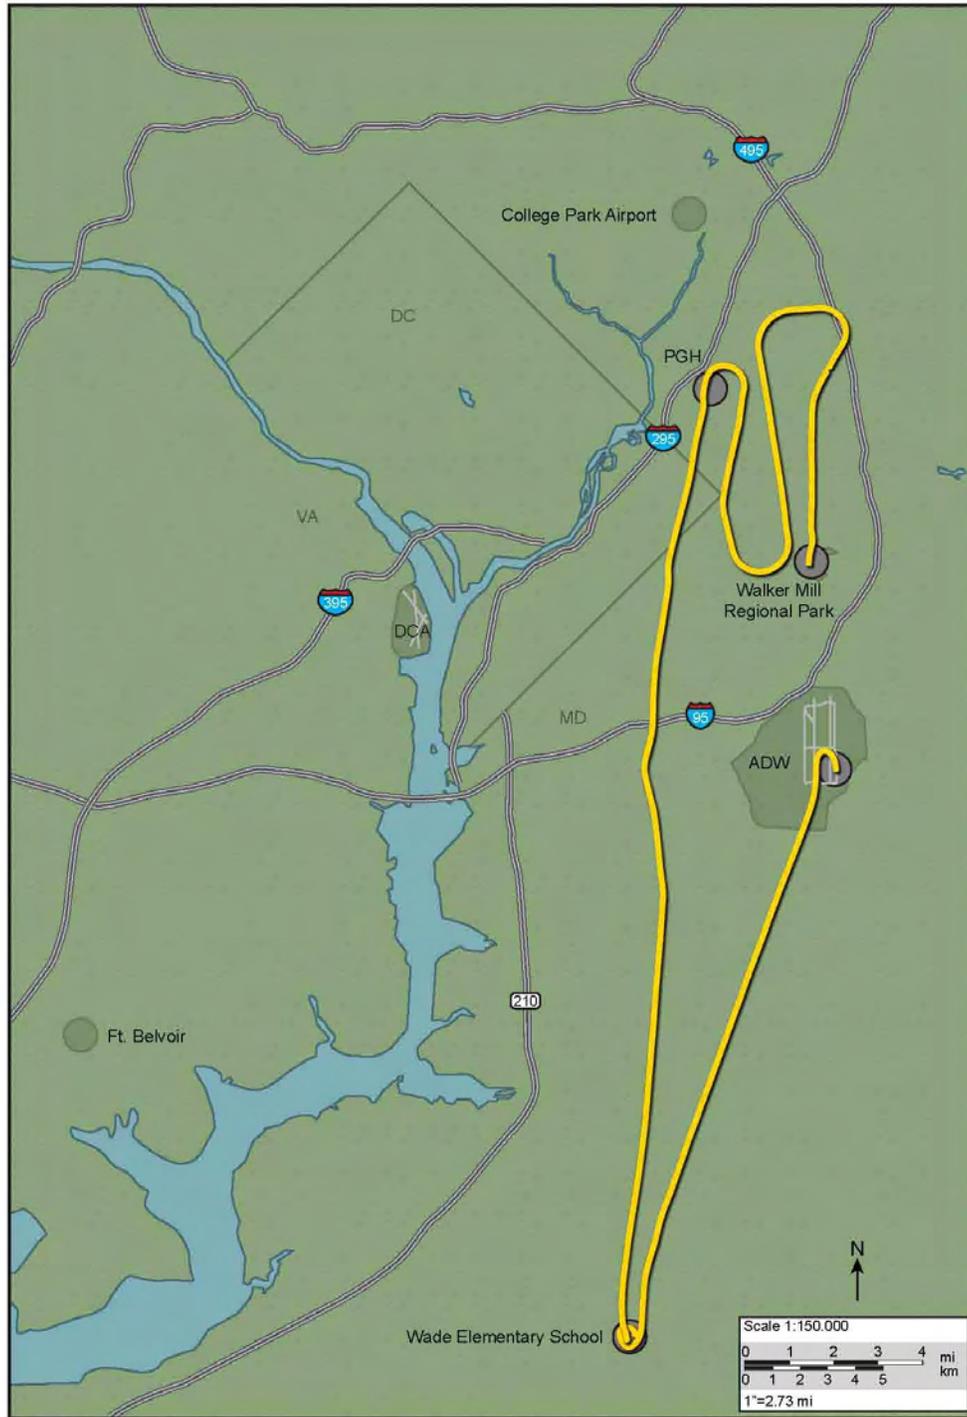
Figure 1. Trooper 2 ground track indicated by yellow line.

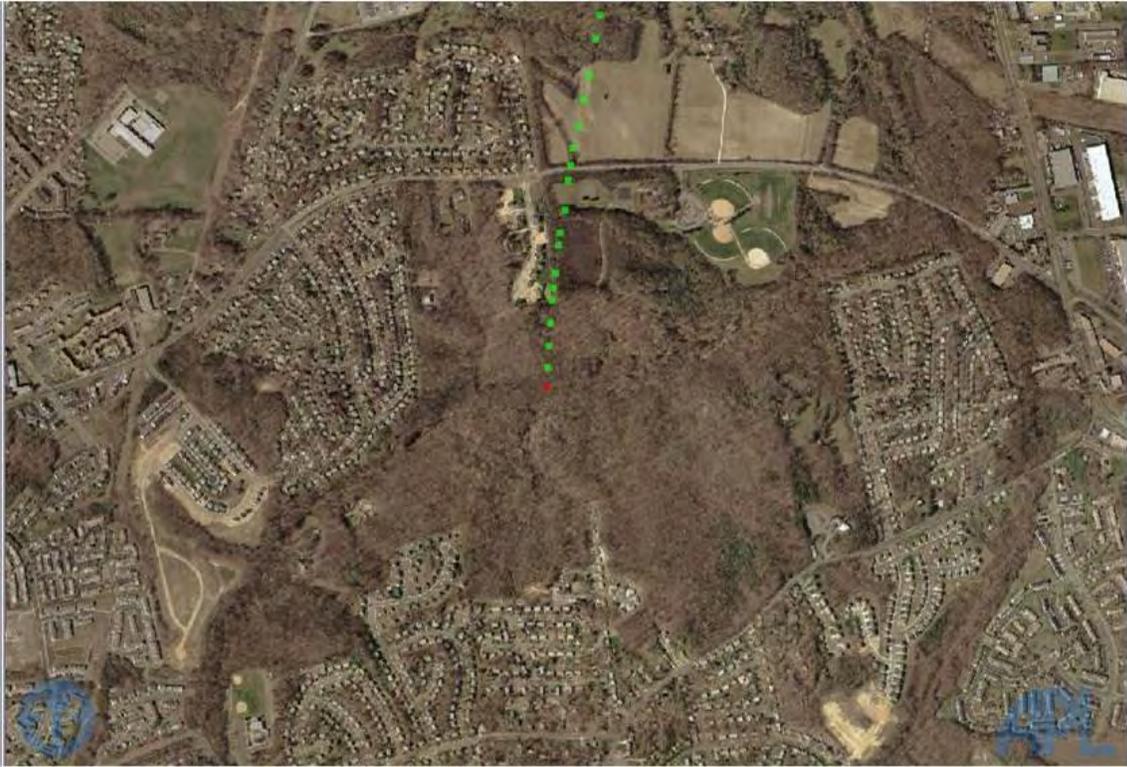
The accident occurred about 3.2 miles from the threshold of runway 19R and along the extended runway centerline. The wreckage was found in a heavily wooded area of Walker Mill Regional Park at an elevation of about 200 feet msl. Figure 3 on the following page shows an aerial photo of the park.

Figure 3. Aerial photograph of Walker Mill Regional Park, overlaid with the locations of Trooper 2. Green dots show Trooper 2 locations recorded by ADS-B; the red dot is the last ADS-B target received.

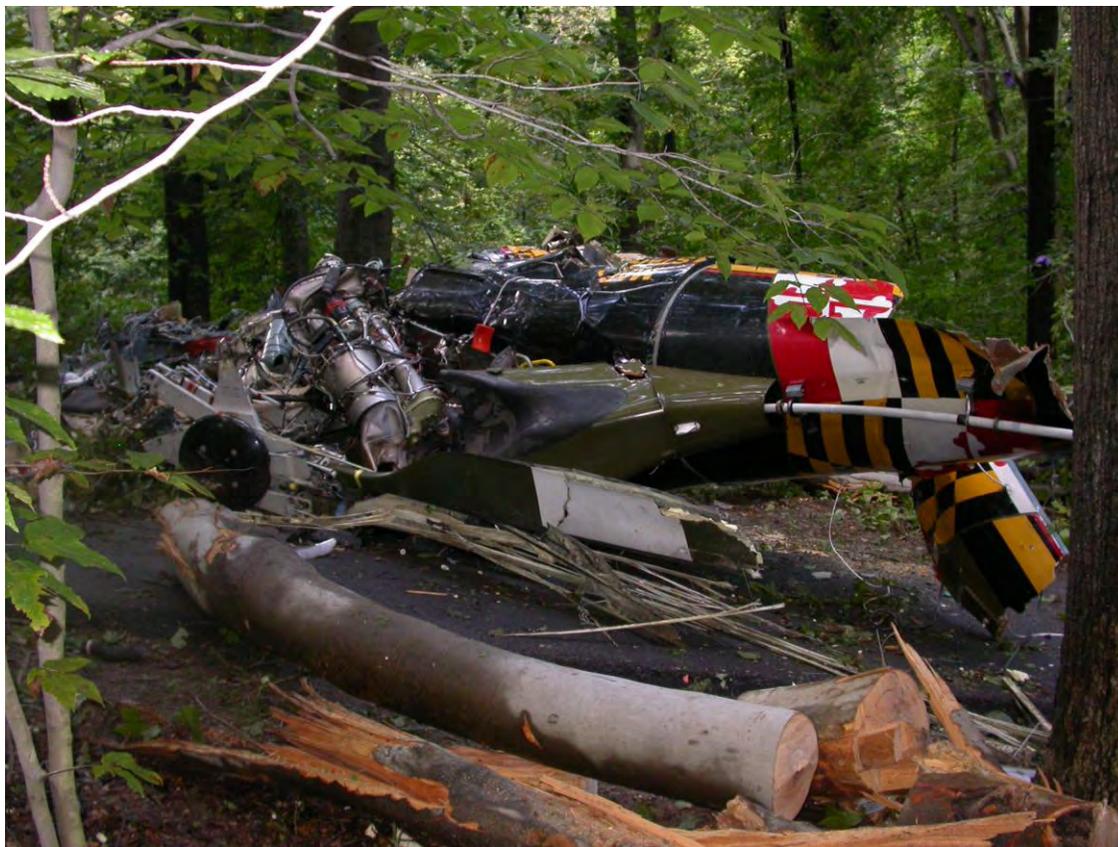
Examination of the crash site revealed that the helicopter initially collided with the upper section of an 80-foot tree in a level, descending attitude on a heading of 191° magnetic. A debris path approximately 164 feet long extended from this tree to the main wreckage. The helicopter was separated into three main parts and many smaller pieces. All components of the helicopter were accounted for at the accident site. In addition, no evidence was identified of any preimpact mechanical failures or malfunctions of the aircraft's systems or the airframe.

As shown in figure 5 below, the fuselage came to rest on its left side. The right side of the fuselage was crushed and exhibited horizontal scrape marks, and the cabin and cockpit areas were extensively damaged. The right-side pilot's door was located in a tree near the main wreckage.

Figure 5. Photograph of the accident site.

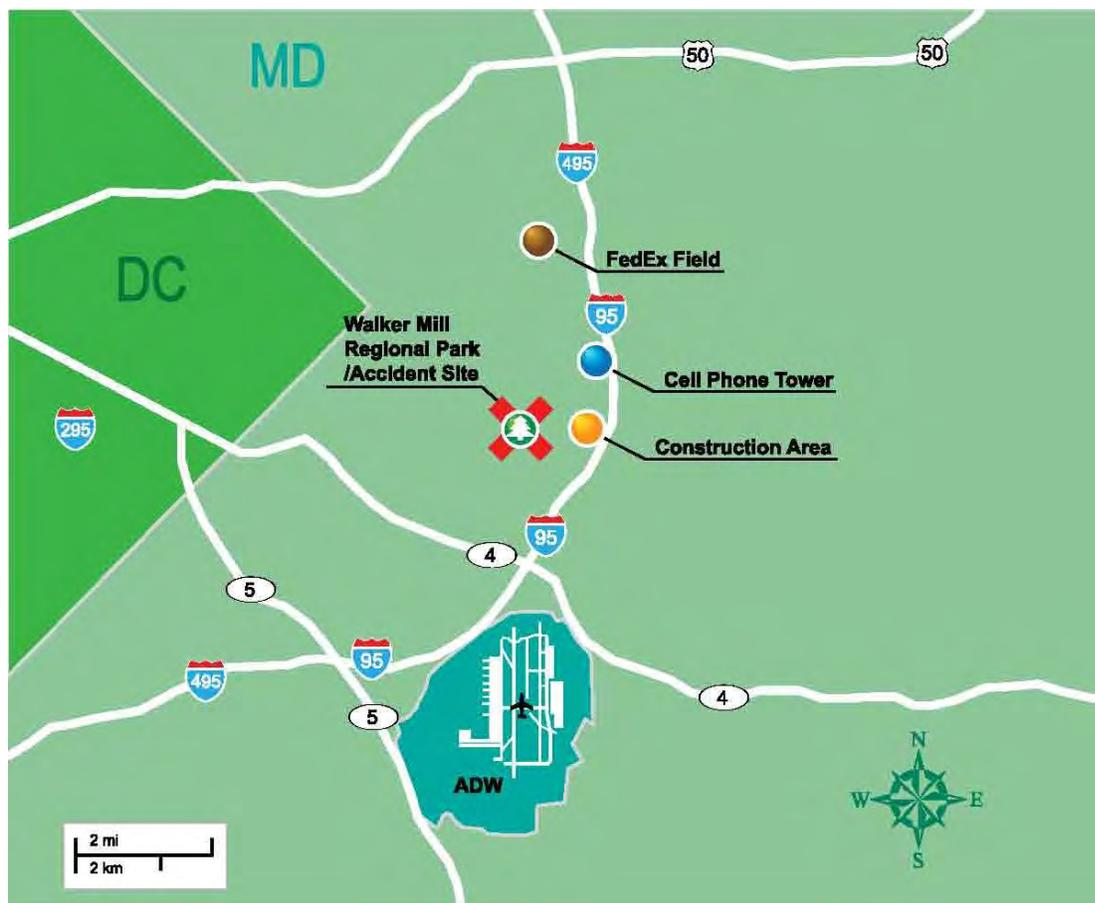
minutes, seconds. The DO also added that the location of the coordinates was approximately 2 nautical miles southwest of FedEx Field.⁴² (See figure 6 below.)

Figure 6. Map of search area (not to scale).

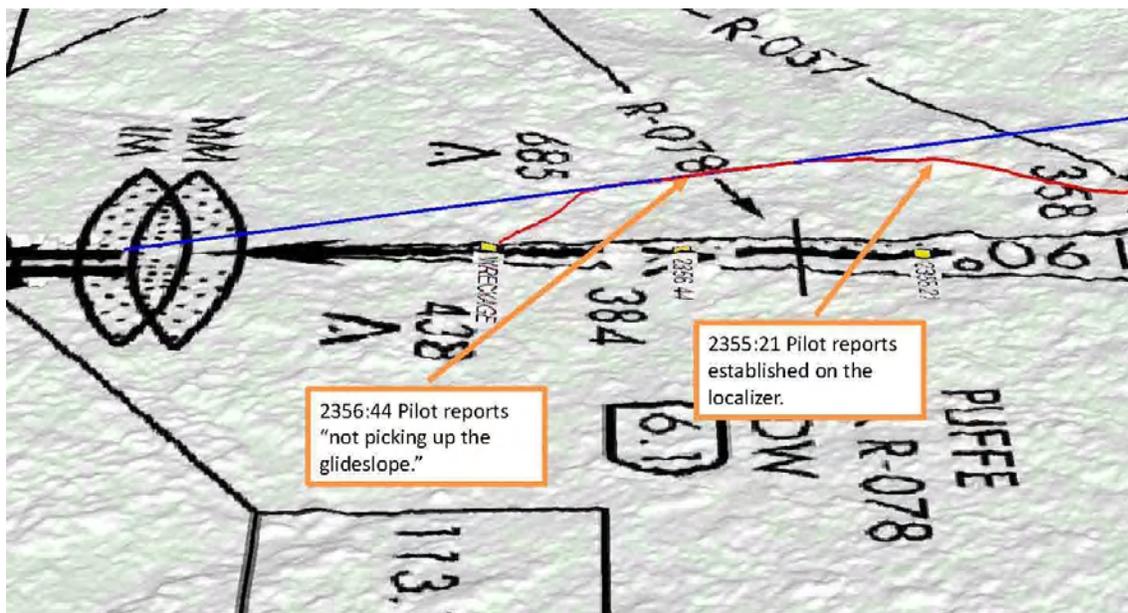
Radar and ADS-B data indicated that at the time of the pilot's transmission, the helicopter was maintaining a descent consistent with following the glideslope. (See figure 7 below.) Additionally, a postaccident flight test conducted by the FAA revealed no anomalies with the

Figure 7. Comparison of Trooper 2’s flightpath to the runway 19R glideslope. (Not to scale.) Blue line indicates runway 19R glideslope centerline; red line indicates Trooper 2’s flightpath.

instrument approach equipment, and NTSB testing of the helicopter's navigation equipment found no deficiencies that would have precluded the pilot from capturing the glideslope. The NTSB was unable to determine which navigational frequencies the pilot had selected or what the pilot was seeing on his instruments. Thus, the NTSB concludes that no evidence was found that suggests that the glideslope was not functioning properly. Further, the lack of information regarding the accident airplane's navigation frequency settings and flight instrument indications precluded NTSB investigators from determining why the pilot believed he was not receiving a valid glideslope signal.
