Midair Collision Over Hudson River
Piper PA-32R-300, N71MC
and Eurocopter AS350BA, N401LH
Near Hoboken, New Jersey
August 8, 2009

Aircraft Accident Summary Report

NTSB/AAR-10/05
PB2010-910405

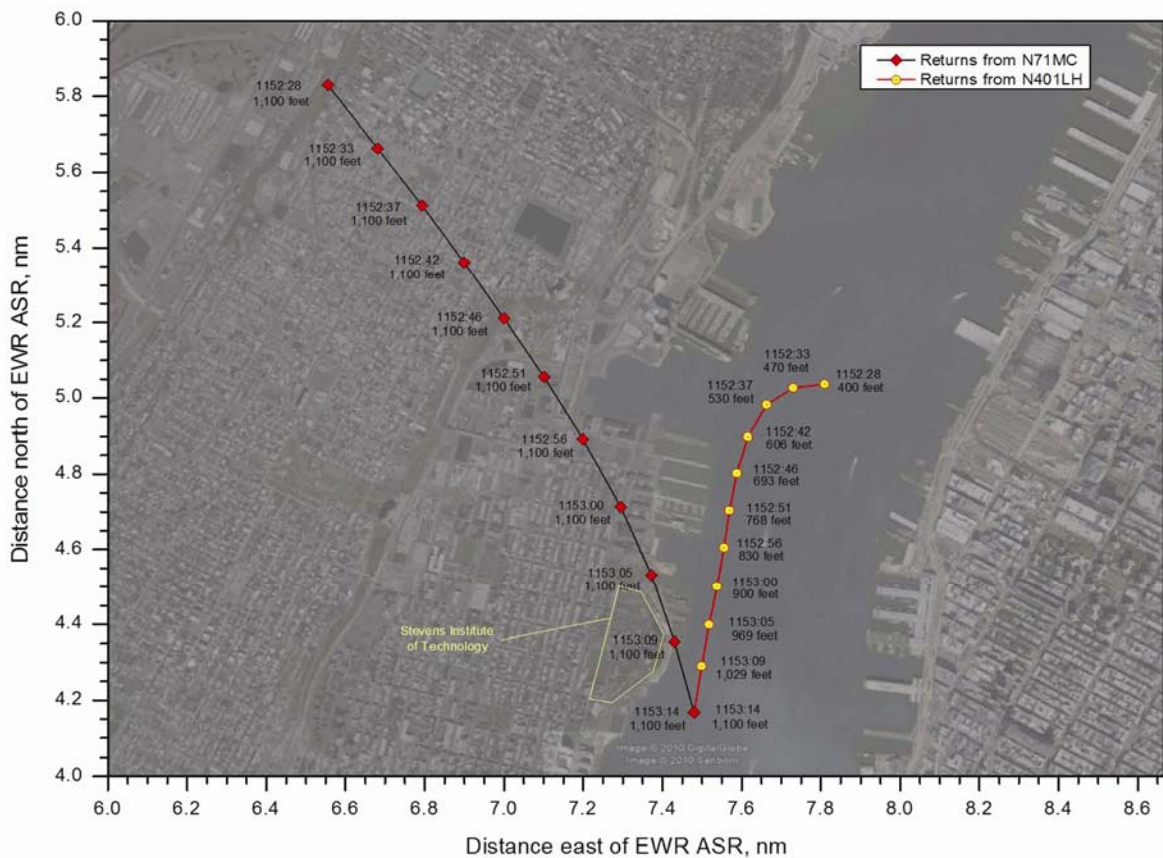
calculate the position and orientation of each aircraft in the minutes preceding the accident.²² Figure 1 shows the ground tracks of the accident aircraft and the collision location over a Google Earth™ image of the Hudson River Class B exclusion area along with each aircraft's mode C-reported altitudes at each data point. This information was used to estimate the approximate location of each aircraft during the same time as viewed from the other aircraft's windscreen and the traffic information that could have been presented on the navigation display in each aircraft, as discussed in section 2.2. Figure 2 shows the Class B exclusion area in relation to the surrounding Class B airspace. The accident aircraft ground tracks just before the collision are also depicted.

Figure 1. Accident aircraft ground tracks.

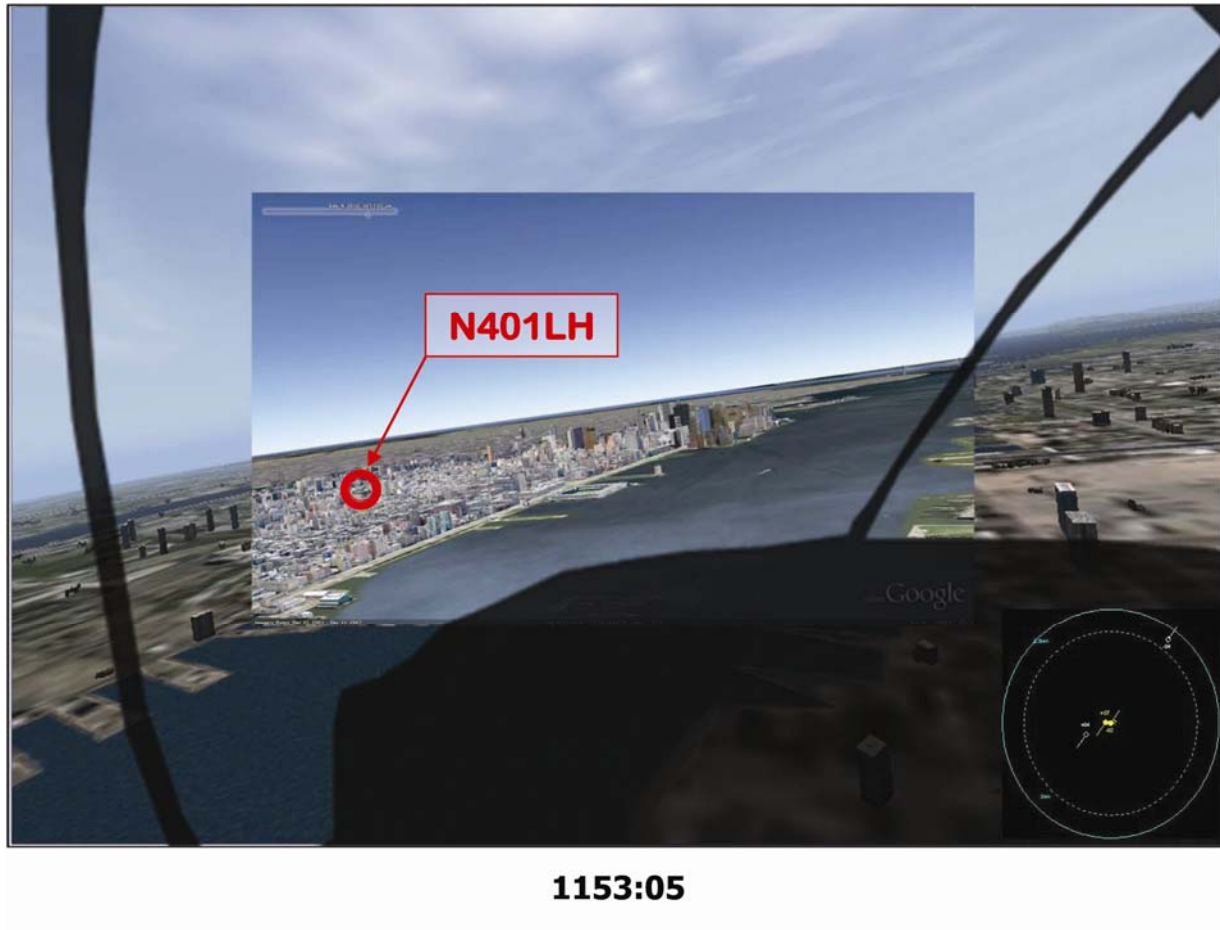
Figure 3. View of helicopter from airplane cockpit about 9 seconds before collision.

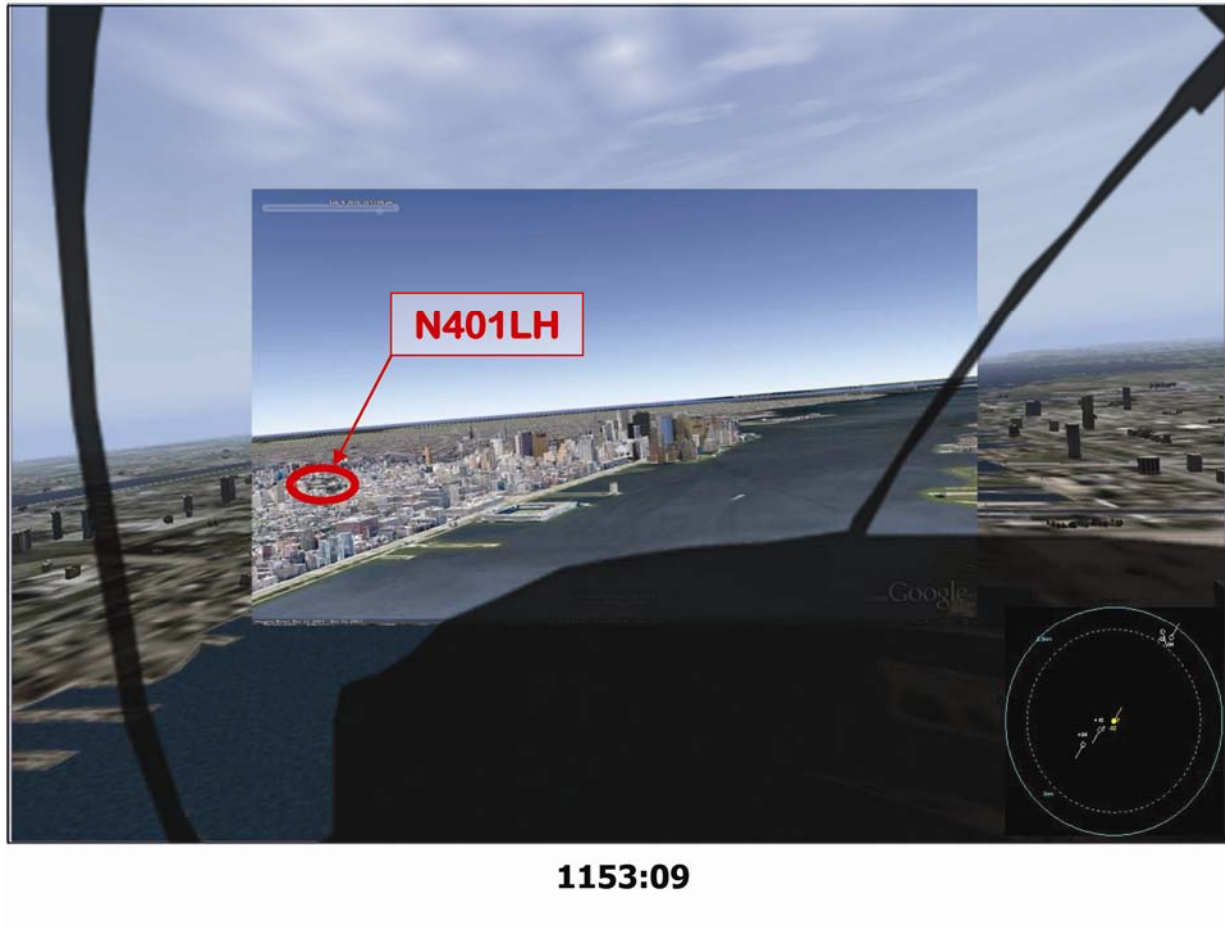
Figure 4. View of helicopter from airplane cockpit about 5 seconds before collision.

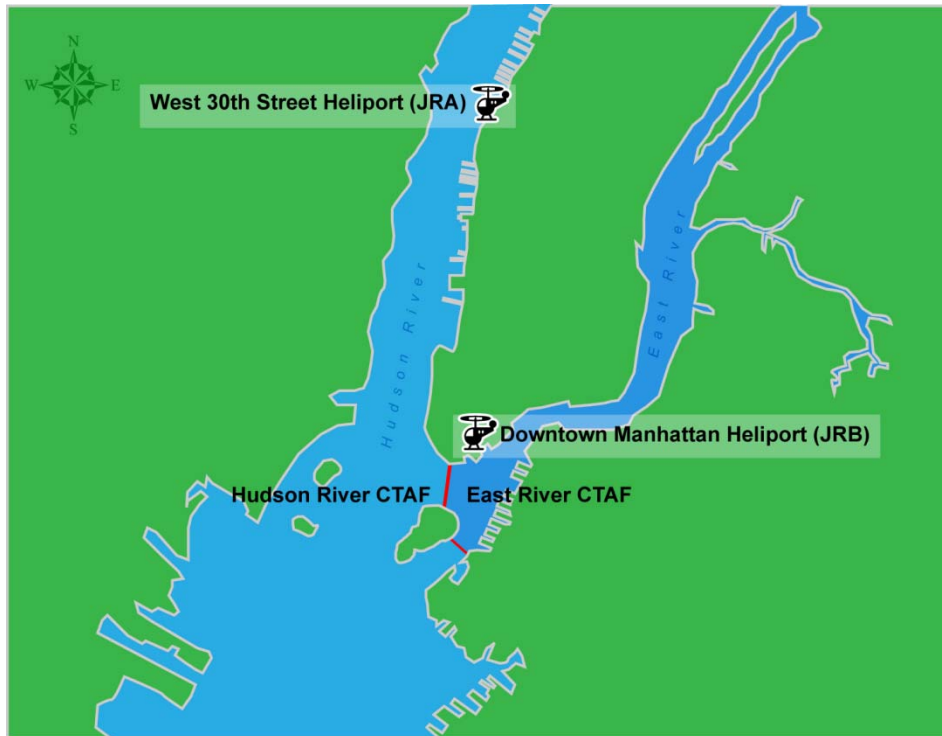
Figure 6. Location of West 30th Street and Downtown Manhattan Heliports and Boundary Between Hudson River and East River common traffic advisory frequencies.

The NTSB concludes that pilots operating air tour helicopters to and from JRB may not be fully aware of other aircraft operating over the Hudson River because the CTAF used for such flights is for the adjacent East River area. Therefore, the NTSB recommends that the FAA redefine the boundaries of the East River CTAF so that JRB will be located in the area that uses the Hudson River CTAF.
