Crash Following Loss of Engine Power Due to  
Fuel Exhaustion  
Air Methods Corporation  
Eurocopter AS350 B2, N352LN  
Near Mosby, Missouri  
August 26, 2011

NTSB/AAR-13/02  
PB2013-104866

# Aircraft Accident Report

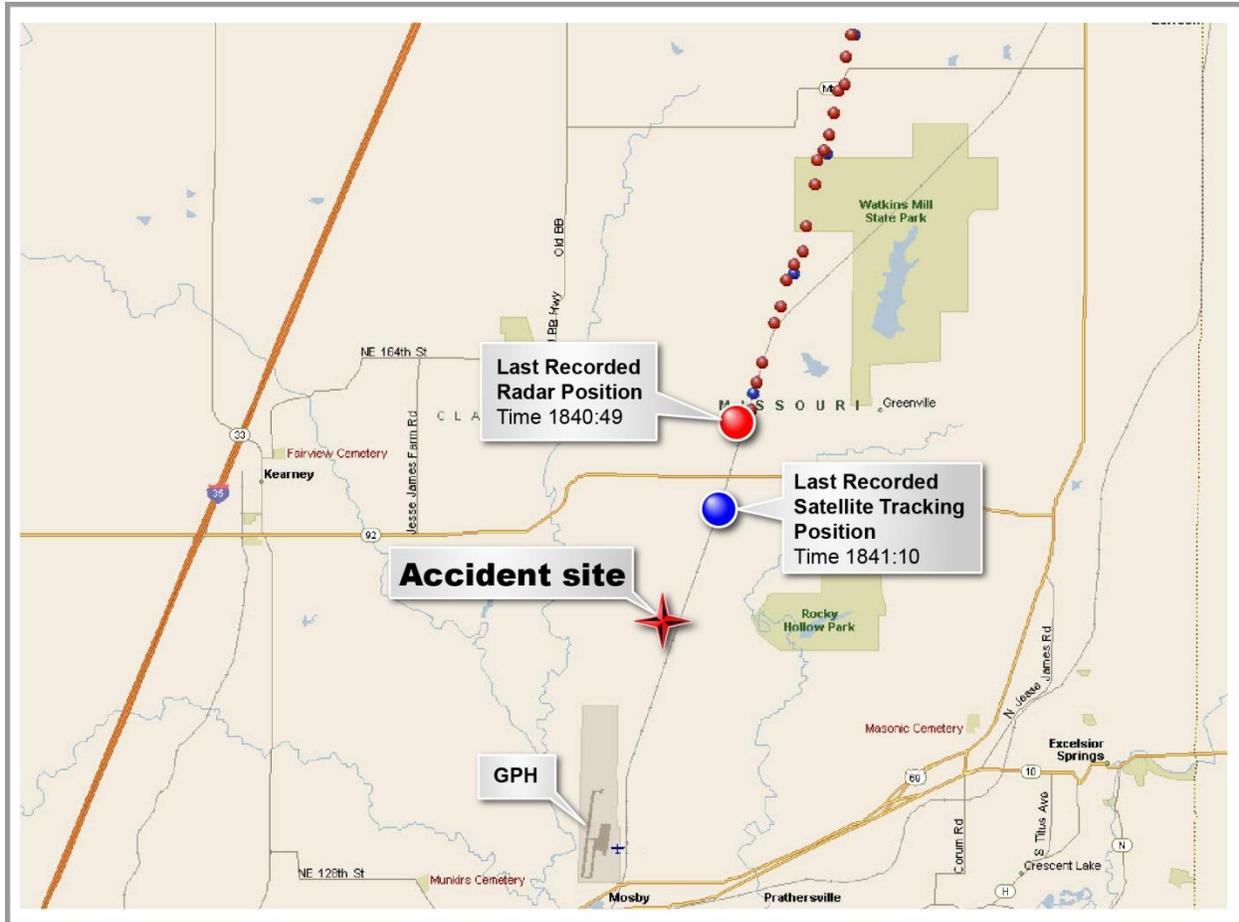
an average ground speed of 111 to 116 knots. The last few minutes of data showed the helicopter in a shallow descent. About 1841, the last satellite tracking system position recorded was about 0.9 nm from the accident site and showed the helicopter was about 373 feet agl with a 116-knot ground speed. Figure 3 shows the last few miles of flight track data.

**Figure 3.** Flight track of the last few miles of the accident flight showing radar data (red dots) and Air Methods satellite tracking system data (blue dots).

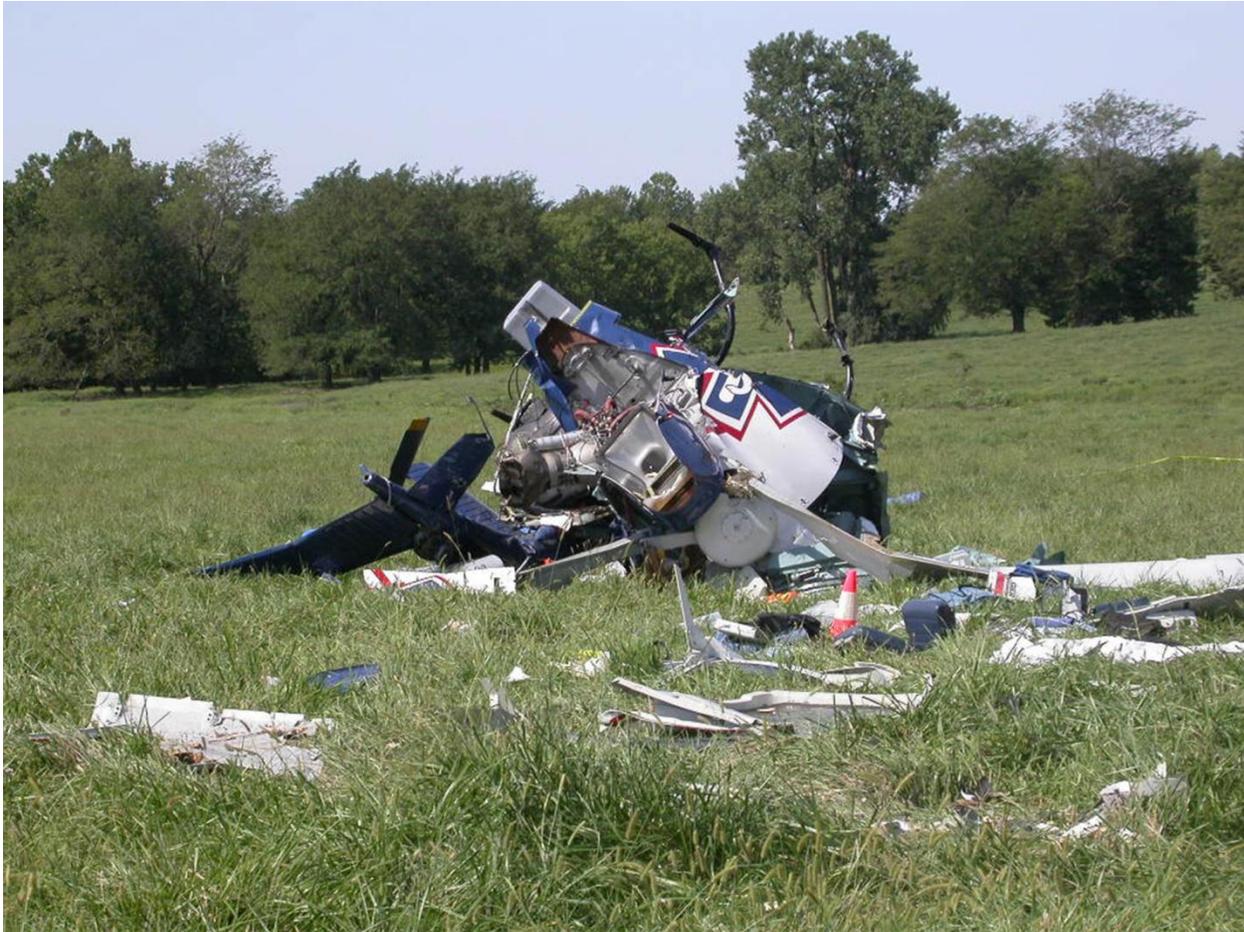
As shown in figure 4, the aircraft structure was heavily fragmented and scattered along a 100-foot-long debris path, which was oriented on a heading of about 242°.

**Figure 4.** Photograph of the accident site.

The wreckage displayed vertical crush damage consistent with impact at a high rate of descent. The main rotor blades remained attached to the rotor hub, were bent but not twisted, and had minimal leading-edge damage. Similarly, the tail rotor blades exhibited little impact damage and were relatively straight, although one blade was partially separated at the blade root. The damage to the main and tail rotor blades was consistent with a low rotor rpm at impact. The impact signatures to the components of the airframe structure were consistent with the initial impact occurring in a 40° nose-low and slight left-bank attitude, on a heading of about 030° (nearly opposite to the direction of travel). Figure 5 is a diagram illustrating the estimated impact attitude of the helicopter.

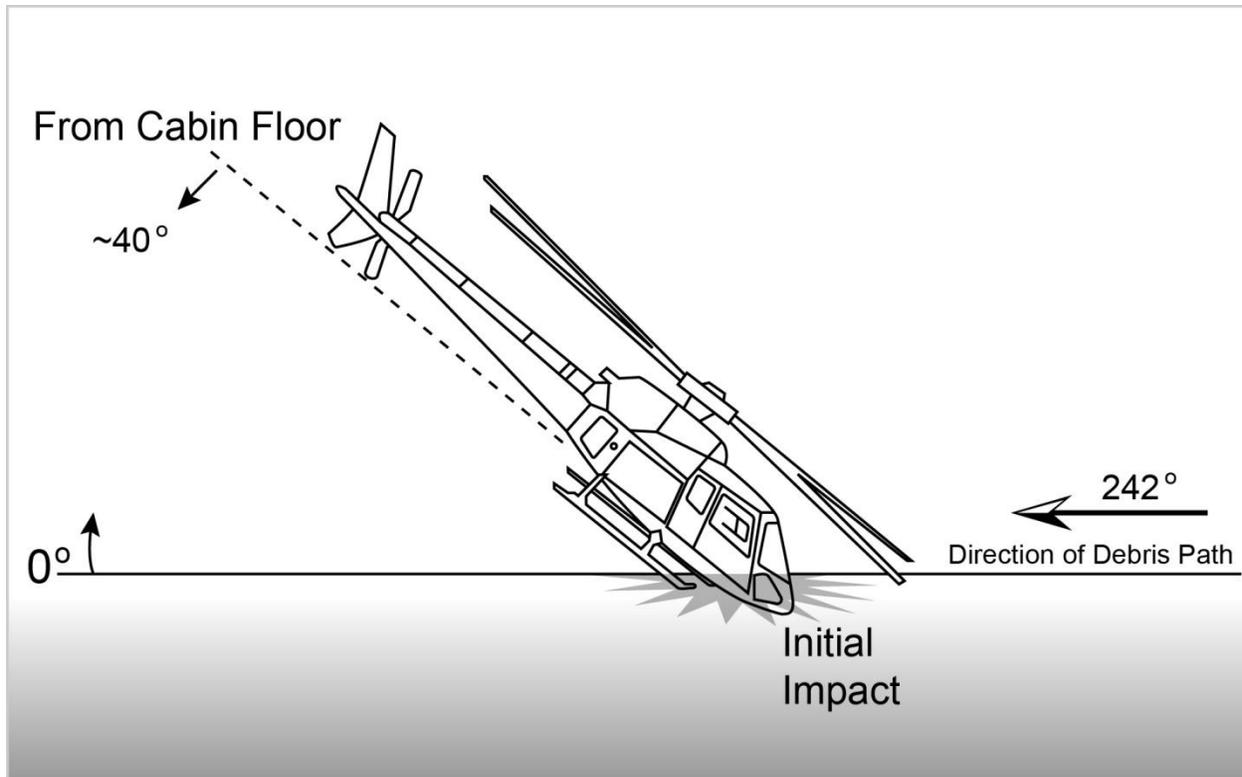
**Figure 5.** Diagram showing the estimated impact attitude of the helicopter.

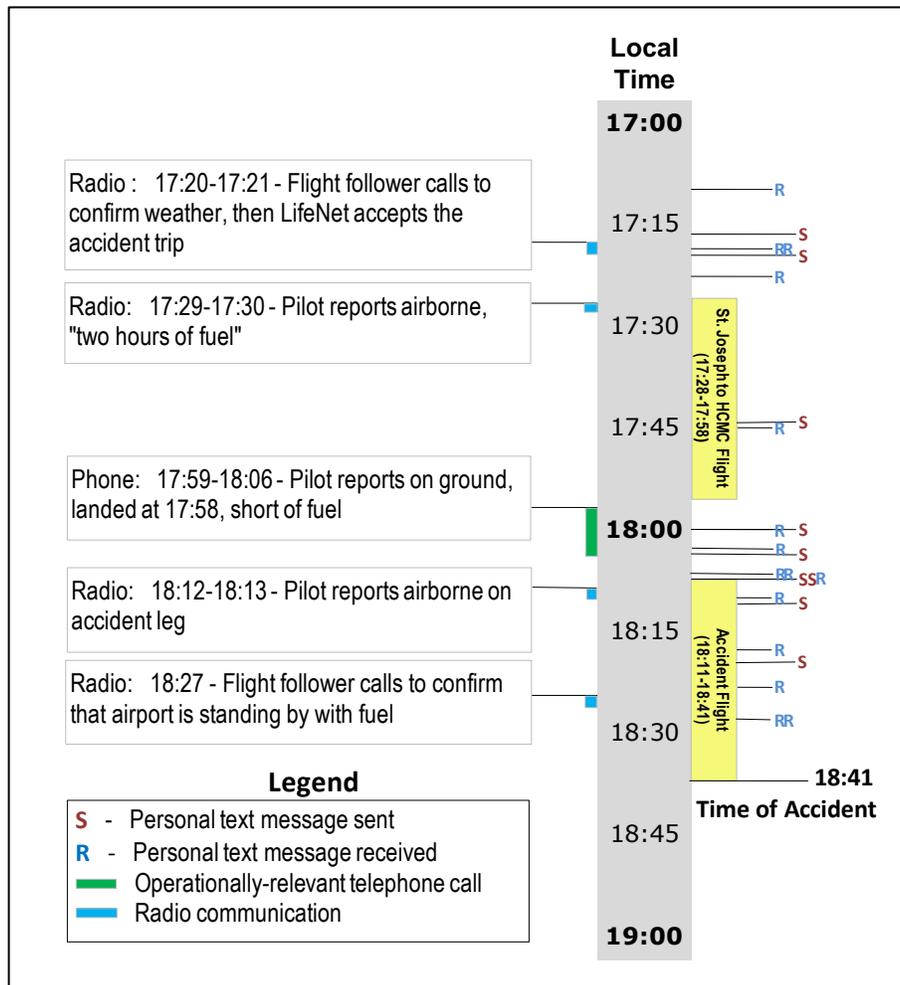
Figure 6b, which covers the time period from 1700 to the accident, shows that text messages were sent from the pilot’s cell phone during time periods when the helicopter was in flight on the accident leg and the preceding leg and while the helicopter was on the Harrison County Community Hospital helipad.

Figure 6b. Timeline of the pilot’s communications from 1700 to the accident about 1841.

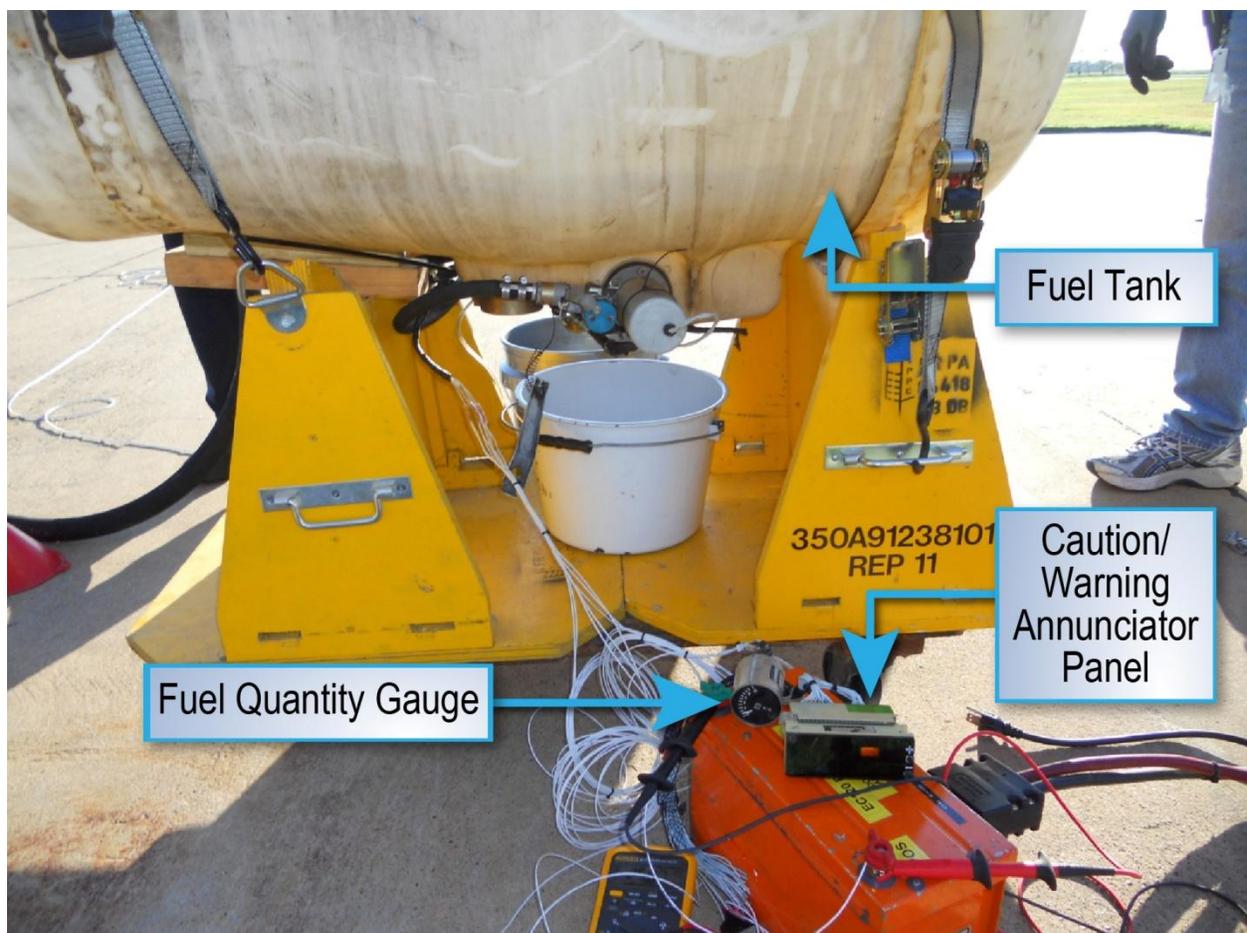
Examination and testing of the helicopter's fuel tank assembly, the fuel quantity gauge, and the caution/warning annunciator panel were conducted under the supervision of National Transportation Safety Board (NTSB) investigators at American Eurocopter in Grand Prairie, Texas. No preimpact anomalies were identified. The fuel system performed as designed, and the level at which the low fuel level light illuminated was 15 percent or 17.7 gallons, which should have provided the pilot slightly more time before flameout than was indicated in the RFM. The quantity indication provided by the fuel quantity gauge was accurate at all levels. Figure 8 shows a photograph of the fuel system component examination setup.

**Figure 8.** Photograph of the fuel system component examination setup.

An operational check of the caution/warning annunciator panel was performed and revealed that all lights were working properly. Examination of the individual light bulb filaments revealed that the filaments for both bulbs from the low fuel level light exhibited slightly stretched coils consistent with the light being illuminated at the time of impact.

The brightness switch on the caution/warning annunciator panel was found on the dim setting at the accident site. During the examination, the panel was illuminated in daylight conditions and observed in both bright and dim settings. With the panel in the dim position, only the low fuel pressure light (the only light that does not convert to the dim setting by design) was conspicuously illuminated. It was not possible to determine whether the panel was switched to the dim setting during the previous NVG training flight and never returned to bright for the accident flight, whether the panel was switched to the dim setting during the accident flight, or whether this setting occurred during impact.
