Crash During Nonprecision Instrument
Approach to Landing
Execuflight Flight 1526
British Aerospace HS 125-700A, N237WR
Akron, Ohio
November 10, 2015

NTSB/AAR-16/03
PB2016-104168

Aircraft Accident Report

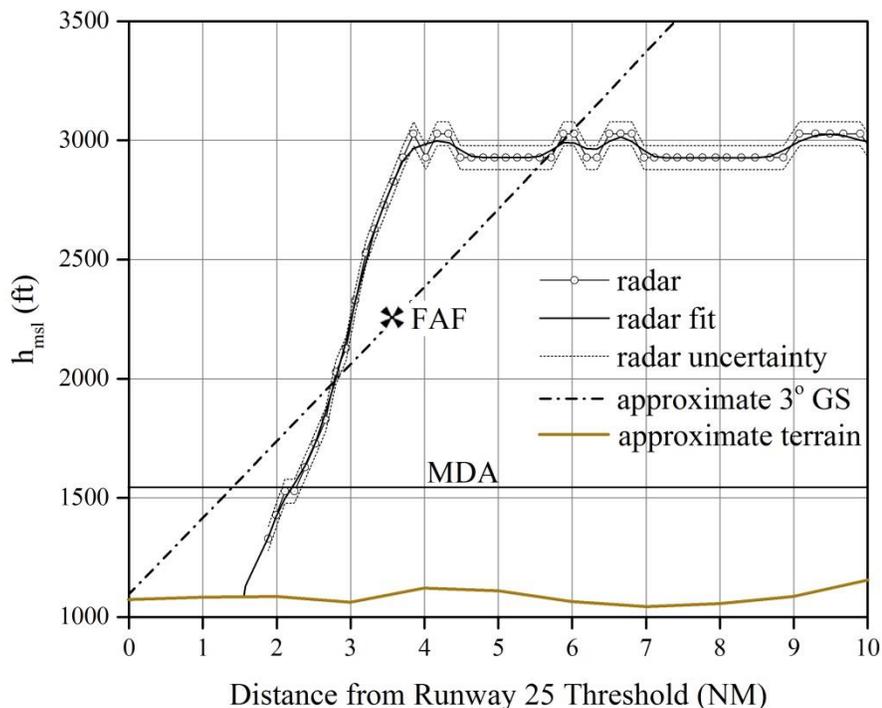
At 1449:22.9, when the flight was about 4 nautical miles (nm) from the FAF for the localizer 25 approach at AKR, the approach controller advised that the pilots of the slower airplane ahead had cancelled their IFR flight plan and cleared the Execuflight airplane for the localizer approach. The captain acknowledged the clearance and advised that they were established on the localizer. Once established on the localizer approach, the flight was no longer required to remain at the previous ATC-assigned altitude of 3,000 ft msl and could descend to the FAF minimum crossing altitude of 2,300 ft msl. Radar data indicated that the airplane remained level at 3,000 ft msl for about 2 minutes before it began to descend (see figure 2, which shows the airplane's descent path).

Figure 2. Profile view of the airplane's approach to runway 25 at Akron Fulton International Airport based on radar data.

Note: The 3° glideslope [GS] depicted is for reference only; the localizer approach to runway 25 does not include vertical guidance.

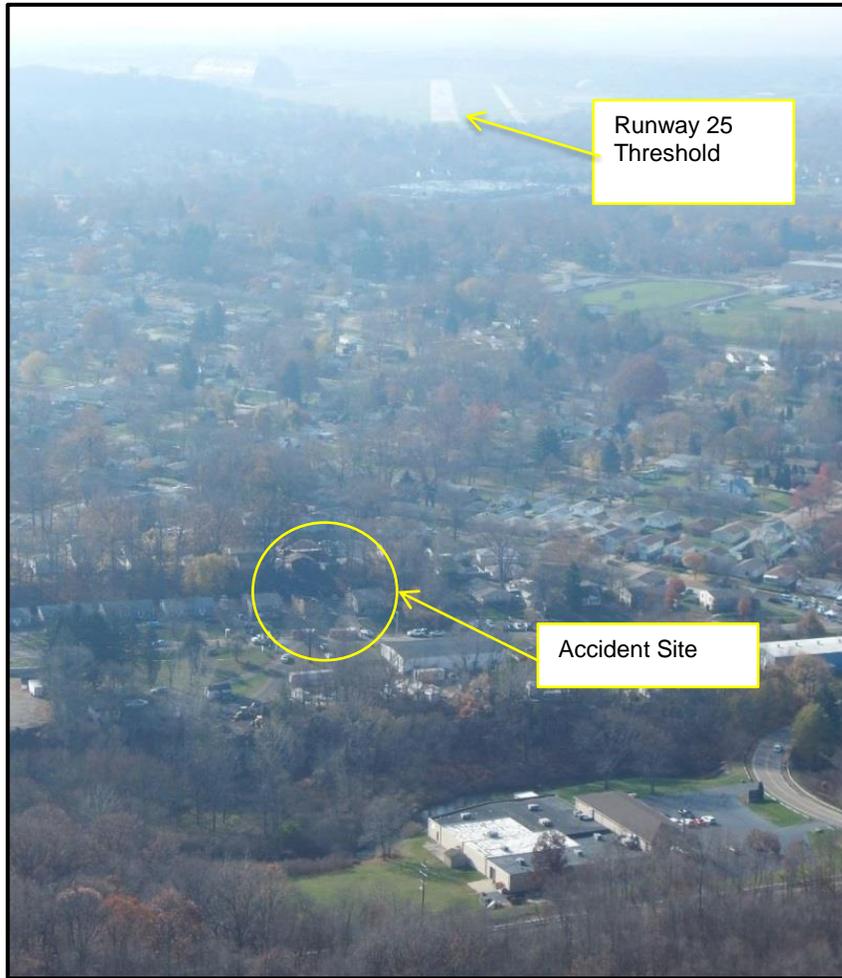
Figure 3. Aerial photograph showing the location of the accident site relative to the runway 25 threshold.

The apartment building that the airplane struck and two cars parked behind the building were destroyed as a result of the airplane's impact and the postcrash fire. The apartment buildings on either side of the destroyed building sustained damage due to debris impact, and the detached garages of two houses behind the destroyed building were damaged by the postcrash fire.

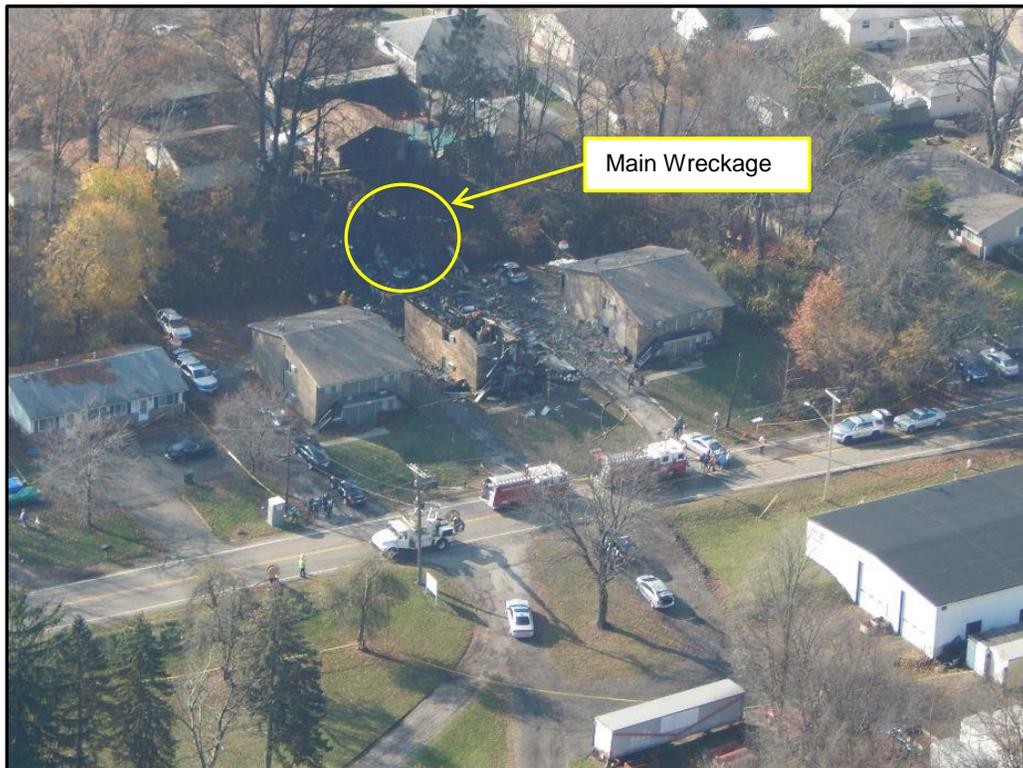
Examination of the accident site indicated that the airplane struck tree branches and power lines before impacting terrain in the front yard of a four-unit apartment building. Pieces of the left aileron and an outboard portion of the left wing were located in an area of ground scarring in the front yard. The airplane traveled through the building and came to rest on an embankment located behind the building (see figure 4 for an aerial photograph of the accident site). While most of the wreckage was consumed by fire, all major components of the airplane were located between the front yard and the airplane’s final location on the embankment. No airplane structure was located along the flightpath before the first pieces of structure identified in the front yard.

Figure 4. Aerial photograph of the accident site showing the destroyed apartment building.

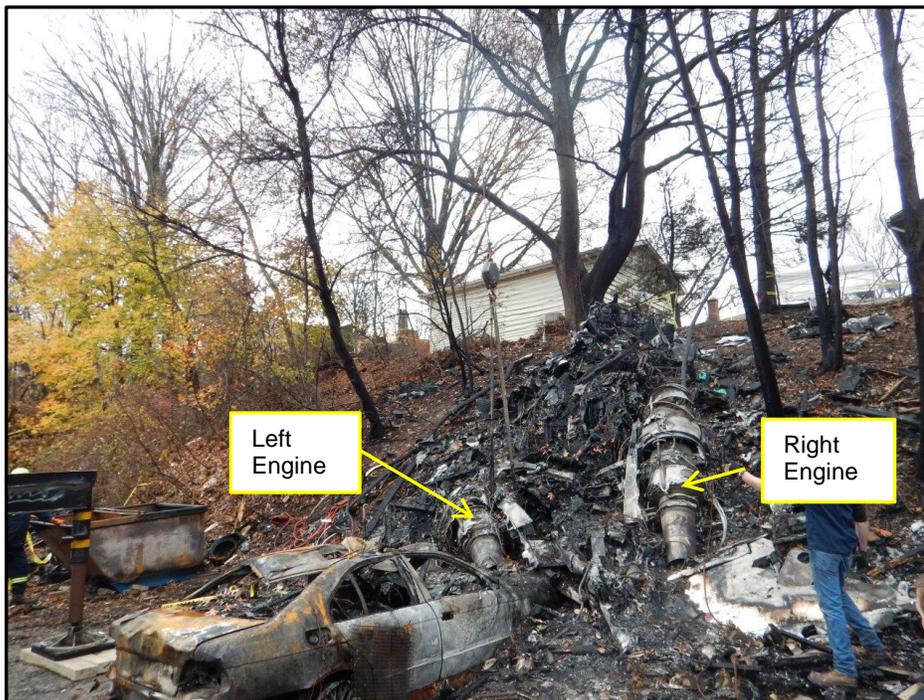
The left main landing gear and associated mating wing structure were found in the remains of the apartment building. The right main landing gear and associated mating wing structure were located between the rear of the building and the embankment. The burned remains of the entire fuselage and the empennage were located on the embankment (see figure 5 for a view of the fuselage and engines). Inboard and outboard portions of the right wing, the nose landing gear, both engines, and the APU were also located on the embankment. Examination indicated that, at impact, all landing gear were down and locked, and the flaps were extended to about 45°.

Figure 5. Photograph of the fuselage and engines at the accident site.

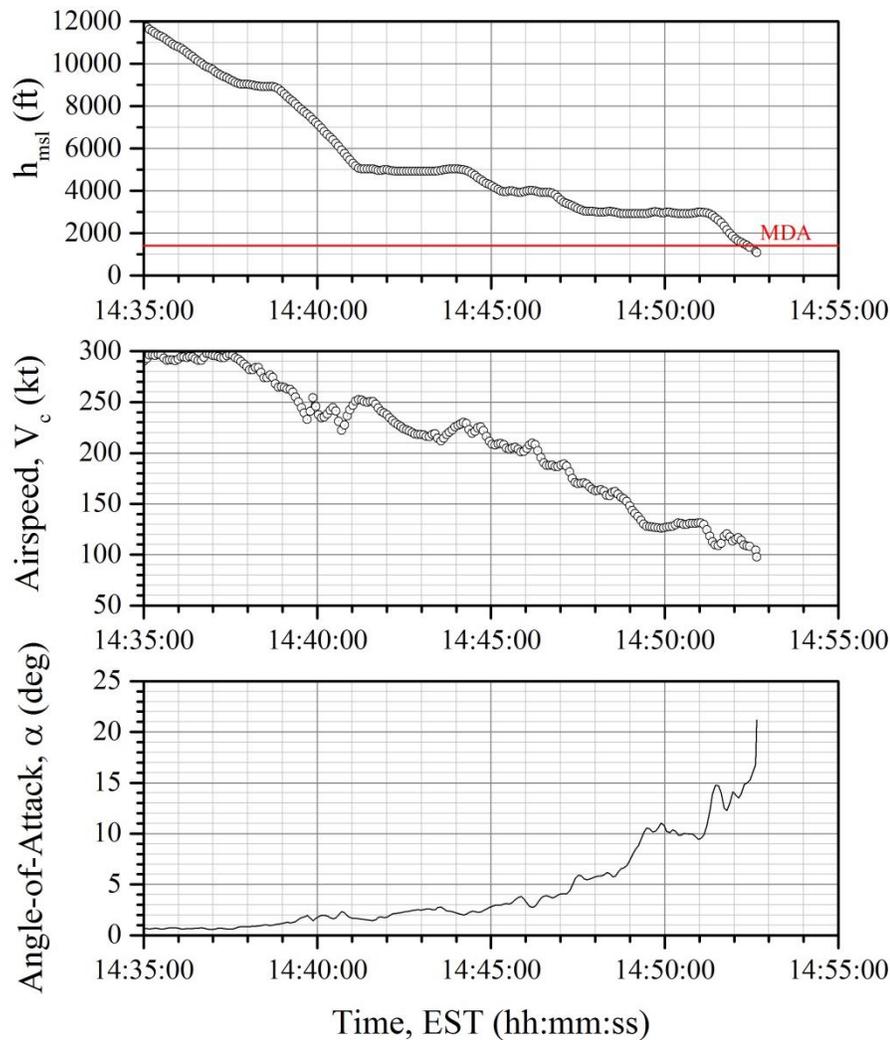
Figure 6. Altitude, estimated airspeed, and estimated angle of attack for the final minutes of the flight based on radar data.
