Collision with Terrain  
Hageland Aviation Services, Inc.  
dba Ravn Connect Flight 3153  
Cessna 208B, N208SD  
Togiak, Alaska  
October 2, 2016

NTSB/AAR-18/02  
PB2018-100871

# Aircraft Accident Report

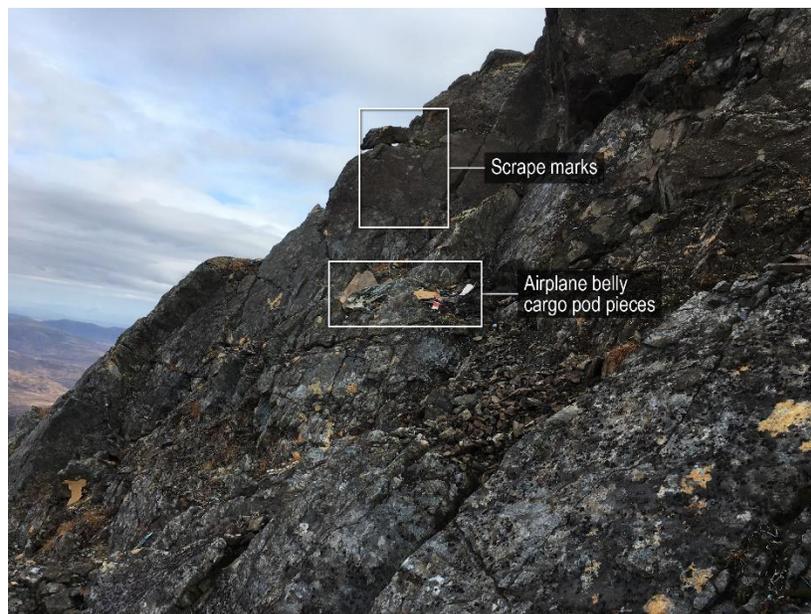
Evidence of the airplane's initial impact, which included scrape marks and pieces of the airplane belly cargo pod, was at an elevation of about 2,300 ft msl on the northwest side of a steep, rock-covered ridge about 9 nm southeast of the airplane's last Spidertracks position (see figure 2).

**Figure 2.** Photograph of the northwest (initial impact) side of the mountain ridge showing scrape marks and pieces of the airplane belly cargo pod.

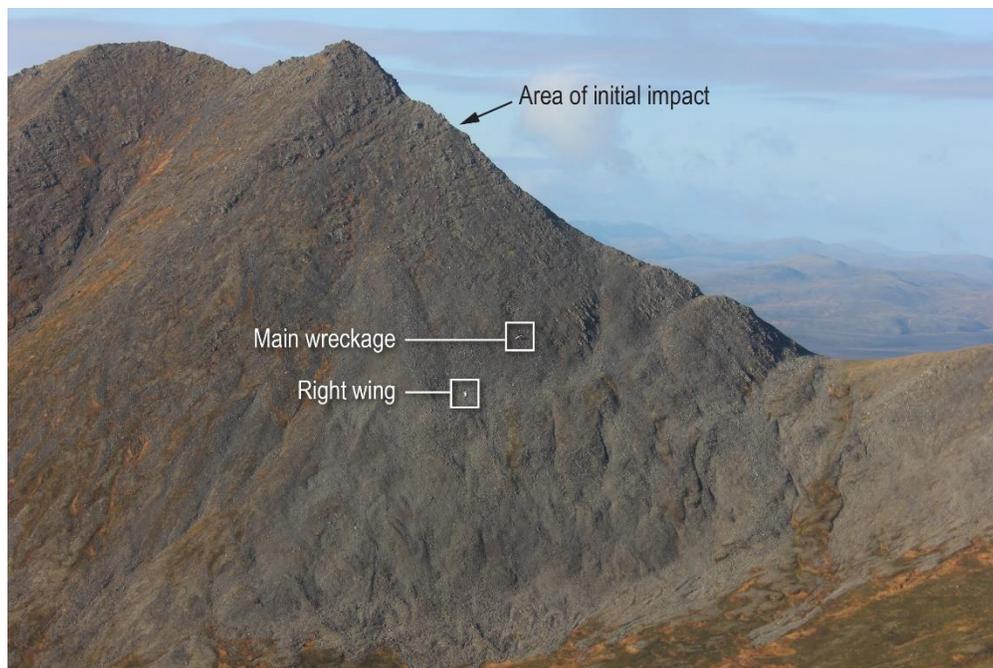
The main wreckage was located on the opposite (southeast) side of the ridge from the initial impact. The main wreckage was found at an elevation of about 1,500 ft, and the right wing was found about 200 ft below the main wreckage. (See section 1.5.1 for more wreckage and impact information.) The ridge peak adjacent to the initial impact location was about 2,500 ft msl and sloped sharply toward a saddle of lower terrain (see figure 3).

**Figure 3.** Photograph of wreckage location showing the southeast side of the ridge.

Note: The accident airplane's initial impact was on the opposite side of the ridge (approximate location indicated by the black arrow), and the main wreckage and right wing were found on the southeast slope.

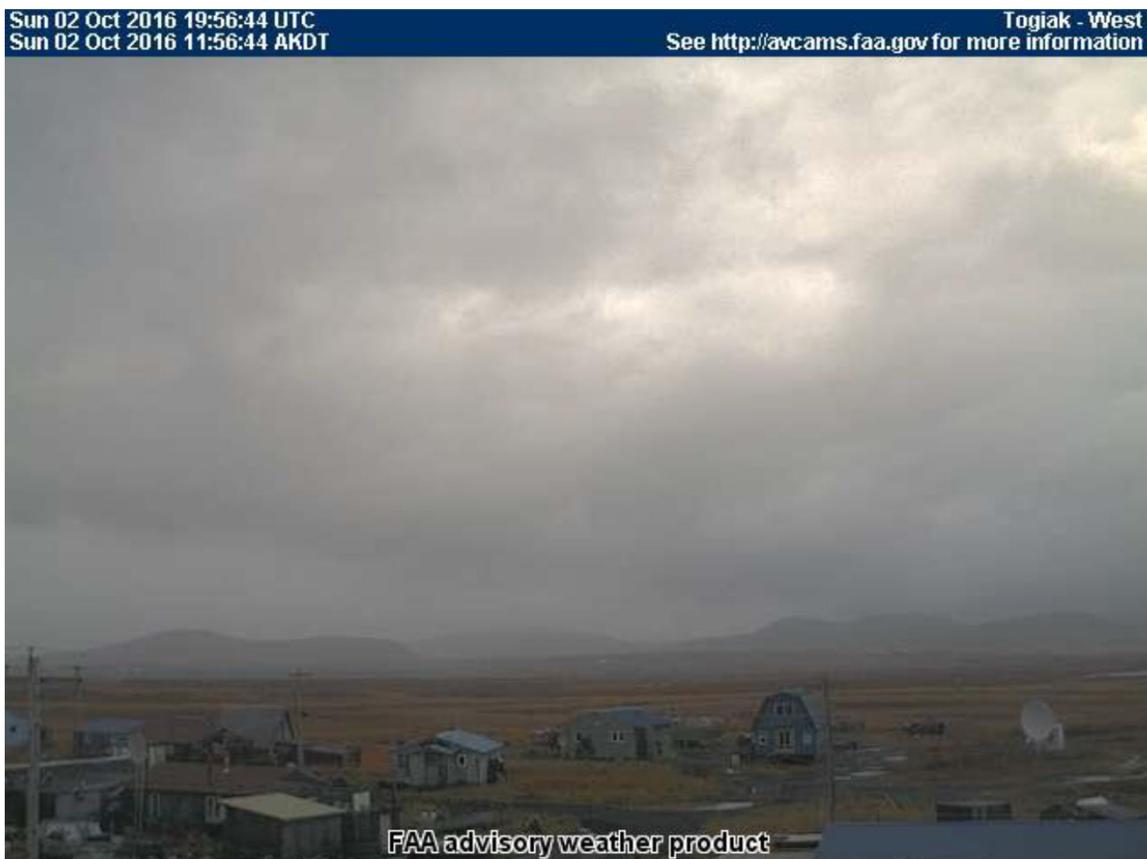
accident site location. The west-facing camera captured an image at 1156 that showed that low clouds partially obscured the top of a 1,300-ft mountain located 7 miles away (see figure 5).

**Figure 5.** View from the PATG west-facing FAA weather camera at 1156.

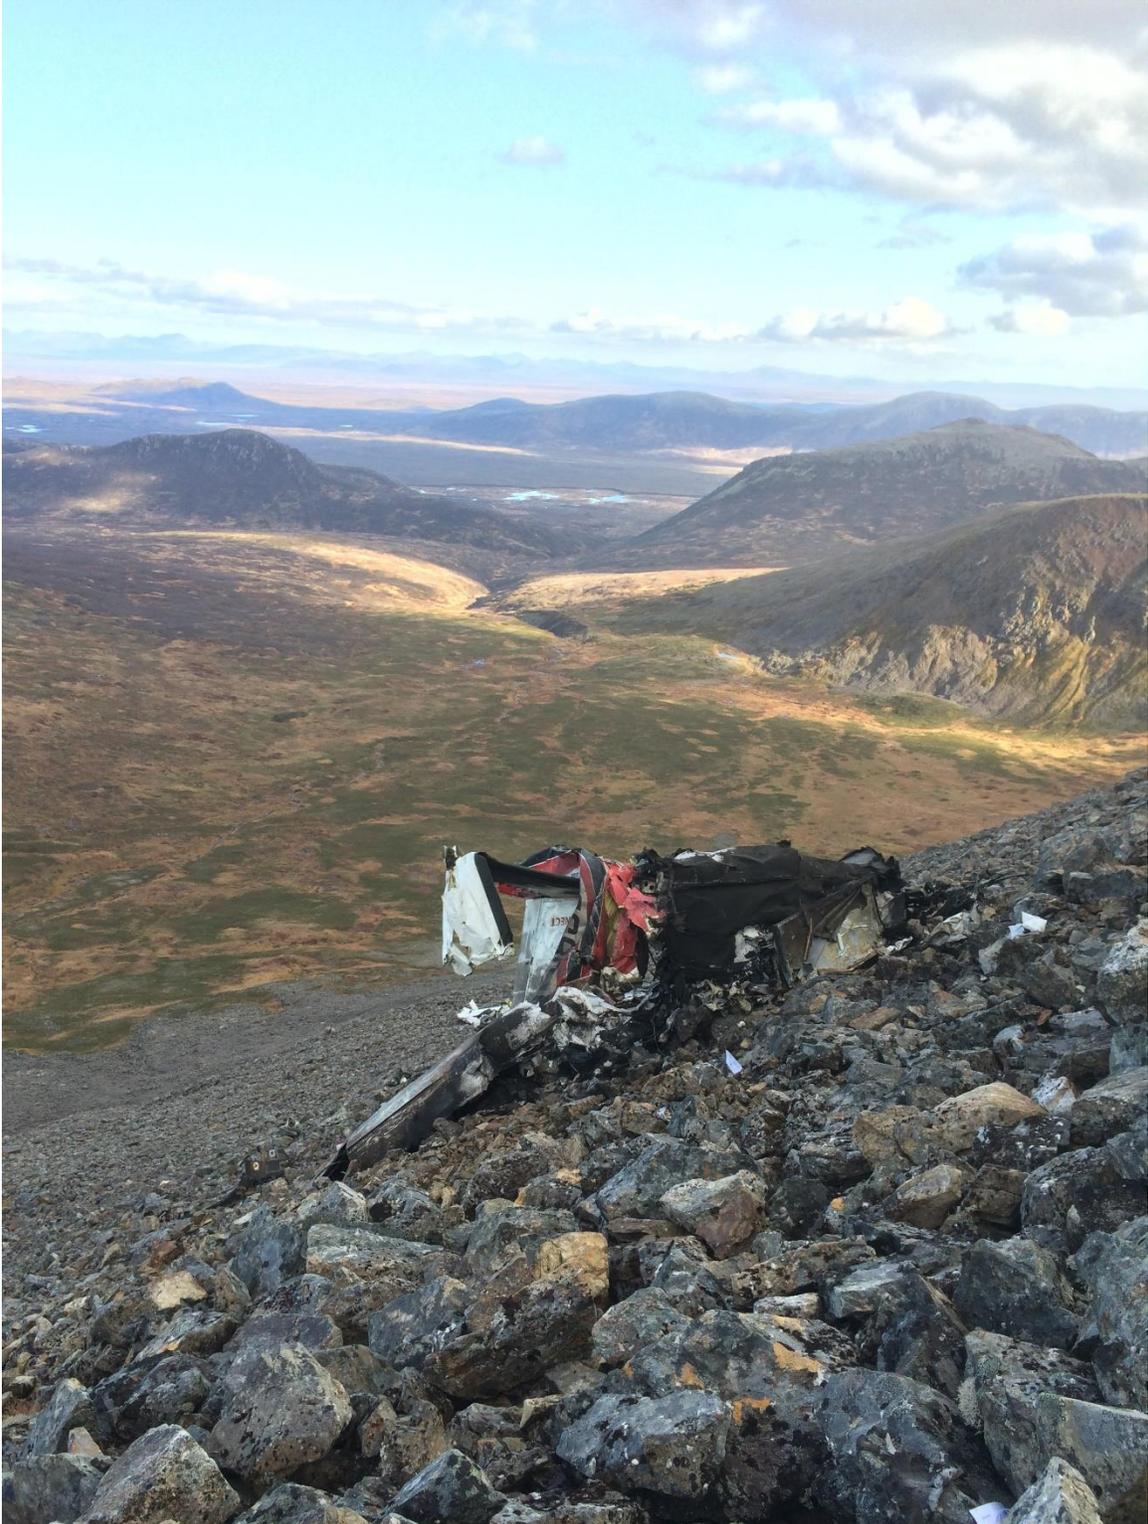
Evidence of the airplane's initial impact was found on the northwest side of the ridge and included scrape marks on the rock face (consistent with propeller blade strikes), propeller blade fragments, and pieces of the airplane's belly cargo pod. The remainder of the wreckage was found on the opposite (southeast) side of the ridge, separated into several sections and scattered down the steep slope. The fuselage and cockpit showed evidence of crush and thermal damage with portions largely consumed by fire. Both wings were separated from the fuselage and each showed leading-edge crush damage. The left and right flaps remained attached and were in the up position. The empennage was separated with the vertical stabilizer, rudder, and horizontal stabilizers attached (see figure 6). The elevator showed crush damage. Examination of the recovered flight control components for the rudder, elevator, ailerons, aileron trim, and flaps identified no evidence of any preimpact mechanical anomaly.

**Figure 6.** Separated section of empennage with vertical and horizontal stabilizers and rudder attached.

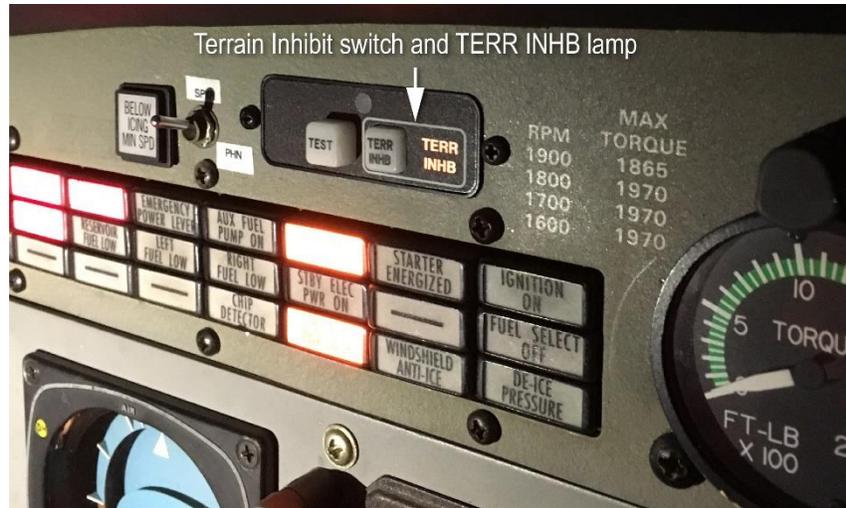
As described in section 1.3.3, at all times the terrain inhibit switch was engaged to inhibit the alerts, a white TERR INHB lamp was illuminated on the terrain awareness annunciation control unit (see figure 10). According to the Hageland chief pilot, when asked if this cue were conspicuous, she stated, "Extremely. It's directly in front of the pilot and it's in their line of sight." When asked how difficult it would be to ignore, she stated, "It's a really bright white light. I won't use the word impossible, but it's very, very difficult to ignore." A check airman also described it as "very bright," stating that "it can be obnoxious if we don't un-inhibit it."

**Figure 10.** Photograph of the terrain inhibit switch engaged and the TERR INHB lamp illuminated in an exemplar Cessna 208B.
