Departure From Controlled Flight
Trans-Pacific Air Charter, LLC
Learjet 35A, N452DA
Teterboro, New Jersey
May 15, 2017

NTSB/AAR-19/02
PB2019-100271

Aircraft Accident Report

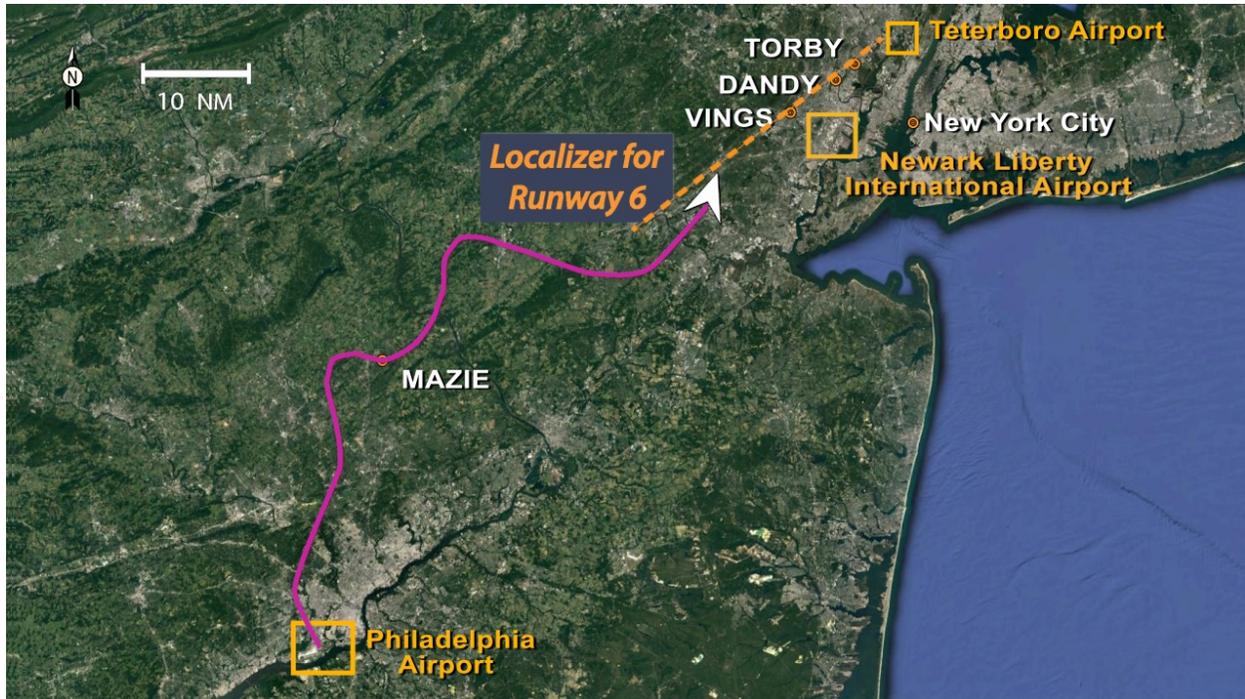
Figure 1. Accident airplane's ground track en route to TEB.

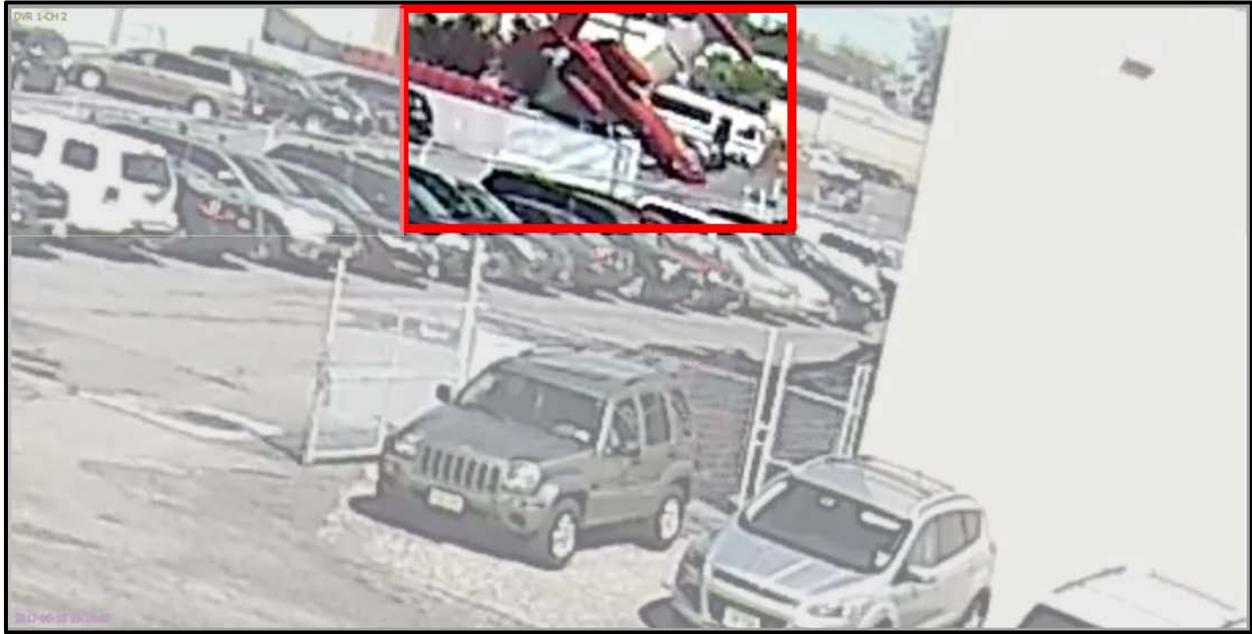
One witness reported seeing the airplane make two “hard” turns, the last of which was to line up for runway 1. Witnesses reported seeing the airplane nearly inverted in a nose-low attitude just before impact. A security camera recorded the airplane’s impact in a parking lot about 0.5 mile south of runway 1 at TEB. Three buildings and 16 vehicles were damaged or destroyed by the impact forces and postcrash fire.

Figure 6. Security video image of N452DA at ground impact.

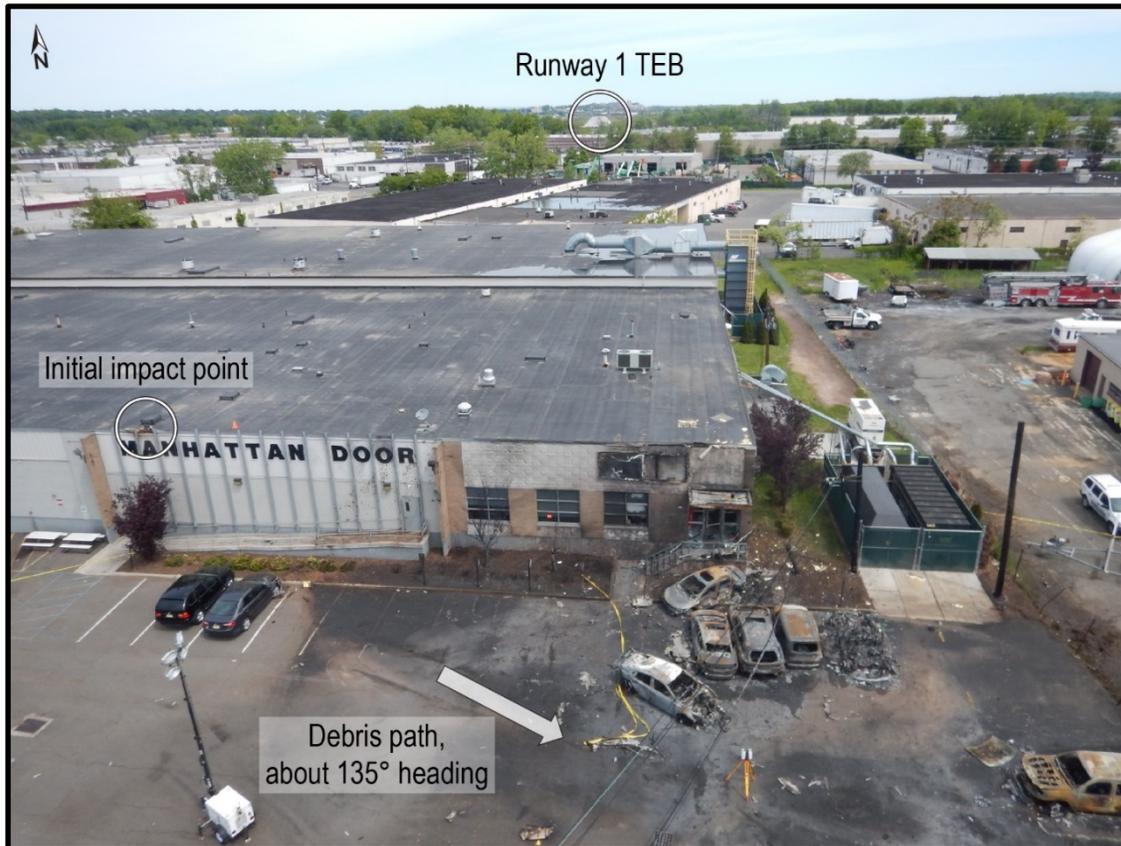
Figure 7. Photograph of the initial impact point and start of the debris path.

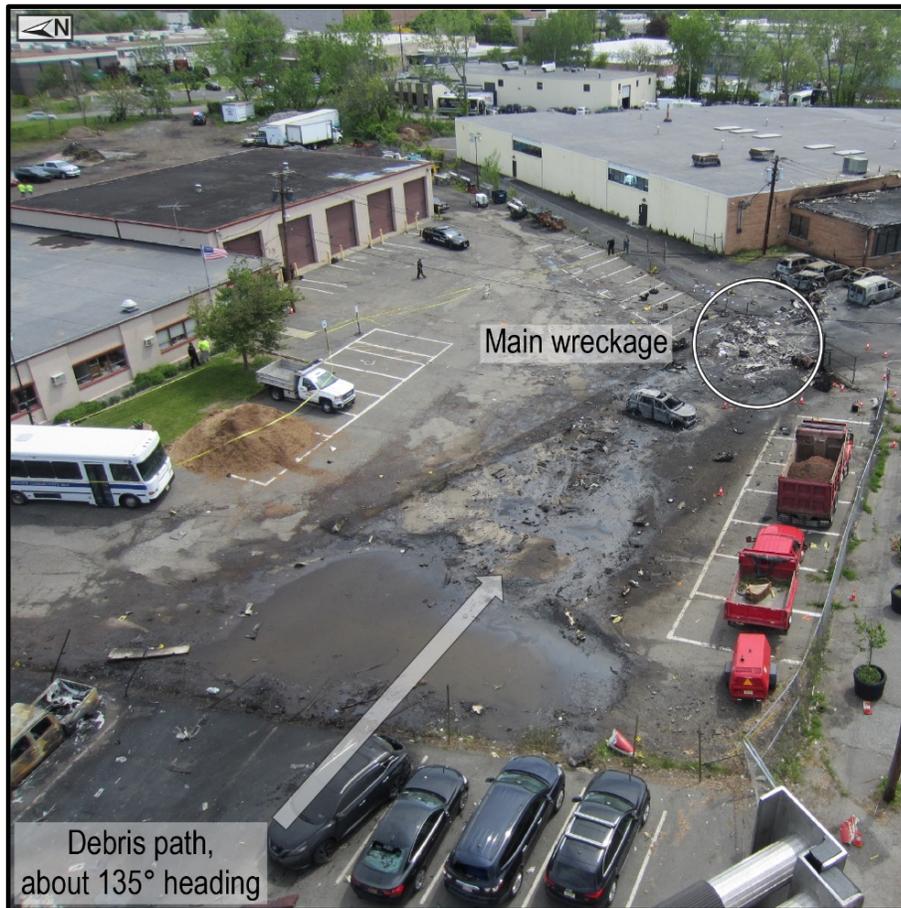
Figure 8. Photograph of the continuation of the debris path.

Both engines were found separated from the main wreckage near the farthest point of the debris path. The left engine traveled about 25 ft farther than the right engine. Compressor blades from both engines were bent opposite the direction of rotation; the blades also exhibited tearing and battering damage, indicating that the engines were operating at the time of impact. The oil caps from each engine were found in place, and oil drained from both engines when they were moved. The thrust reversers from both engines were found in the stowed position.

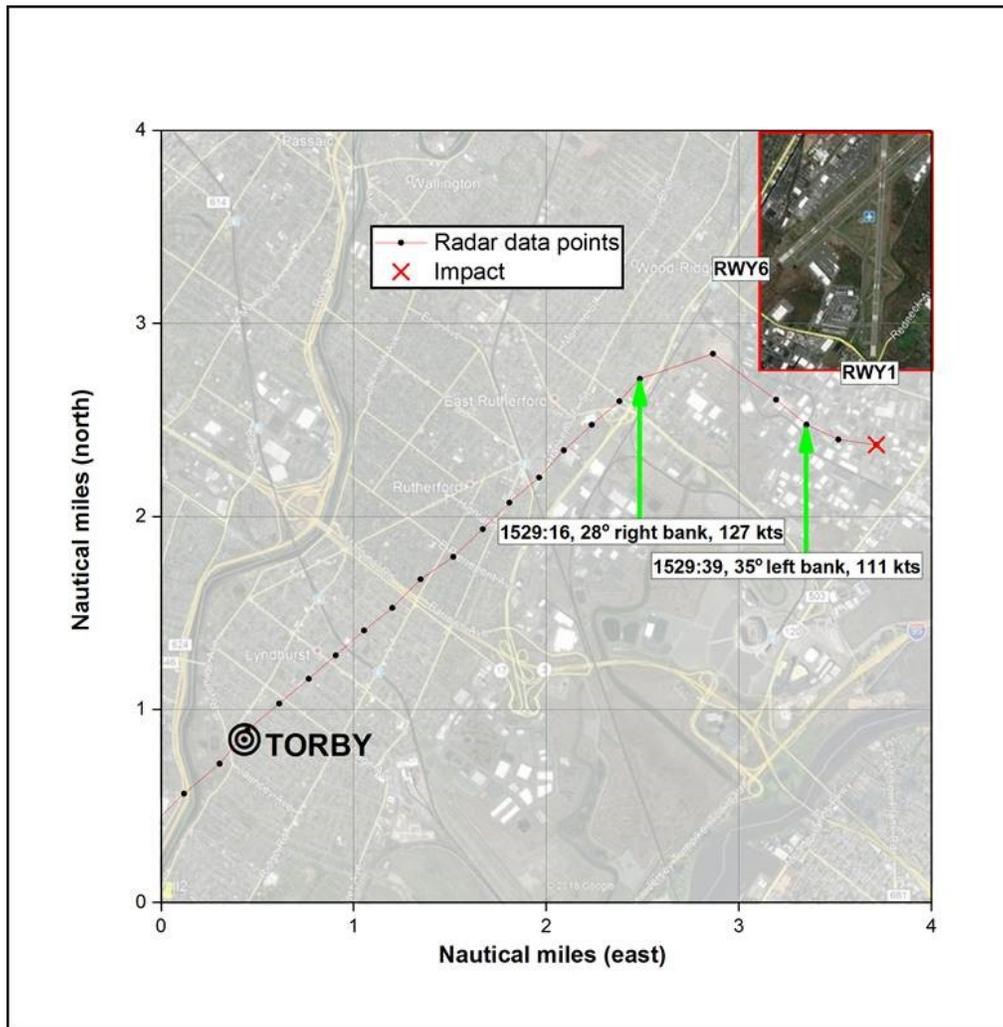
Figure 9 shows the airplane's approach to the airport starting just before TORBY, the final approach fix. Radar data indicated that the airplane began the circle-to-land maneuver about 2.8 nm beyond TORBY (1 nm from the TEB runway 6 threshold). During the airplane's first turn to the right, the bank angle reached 28°, and the airspeed decreased from 127 to about 123 kts starting at 1529:16. The airplane's altitude also decreased from 650 to 350 ft during the right turn. After the EGPWS 500-ft callout at 1529:18, the airplane returned to wings level and climbed 100 ft. About 1529:36, the airplane began a left turn toward the runway at an altitude of 450 ft and an airspeed of 120 kts. At 1529:39, the airplane reached a left bank angle of 35°, and the airspeed decreased to about 111 kts.

Figure 9. Radar data depicting the airplane's track during the approach.

Manufacturer-provided data indicated that the stall speed for the accident airplane in a 35° level turn was 102 kts. Although radar data indicated that the airplane remained 9 kts above the stall speed during the final left turn, the margin does not account for the effect of wind gusts or flight control inputs that could reduce the airplane's airspeed below the stall speed. The left-wing-down aileron input required to make the turn to final and to counter the strong left crosswind would have increased the AOA of the right wing and potentially led that wing to stall first, inducing a roll to the right. Radar data and the security video showed that the airplane rolled to the right (away from the runway) before impact.

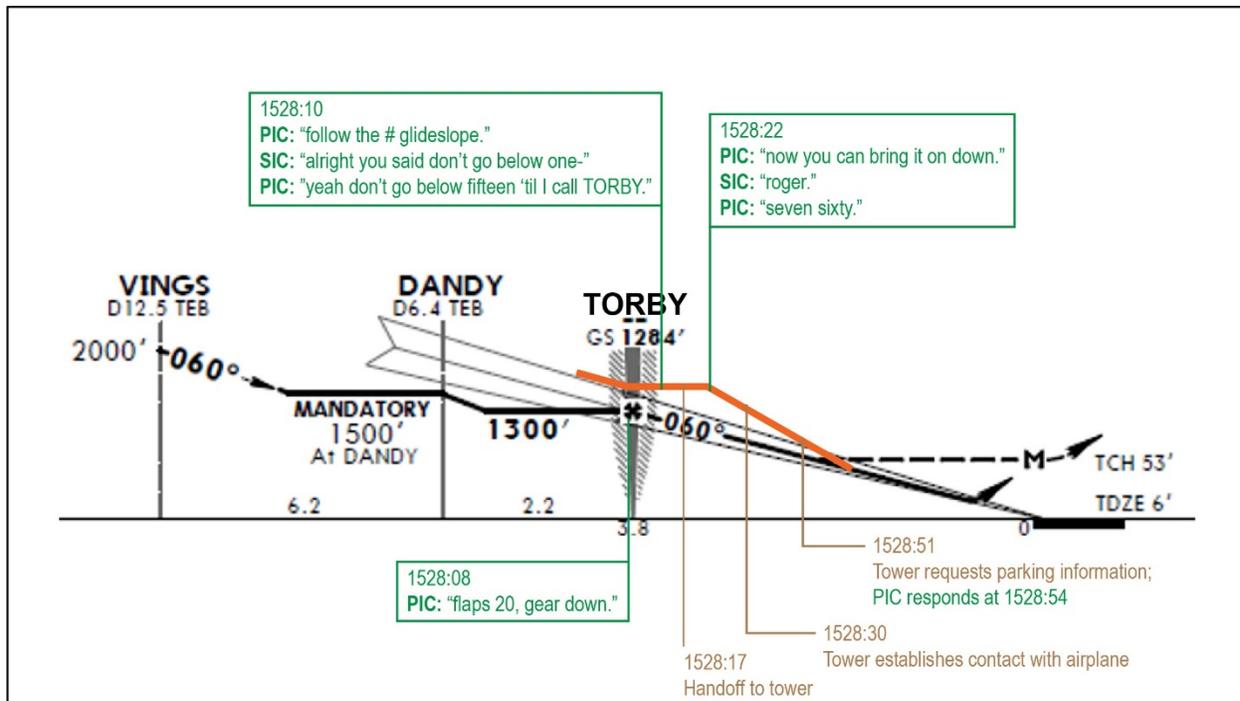
The airplane crossed TORBY at 1528:08 at an altitude of 1,550 ft. At 1528:10, the PIC again told the SIC (with emphasis) to “follow the # glideslope.” The SIC replied, “alright you said don’t go below one—,” and the PIC interrupted with, “yeah don’t go below fifteen ‘til I call TORBY.” About that time, the airplane was about 0.3 nm past TORBY and was above the glideslope (see figure 10). At 1528:54, the PIC responded to a low-priority ATC transmission asking about the crew’s intended parking location instead of focusing on the approach.

Figure 10. Diagram illustrating the airplane’s vertical profile between TORBY and the MDA along with relevant events.

Note: The orange line approximates the airplane’s vertical path from 1527:54 to 1528:58. The dashed line (MDA) is shown on the Jeppesen instrument approach chart for TEB (see figure 5).

Neither pilot verbally acknowledged crossing the final approach fix, and neither mentioned the ATC instruction to begin the circle-to-land maneuver at TORBY. Thus, the NTSB concludes that the flight crewmembers’ failure to verify the approach and conduct an approach briefing resulted in confusion and errors that led them to mismanage the vertical profile for the approach and not initiate the circle-to-land maneuver according to ATC instructions.

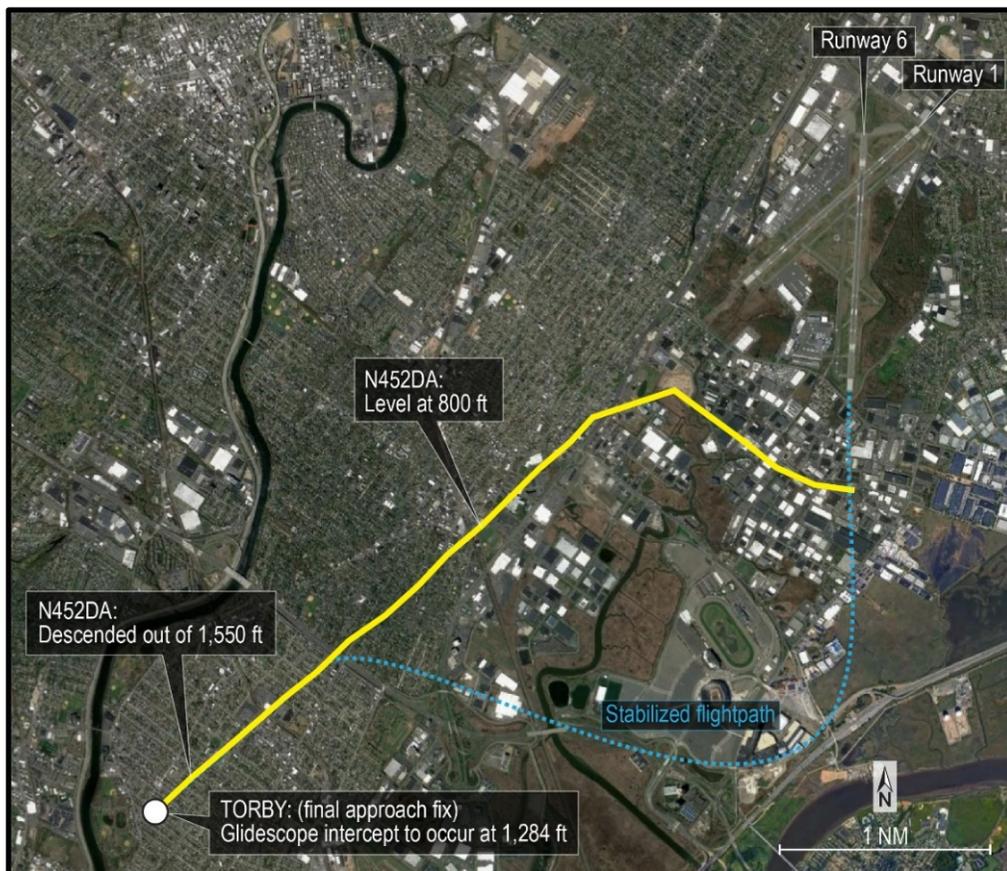
Contrary to the ATC clearance, the crew did not begin the circle-to-land maneuver at TORBY and continued to fly past TORBY before the PIC instructed the SIC to descend to the MDA. Although the MDA for a circling approach was 760 ft, the weather was clear, and the pilots did not have to descend to the MDA to see the airport environment. Further, the crew began the descent to the MDA from an altitude about 250 ft above the minimum crossing altitude for TORBY and continued to fly inbound toward the airport; thus, the MDA was reached when the airplane was beyond a position at which the crew could maneuver to runway 1 and fly a stabilized approach. However, the crew continued to fly the approach without discussing that the turns to align with the runway would be late. During this critical period, the PIC remained focused on coaching the SIC and ensuring that the SIC stopped the airplane's descent at the MDA. According to CVR and radar data, the airplane was 1 nm from the threshold of runway 6 by the time the flight crew began the circling maneuver to runway 1 (see figure 11).

Figure 11. Overhead image showing a stabilized flightpath to runway 1 (in blue) compared with the accident airplane's flightpath (in yellow).

Two turns (first to the right and then to the left) were required for the circling maneuver to align the airplane with runway 1. Per SOPs, the target airspeed was 139 kts (V_{REF} of 119 plus 20 kts); the PIC had previously indicated that the approach speed was 126 kts, which is further evidence that he did not adequately prepare for the approach. Early in the right turn, the SIC attempted to transfer the controls to the PIC, stating with emphasis, “your flight controls.” The
