**AIRCRAFT ACCIDENT REPORT. JAPAN AIR LINES,
LTD., DOUGLAS DC-8-33, JA-8006. SAN
FRANCISCO, CALIFORNIA**

**NATIONAL TRANSPORTATION SAFETY BOARD,
WASHINGTON, D.C**

AIRCRAFT ACCIDENT REPORT

**JAPAN AIR LINES, LTD.,
DOUGLAS DC-8-33, JA-8006
San Francisco, California
December 25, 1965**

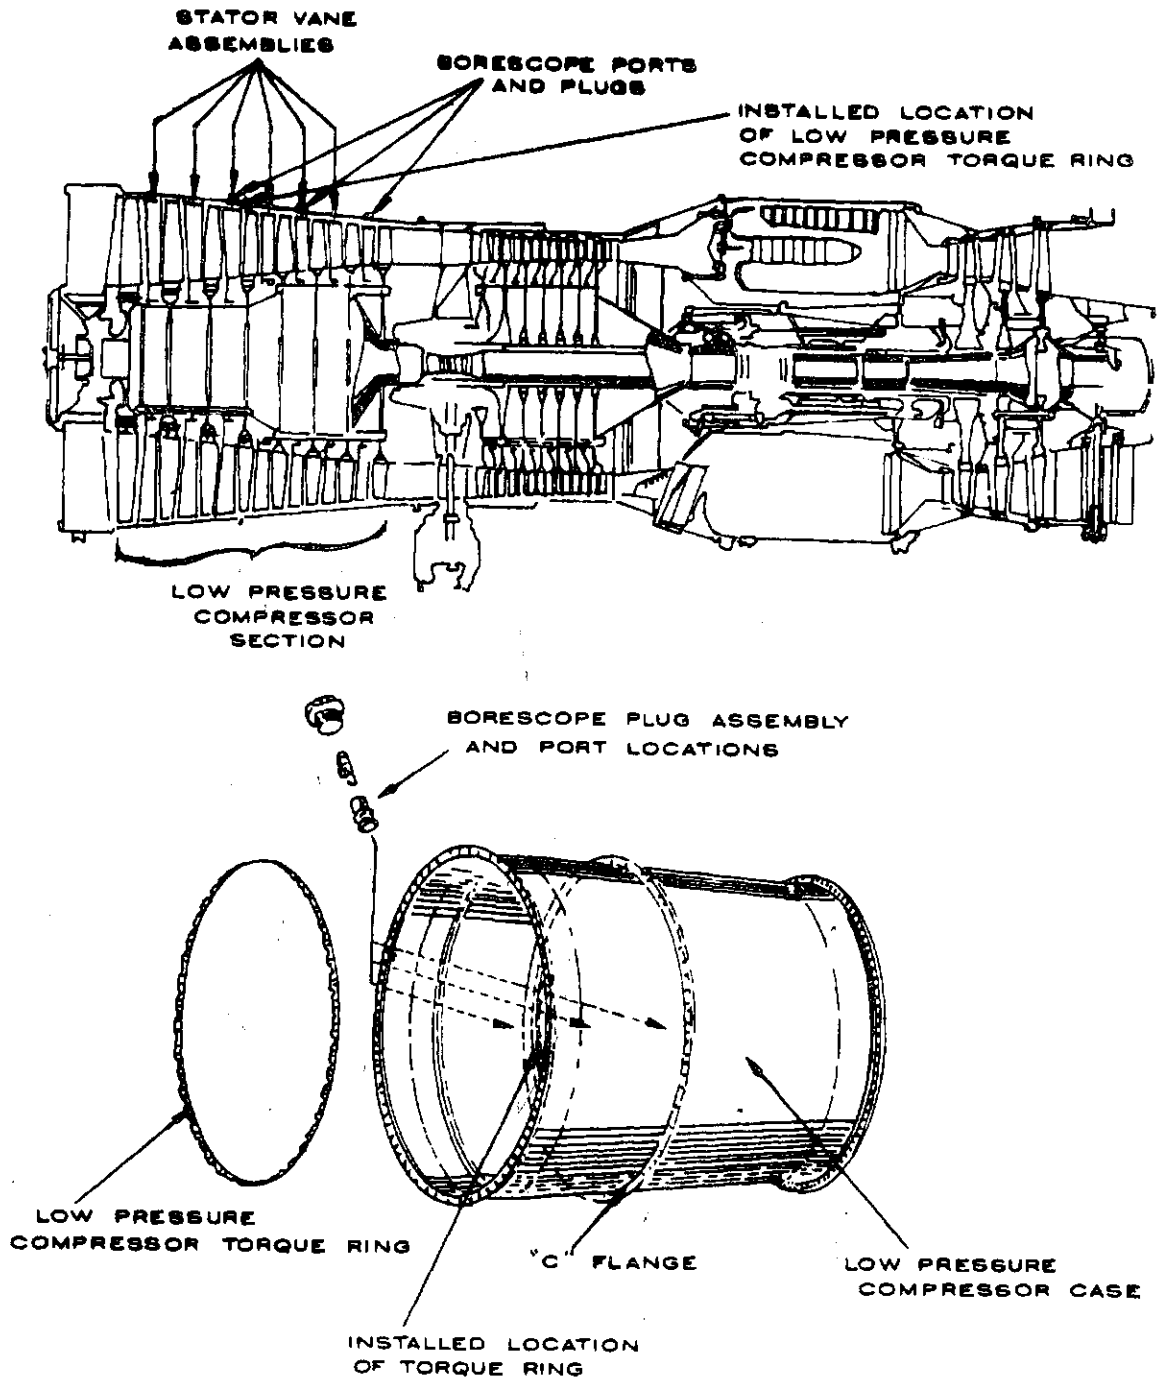
EXPLANATORY DIAGRAM

Engine overhaul records showed that during the course of the engine overhaul the low pressure compressor torque ring, P/N 310172, was found cracked and therefore replaced. The torque ring is located in the low pressure compressor at the area of the compressor case "C" flange adjacent to the fourth stage compressor stator assembly. ^{5/} It serves to prevent rotation of the compressor stators. In position, the ring is tightly fitted and a series of slots on the ring mate with a series of lugs on the outer diameter of the fourth stage stator shroud. By design the torque ring is secured in place by 90 rivets, P/N AN 13340, made of AMS 7232, a nickel base alloy. The design shear strength of each rivet is 16,000 p.s.i. at 350 degrees, C. The ring is riveted to the compressor case "C" flange.

There are three borescope inspection ports in the outer compressor case and stator outer shroud. Each of the ports is closed by a threaded plug. Though not designed for the purpose, the ports and plugs tend to impede rotation of the compressor stator assembly.

Since no rivet material was found and the rivet holes in the area of damage were not elongated, the Board concludes that the low pressure compressor torque ring designed to prevent rotation of the low pressure compressor stator assembly was not secured in place by riveting during overhaul of the engine. As a result, when the restraining effect of the tight fit of the ring and the three borescope inspection port plugs was overcome by the normal rotational forces within the compressor, the stator assembly and torque ring began to turn.

At high rotational speed the torque ring bearing on the low pressure compressor case literally ground through the case until the case was so weakened that it disintegrated with explosive force. This is clearly sustained by the extreme abrasive and heat damage found on the recovered pieces of compressor case and stator vane assembly which came from the precise location where the torque ring would make contact.
