# AIRCRAFT ACCIDENT REPORT

BRANIFF AIRWAYS, INC.

BAC 1-11, N1553

NEAR FALLS CITY, NEBRASKA

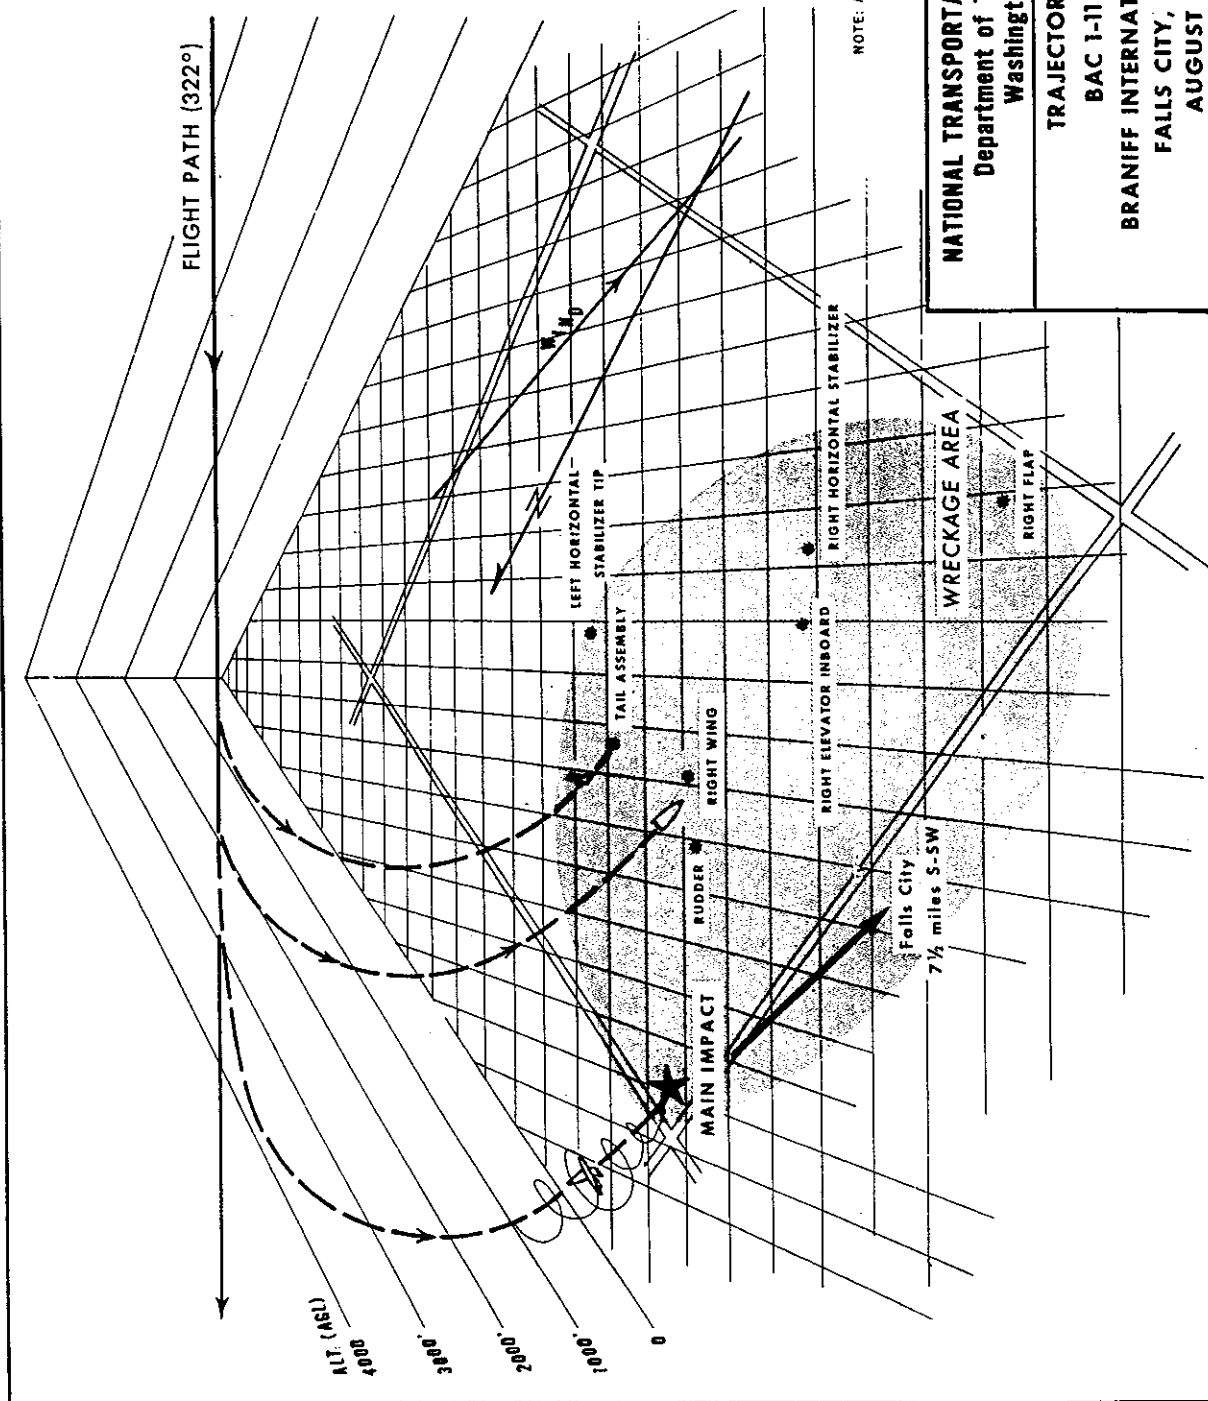
TRAJECTORY CHART

the aircraft was heading approximately 110 degrees magnetic with the right wing low. There was no indication of any horizontal displacement after initial impact. Portions of the right wing and the empennage were not found at the impact site. The right wing had separated near Rib 11 and the outboard section was found at a true bearing and distance from the main impact site of 147 degrees/2,503 feet respectively. The separated portion of the vertical fin with the left tailplane and part of the right tailplane attached was found 131 degrees/2,752 feet from the site, while the piece of the right tailplane outboard of Rib 3 was located 159 degrees/4,375 feet from the site. These and all other major pieces of the aircraft were found within a one square mile area located to the south and east of the site. (See Appendix D, Trajectory Chart.)

the air of the falling objects and projecting these backward from the known locations on the ground. The intersection of the paths of common or associated objects is indicative of the likely point in the air where the part(s) separated from the aircraft. This approach, therefore, is useful in assessing the probable structural failure sequence. Work of this nature is certainly not an exact science since one must first make some basic assumptions which then have significant effect upon the accuracy of the final results. However, the trajectory analysis is considered a valuable tool which can be used to verify the results of other work or to point out possible avenues of research. Since Flight 250 was being tracked by USAF Air Defense Command radar reasonably accurate information regarding the track, ground speed and height above ground was known. The drag coefficients of the various falling parts and the mean velocity of the wind acting upon these parts have had to be estimated using the best available data. However, reasonable variations in these parameters did not affect the basic conclusions. Based upon a study of the separated components it was concluded that: (1) the breakup must have occurred within a very short time, perhaps in a time interval in the order of two seconds, and (2) the fin-tailplane combination probably separated before the wing.
