AIRCRAFT ACCIDENT REPORT

TRANS WORLD AIRLINES, INC.

CONVAIR 880, N821TW

CONSTANCE, KENTUCKY

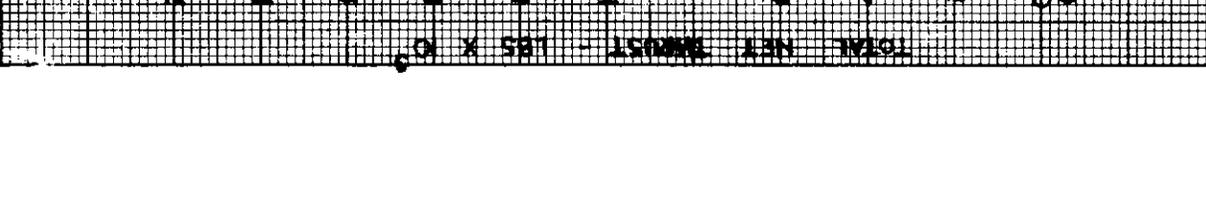
COMPUTED TOTAL NET THRUST BASED ON GENERAL ELECTRIC SOUND SPECTRAL STUDY TWA CONVAIR 360, NWA CONSTATEL, KY, 11-20-67

ALTITUDE AND INDICATED AIRSPEED DATA EXTRACTED FROM FOR RECORD AMBIENT CONDITIONS OBSERVED AFTER ACCIDENT
