AIRCRAFT ACCIDENT REPORT

LOS ANGELES AIRWAYS, INC.

S-61L HELICOPTER, N300Y

AUGUST 14, 1968

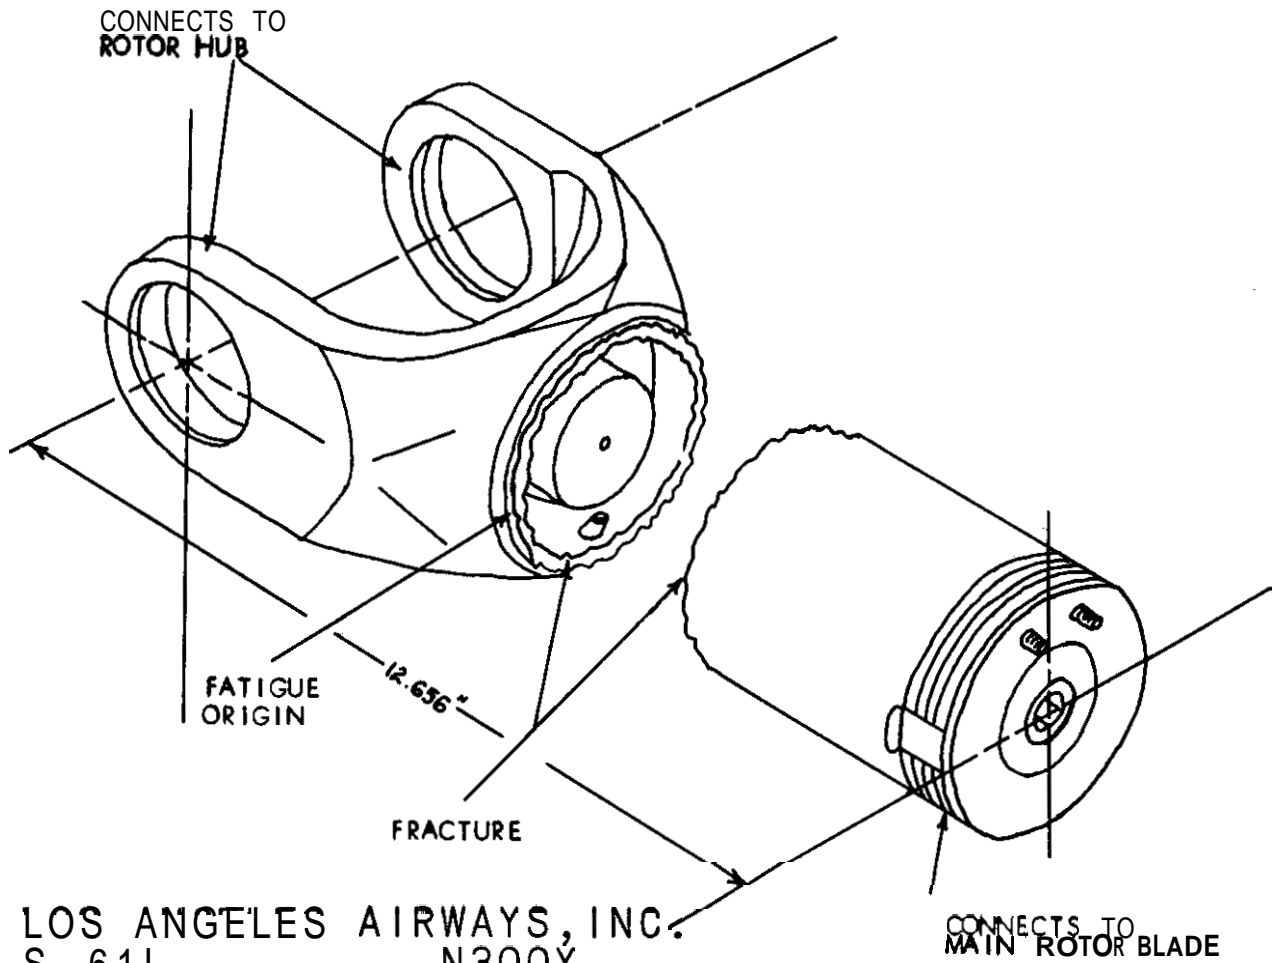
ATTACHMENT I
MAIN ROTOR SPINDLE
PART NO. S6110-23325-2B

assembly were located in the main impact area. The fifth main rotor blade (yellow) including the sleeve and part of the spindle, was located approximately one quarter of a mile northwest of the main wreckage site. Minor parts associated with this rotor blade were scattered over a three-block area northwest of the park. Examination of the yellow blade spindle (S/N AJ19) revealed a fatigue fracture in the shank of the spindle adjacent to the shoulder at the inboard end of the shank. (See Attachment 1.)

A stereomicroscope examination of spindle AJ-19 revealed that the nucleus of the fatigue fracture was on the trailing side of the spindle, one-eighth of an inch below the centerline, approximately at the shank tangency point, with the 0.125 inch radius at the shank/fork junction. The crack had originated in the base metal surface at the interface with the nickel plating, and propagated through approximately 72 percent of the shank cross-section prior to the failure. Additional laboratory studies revealed the following factors associated with the development of the fatigue crack:

Examination of the wreckage early in the investigation revealed that a fatigue fracture in the shank of the yellow blade spindle resulted in separation of the yellow main rotor blade, and caused loss of control of the aircraft. It was subsequently determined that no other factors related to the operation of the flight were involved. Consequently, the main thrust of the investigation focused on the circumstances surrounding the cause of the fatigue crack and the failure to detect it.
