## AIRCRAFT ACCIDENT REPORT

TRANS WORLD AIRLINES, INC.  
BOEING 707-331C, N787TW  
NATIONAL AVIATION FACILITIES  
EXPERIMENTAL CENTER  
ATLANTIC CITY AIRPORT  
POMONA, NEW JERSEY  
JULY 26, 1969

Adopted: March 25, 1970

NATIONAL TRANSPORTATION SAFETY BOARD  
Bureau of Aviation Safety  
Washington, D. C. 20591

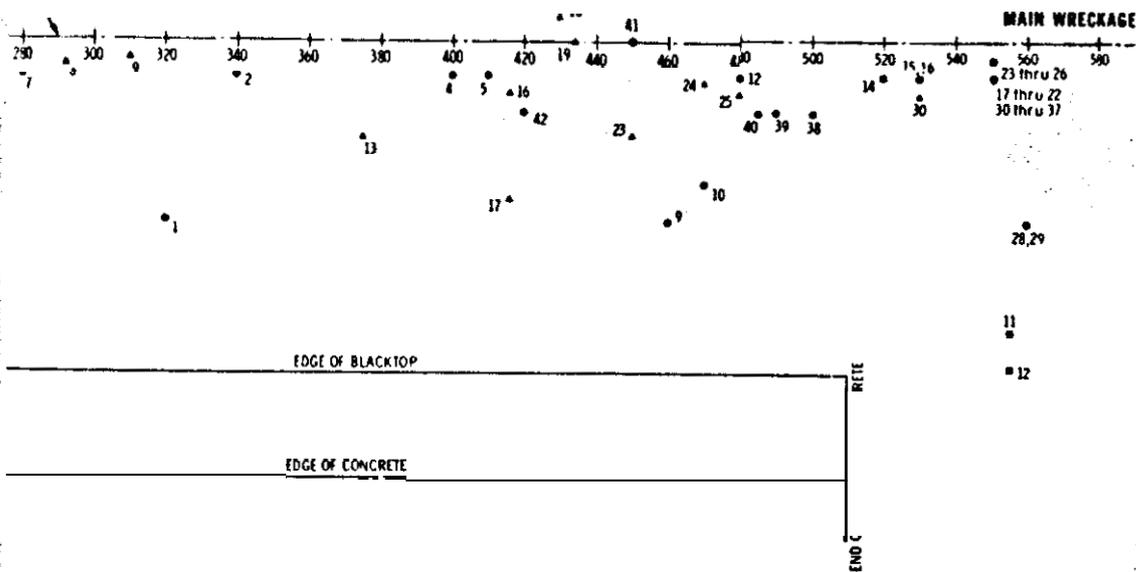
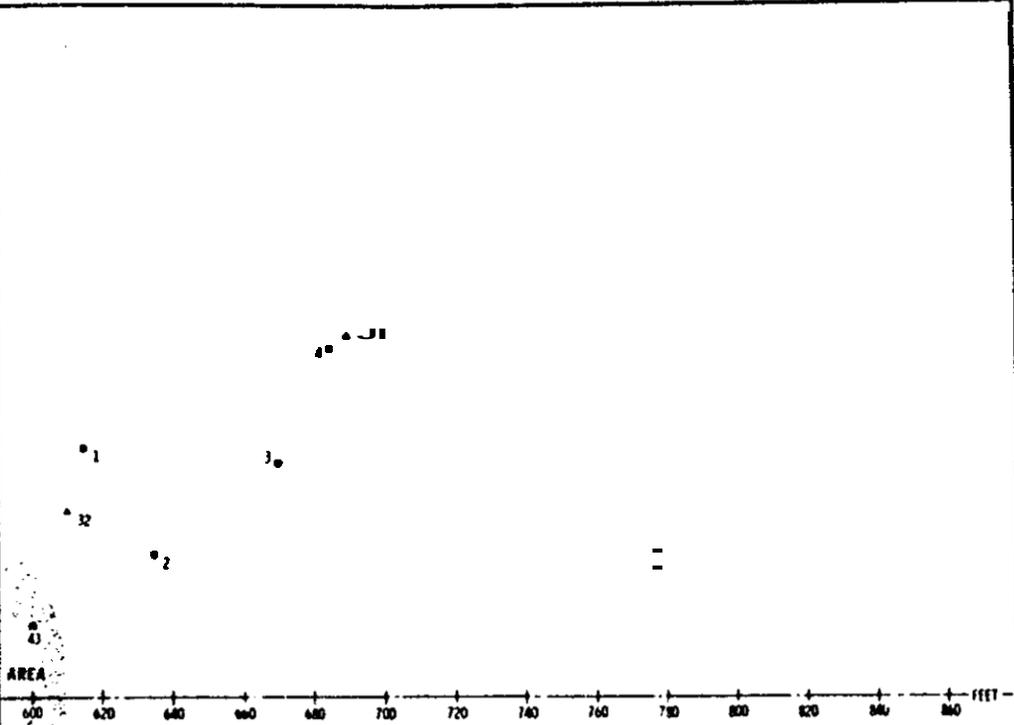
<p>NATIONAL TRANSPORTATION SAFETY BOARD          DEPARTMENT OF TRANSPORTATION          Washington, D.C.</p>
<p>WRECKAGE DISTRIBUTION CHART          TRANS WORLD AIRLINES, INC. B707-331C, N-787T          NAFEC, POMONA, N.J.          JULY 26, 1969</p>

The fuselage had separated into three large sections: The forward fuselage, including the cockpit area; the fuselage center; and the vertical stabilizer and rudder section. Each was heavily damaged by ground impact and the subsequent ground fire. The horizontal stabilizer and tail cone section had separated from the empennage and was found near the main wreckage. (See Appendix C, Wreckage Distribution Chart.)

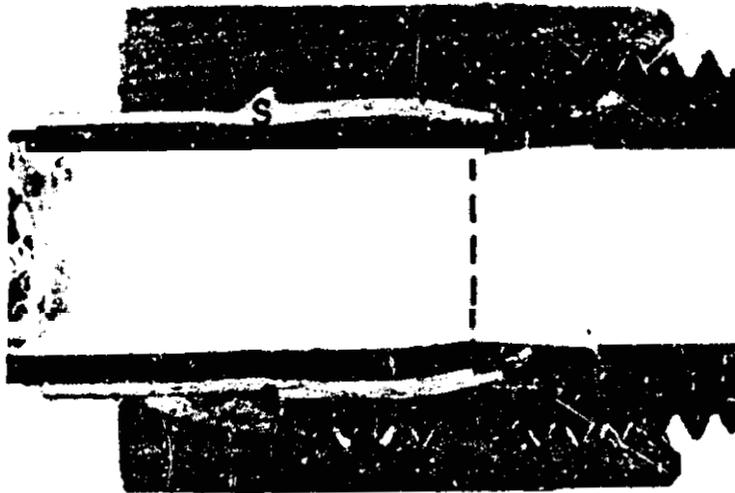
The hydraulic pressure line to the downside of the left outboard spoiler actuator had failed at the bottom of the sharp notch cut in the outside surface of the tube at the edge of the flareless coupling sleeve. Metallurgical examination of the break indicated that the failure was due to metal fatigue. (See Appendix D.)

Longitudinal section through an assembled flareless coupling, illustrating the location of the fracture (dashed line) indicated by arrow "a", Fig. 1. X 4
