AIRCRAFT ACCIDENT REPORT
TAG AIRLINES, INC.
DE HAVILLAND DOVE (DH-104), N2300H
IN LAKE ERIE
JANUARY 28, 1970
Adopted: January 6, 1971

NATIONAL TRANSPORTATION SAFETY BOARD
Washington, D. C. 20591
REPORT NUMBER: NTSB-AAR-71-5

TAG AIRLINES, INC.
De Havilland Dove (DH-104),
N2300H, in Lake Erie,
January 28, 1970

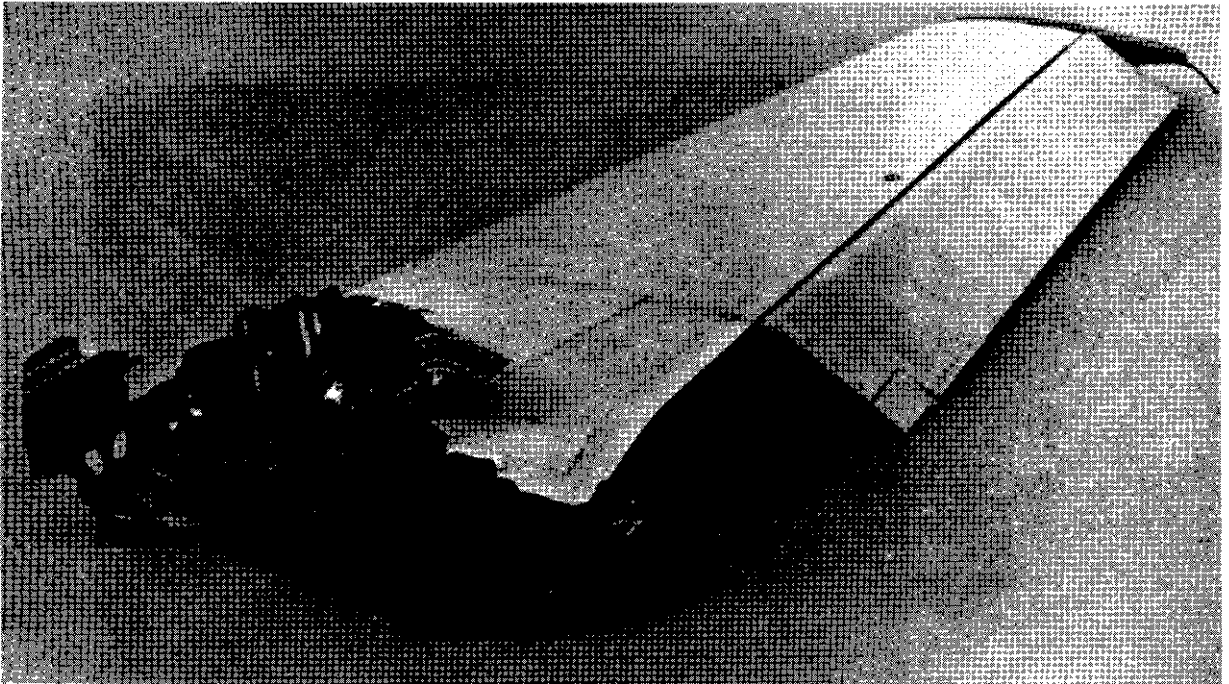
~~The outboard~~ section of the right wing, recovered from the surface of ~~the ice~~, had separated between rib stations 9 and 10 at the leading edge, and the fracture continued inboard toward rib section No. 8 as it progressed aft. The surface of the separation contained sawing/cutting, chisel-like marks from the bottom skin surface upward across the entire width of the wing. ~~The separation commenced 6 feet 7 inches~~ to the right of the outboard engine mount.

Right Outer Wing Section as recovered from Ice floe.

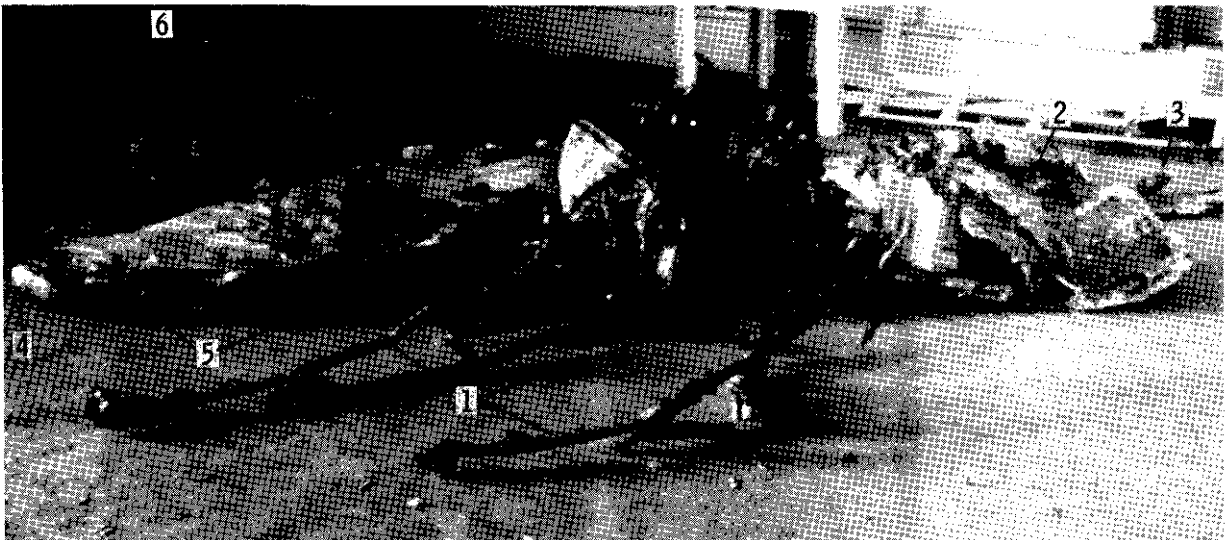
View of right inner wing section lay out from rib station No. 1 outboard to the area between rib stations Nos. 9 and 10.

1. Engine mount framings.
2. Section of top wing skin with fuel tank cap assembly attached.
3. Bottom main spar to fuselage attach fitting.
4. Area of wing separation.
5. Crushed leading edge of wing outboard of engine.
6. Right engine nose cowl panel.

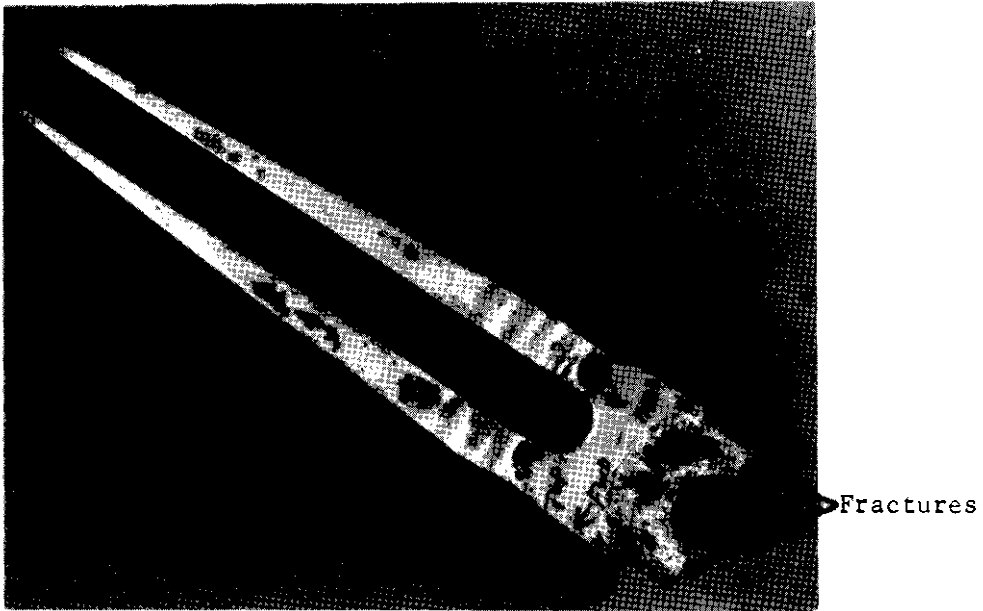
Two sections of bottom wing skin, the forward and aft fuel tank panels between Rib Stations Nos. 1 and 4, were recovered. Attached to the aft panel was a section of the bottom main root joint fitting. This fitting was broken through the 7/8-inch diameter bolt hole at the inboard end of the part of the fitting that had been attached to the wing.

The metallurgical examination of the failed lower root joint attach fitting established it had failed through the 7/8-inch diameter bolt hole at the inboard end of the part of the fitting that had been attached to the wing. (See Attachment 1.) ~~The surface of the break of this part contained well defined characteristics of fatigue failure across nearly all of the fracture surface on one side of the bolt hole and across 50 percent of the area on the other side of the hole.~~ The remainder of the break on the latter fracture was typical of tensile overload. (See Attachment 2.) The tensile overload evidence was present in approximately 25 percent of the total cross sectional area of the failure face.

The bore of the bolt hole had been chromium plated and the plating exhibited a pattern of crazing cracks and numerous larger cracks which had penetrated through the chromium layer but had not entered the parent metal. The fatigue failure originated at the periphery of the hole in an area where the chromium plate was chipped and irregular. (See Attachment 2.)

FAILED WING ATTACHMENT FITTING
FROM TAG AIRLINES DOVE, N2300H
