NATIONAL TRANSPORTATION SAFETY BOARD
WASHINGTON, D. C. 20591
AIRCRAFT ACCIDENT REPORT

Adopted: December 29, 1971

ROCKY MOUNTAIN AIRWAYS, INC.
AERO COMMANDER 680V, N6359U
ASPEN, COLORADO
JANUARY 22, 1970

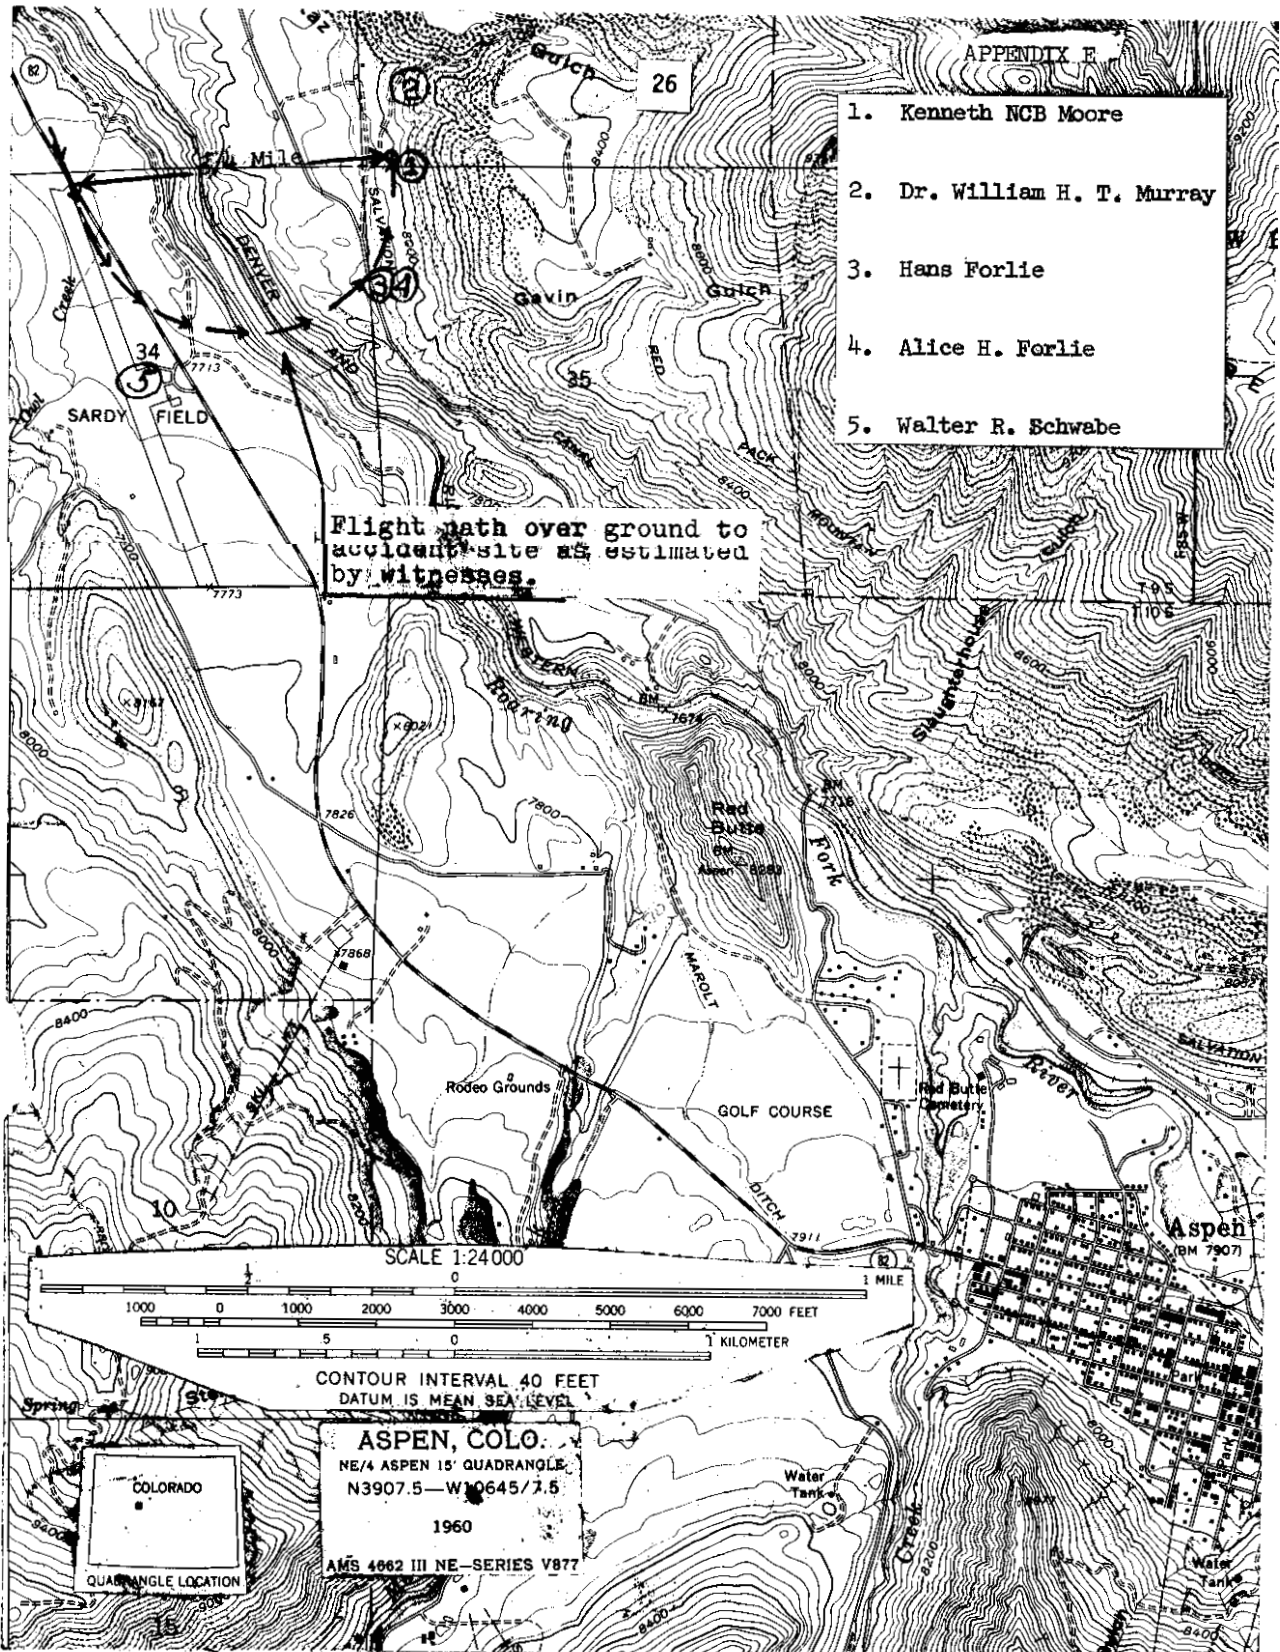
Flight path over ground to accident site as estimated by witnesses.
