AIRCRAFT ACCIDENT REPORT

MONMOUTH AIRLINES, INC.

Scheduled Air Taxi
Beech 99, N-986MA
Allentown-Bethlehem-
Easton Airport
Allentown, Pennsylvania
October 24, 1971

REPORT NUMBER: NTSB-AAR-72-3

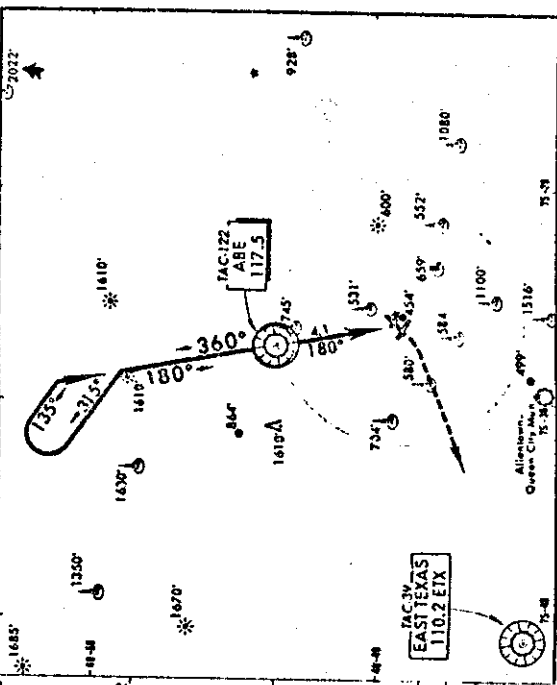
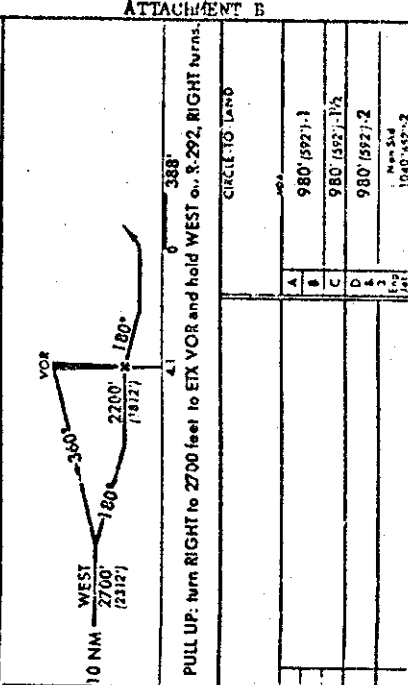
Express Approach Chart
 OCT 171 (13-1)
 ALLENTOWN lower 120.5122.4G
 Approach 118.2
 ALLENTOWN, PA.
 -BETHLEHEM-EASTON
 VOR 117.5 ABE
 # Oct 7 VOR-1
 Class B VORTAC
 Aprt Elev 388'
 Var 10°W
 MSA 376.090' 180° 270° 348'
 3300' 12000' 12500' 13700'

for the approach to Queen City Airport. The ABE VOR-1 approach utilizes the Allentown VOR facility for the approach to ABE. However, the minimum altitude over the final approach fix for the Queen City approach is 1,000 feet, whereas the minimum altitude over the final approach fix for the ABE approach is 2,200 feet. Both of these approach plates were filed together in the same approach plate binder utilized by Monmouth Airlines. (See Attachment B for approach details and minima for each facility.)

Since the flight had been cleared from Wilkes-Barre direct to ABE, the pilot likely would have established course on the Allentown 360° radial utilizing the Allentown VORTAC. Hence, in referring to the approach plate, his main concern might have been the minimum altitude over the final approach fix. According to the Allentown Approach Control communications transcript, the pilot used the 090° radial of the East Texas VOR to establish a reliable position north of the Allentown VORTAC because of the erratic operation of his DME. That the 12-mile fix was established is shown by the pilot's negotiation of the estimate from the station. It is possible that at this point, as a result of fatigue and the previous flight delays, the pilot elected to make a straight-in approach to the ABE Airport without proceeding to the VOR station at the minimum en route altitude, or executing the procedure turn as required. If, in this circumstance, the Allentown Queen City VORTAC approach chart was used incorrectly to determine the minimum altitude for crossing the final approach fix, the aircraft would have been cleared to fly 100 feet below the correct altitude of 2,200 feet as shown on the Allentown Wilkes-Barre chart. (See Attachment B.) The object would be to clear the terrain elevation in the Blue Mountain area.

Since both instrument approach plates are entitled "VCR-1" and have the word Allentown twice in proximity thereto, it is entirely possible that haste, poor lighting, or other factors might have caused the pilots to select the wrong approach plate for the approach they were conducting. Thus, when the aircraft was cleared for the approach and erroneously descended to 1,600 feet m.s.l., there was inadequate terrain clearance, and the ensuing accident was inevitable.

- (1) Require some conspicuous and distinctive marking to be affixed to the Allentown approach plates to enable pilots to identify the proper plate quickly and positively. The words "CAUTION -- VERIFY PROPER APPROACH" or similar phraseology may be appropriate.
- (2) Promptly review all instrument approach plates to determine instances of potential approach plate misidentifications in other locations, and if found, institute the same remedial action.
- (3) As an interim measure, notify the public of this potential hazard by whatever means you deem most expeditious and effective.

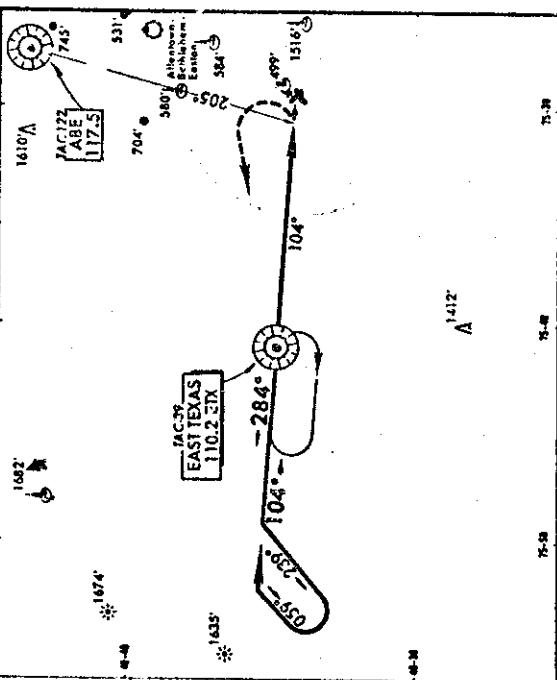
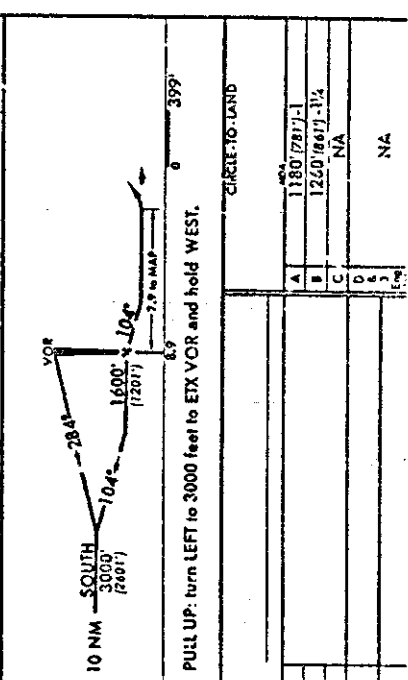
Express Approach Chart
 SEP 24271 (23-1)
 Use Allentown FSS altimeter setting-
 ALLENTOWN Approach 118.2
 ALLENTOWN, PA.
 -QUEEN CITY MUN
 VOR-1
 VOR 110.2 ETX
 Class B VORTAC
 Aprt Elev 399'
 Var 10°W
 MSA 349.090' 180° 270° 348'
 3300' 12000' 12500' 13700'

The Queen City Municipal Airport is close to the ABE Airport, and has a VOR-1 approach plate with peculiar similarity to the ABE VOR-1 approach plate. The Queen City VOR-1 approach utilizes the East Texas VOR facility

The aircraft crashed 10 miles north of the airport and 5 miles north of the Allentown VOR at an altitude of 1,600 feet mean sea level (m.s.l.). In an attempt to ascertain why the aircraft was at that altitude, at that point, the VOR approach plates were reviewed closely. It was noted that 1,600 feet m.s.l. is the low station altitude for the Allentown VOR approach to the Queen City Municipal Airport, utilizing the East Texas VOR. The VOR approach to the Bethlehem-Easton Airport, using the Allentown VOR, has a low station altitude of 2,200 feet m.s.l.
