**AIRCRAFT ACCIDENT REPORT: CHICAGO AND
SOUTHERN AIRLINES, INC., BEECH E18S (ATECO
WESTWIND II) N51CS - PEORIA, ILLINOIS
OCTOBER 21, 1971**

AIRCRAFT ACCIDENT REPORT

CHICAGO & SOUTHERN AIRLINES, INC.
Beech E18S (ATECO WESTWIND II) N51CS

Peoria, Illinois
October 21, 1971

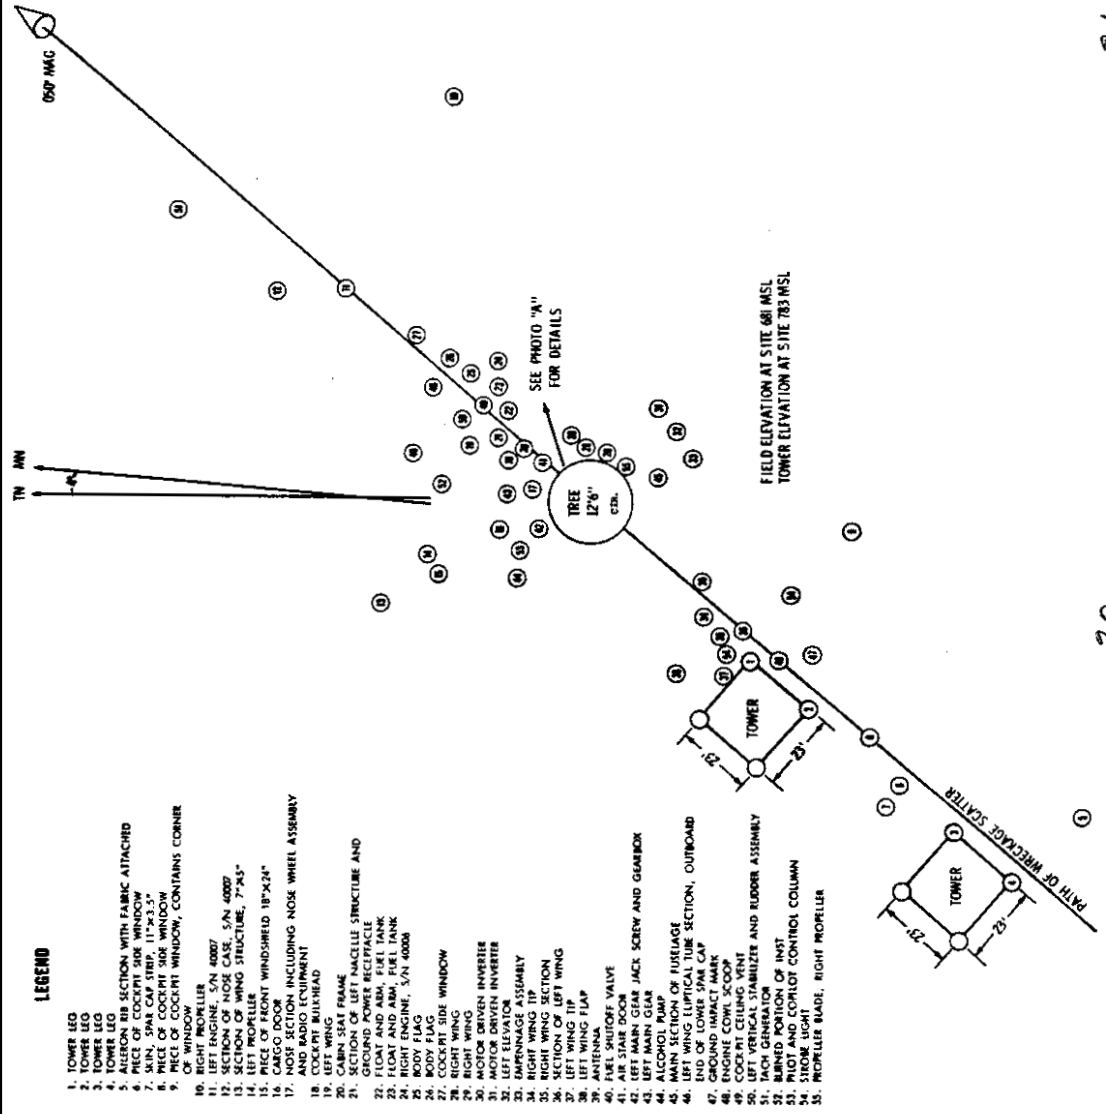
APPENDIX D

1. TOWER LEG
2. TOWER LEG
3. TOWER LEG
4. SECTION WITH FABRIC ATTACHED
5. PIECE OF COCKPIT SIDE WINDOW
6. PIECE OF COCKPIT SIDE WINDOW
7. SKIN, SPAR CAP STRIP, 11" x 3.5"

18. COCKPIT WINDSHIELD
19. LEFT WING
20. CABIN SEAT FRAME
21. SECTION OF LEFT FACELLE STRUCTURE AND PROPELLER REPAIR
22. FLOAT AND AIR FUEL TANK
23. FRONT AND ARM, FUEL TANK

47. GROUND IMPACT MARK
48. ENGINE COWL SCOOP
49. COCKPIT CEILING VENT
50. TACH GENERATOR
51. TACH GENERATOR
52. BURNED PORTION OF INST
53. PILOT AND COPILOT CONTROL COLUMN

54. STROBE LIGHT
55. PROPELLER BLADE, RIGHT PROPELLER

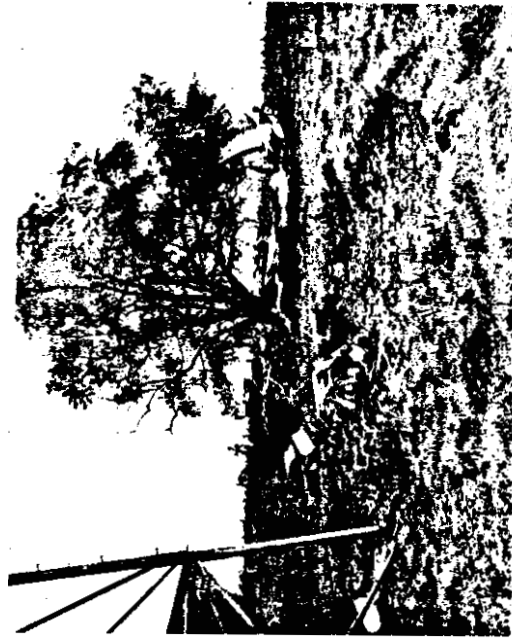
PHOTO "A"

The left wing tip, an 8-foot section of the left wing leading edge, and other structural parts were found adjacent to the base of the easterly tower. Marks were found on one leg of this tower which match impressions on the separated wing leading-edge section. The elevation at the base of the easterly tower is 681 feet m.s.l. (See Appendix E for additional details.)
