AIRCRAFT ACCIDENT REPORT. TANDY CORPORATION GATES LEARJET MODEL 25, N653TC, NEAR THE VICTORIA COUNTY, FOSTER AIRPORT, VICTORIA, TEXAS, 18 JANUARY 1972

REPORT NO. NTSB/AAR-72-24

TANDY CORPORATION
GATES LEARJET MODEL 25, N658TC
NEAR THE VICTORIA COUNTY-FOSTER AIRPORT
VICTORIA, TEXAS
JANUARY 18, 1972

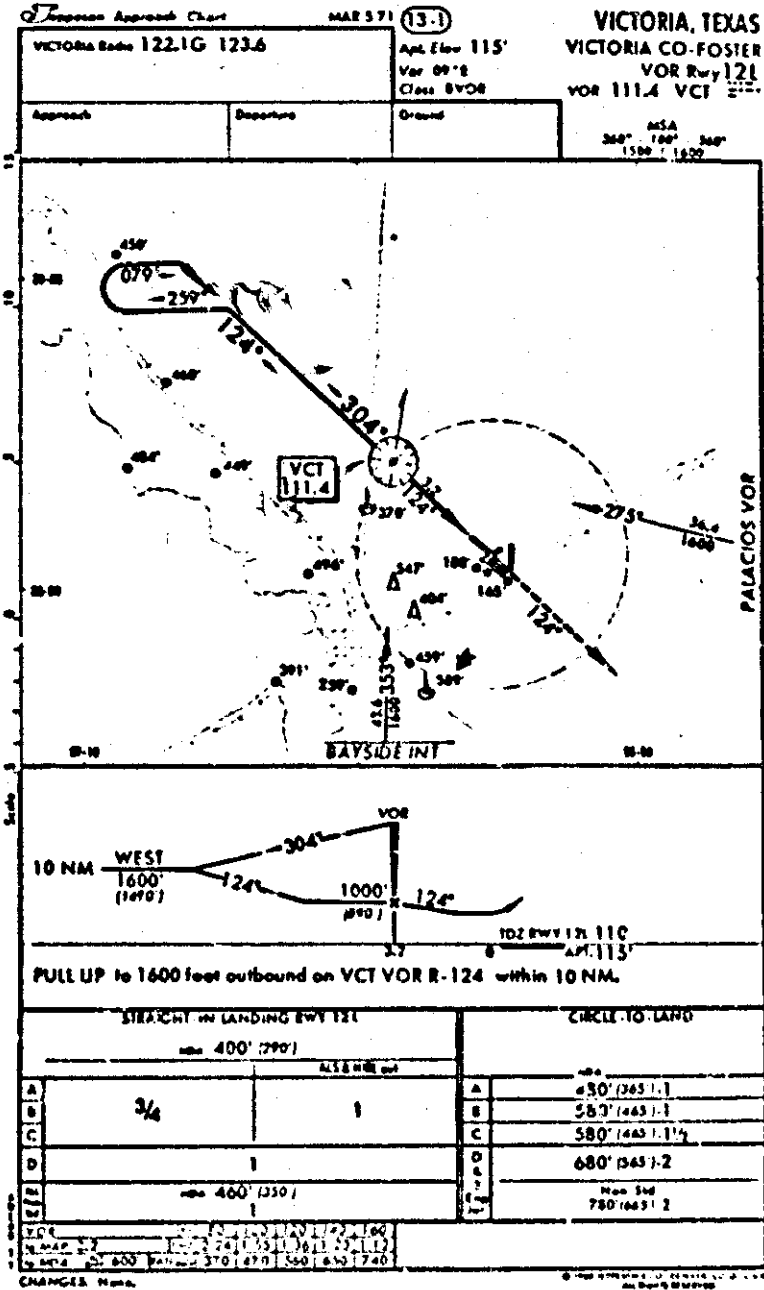
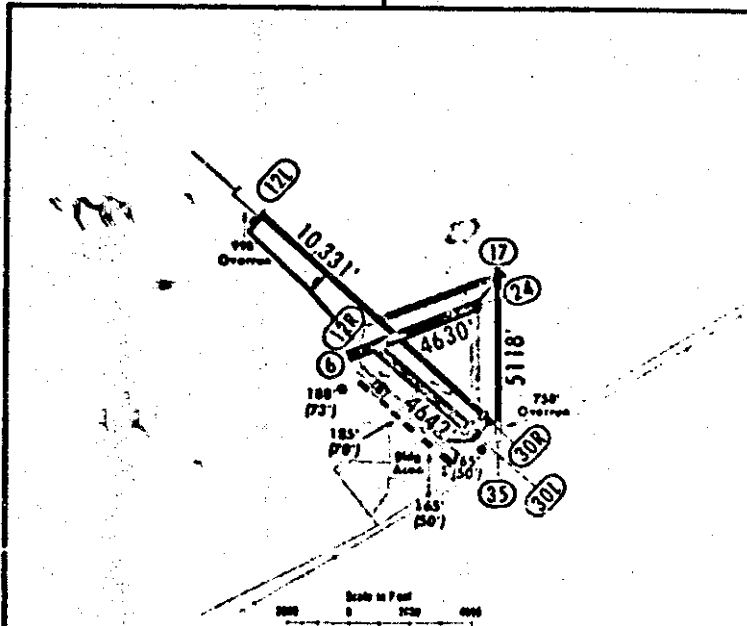
APPENDIX B

1,800 feet left of the centerline projected from the VOR⁴ facility toward the runway. (For details see Appendix B.) The aircraft was almost completely demolished by the surface impact and subsequent ground fire. All occupants in the aircraft were fatally injured.
