**AIRCRAFT ACCIDENT REPORT**

**UNITED AIR LINES, INC.**

**Boeing 737, N9031U**

**REPORT NUMBER: NTSB-AAR-73-16**

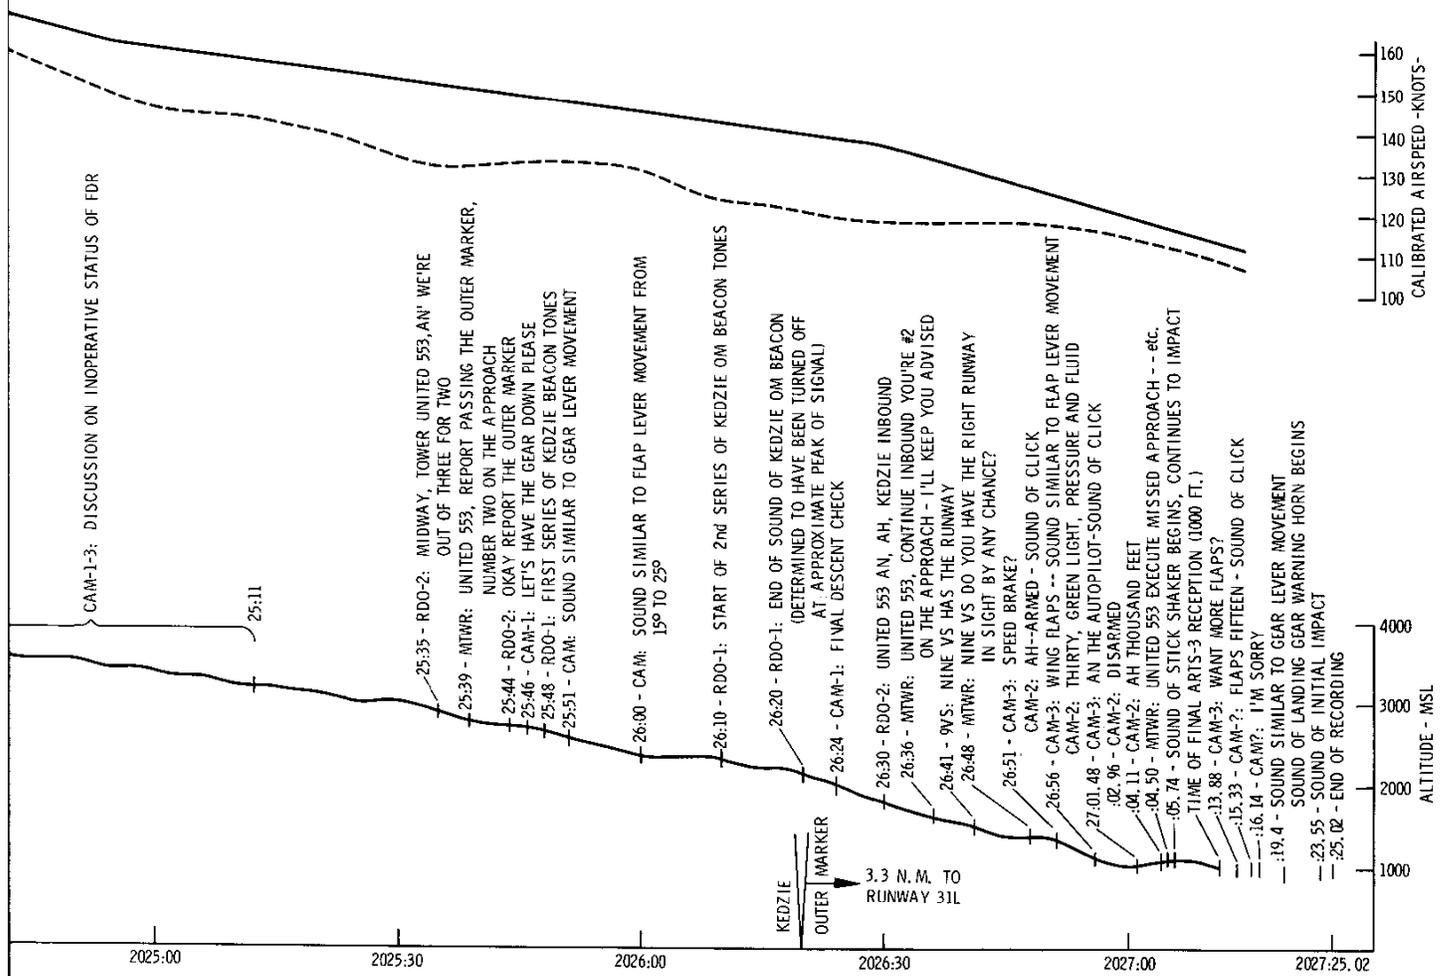
**APPROACH PROFILE DERIVED FROM ARTS III AND CVR DATA**  
**UNITED AIRLINES, INC. B-737, N9031U, FLIGHT 553**  
**NEAR MIDWAY INTERNATIONAL AIRPORT, CHICAGO, ILLINOIS**  
 December 8, 1972

4 seconds of reaching level-off altitude. The 1,500 ft/min descent from the outer marker to the MDA was in excess of that recommended in the company's operations manual.

The indicated airspeeds derived from the ARTS-III data showed a gradual deceleration during this descent, with level-off being initiated approximately at 120 knots. The theoretical performance of the B-737 conflicts somewhat with this evidence. The CVR sound spectrogram study showed that the power remained at 58 percent to 59 percent  $N_1$  throughout the descent. With the thrust produced under the existing conditions, a 1,550 ft/min descent can be achieved in a high-drag configuration, but the stabilized airspeed will be in excess of 130 knots. The performance study indicated that had 30° flaps been selected at 1426:00 and had the spoilers been extended to the flight detent position upon establishing the 1,550 ft/min descent, level-off would have been initiated approximately at 133 knots. Any configuration producing less drag would have resulted in a higher level-off airspeed, which would have been less compatible with the subsequent events. The aircraft's performance corresponding to this thrust and drag configuration was validated by the B-737 simulator tests. Therefore, the Safety Board concludes that level-off airspeed was closer to the theoretical value and that the final descent was accomplished in a 30° flap, landing-gear-down configuration with the spoilers extended to the flight detent position.
