# **AIRCRAFT ACCIDENT REPORT**

**TEXAS INTERNATIONAL AIRLINES, INC.**

**CONVAIR 600, N94230**

**REPORT NUMBER: NTSB-AAR-74-4**

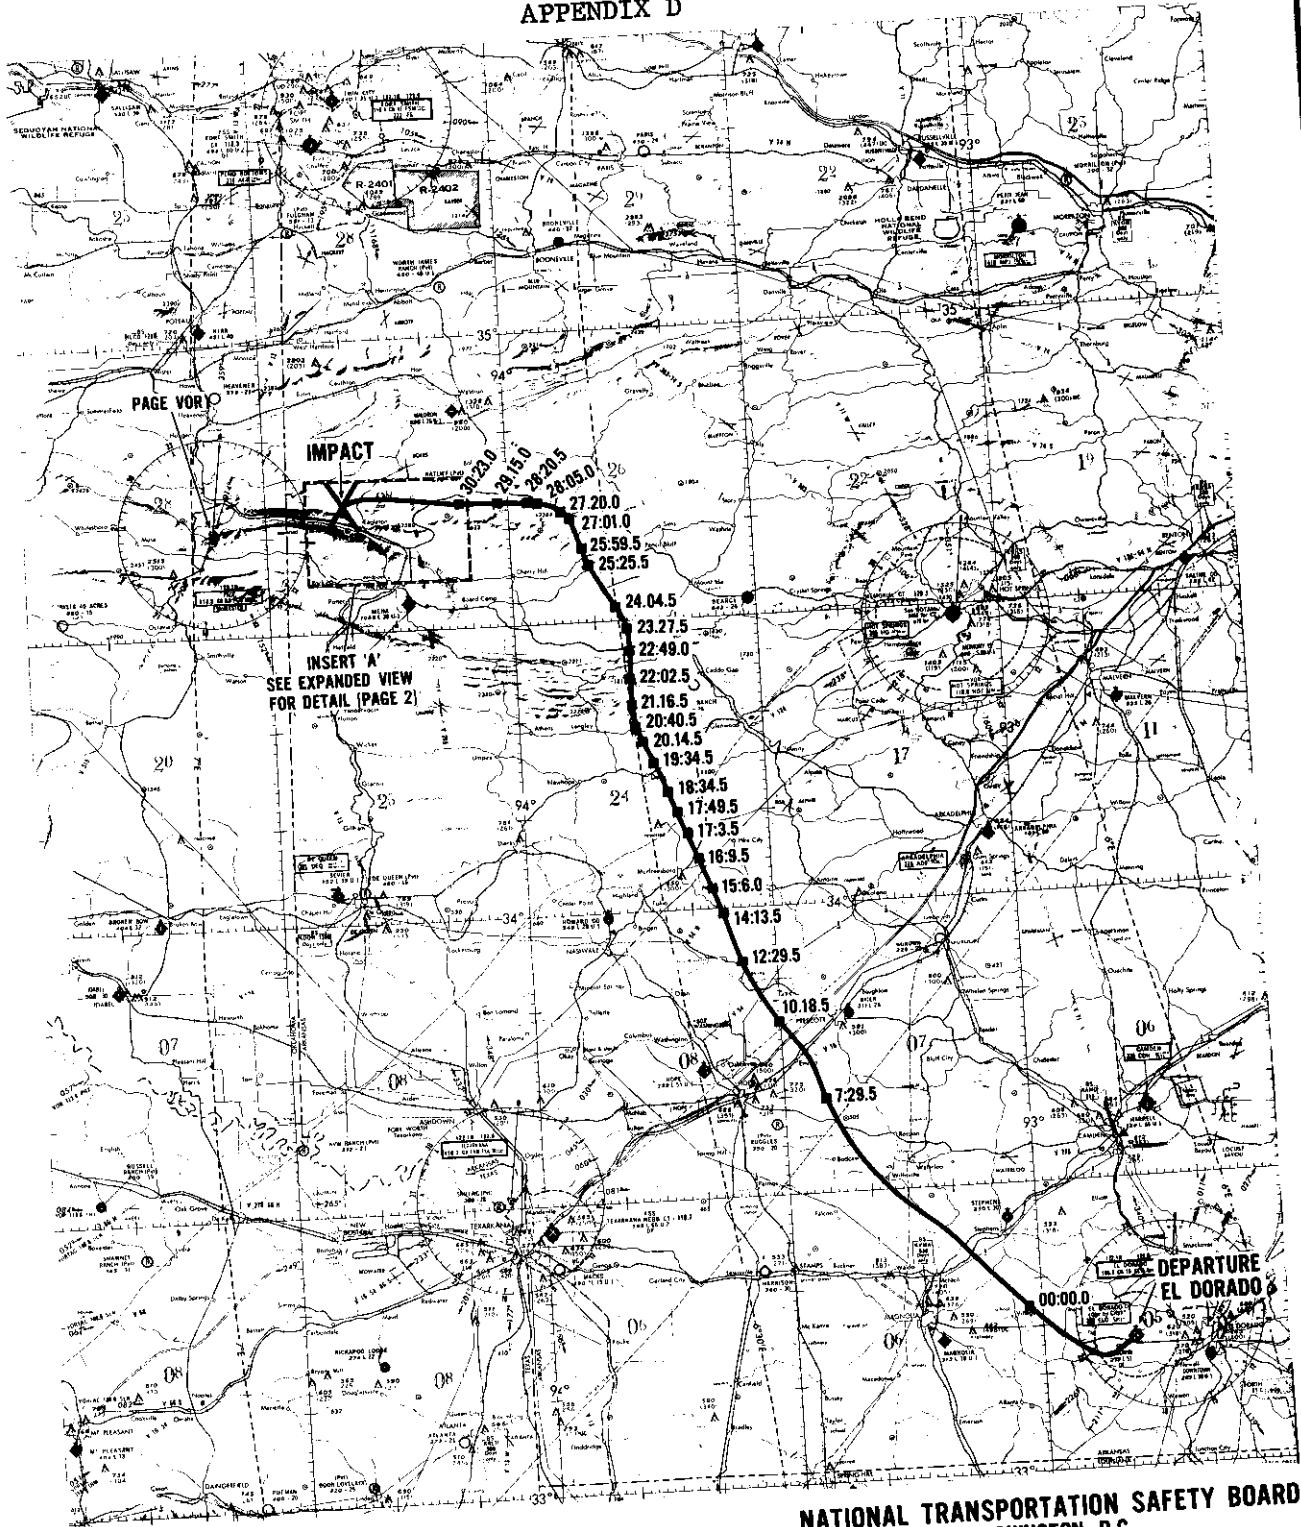
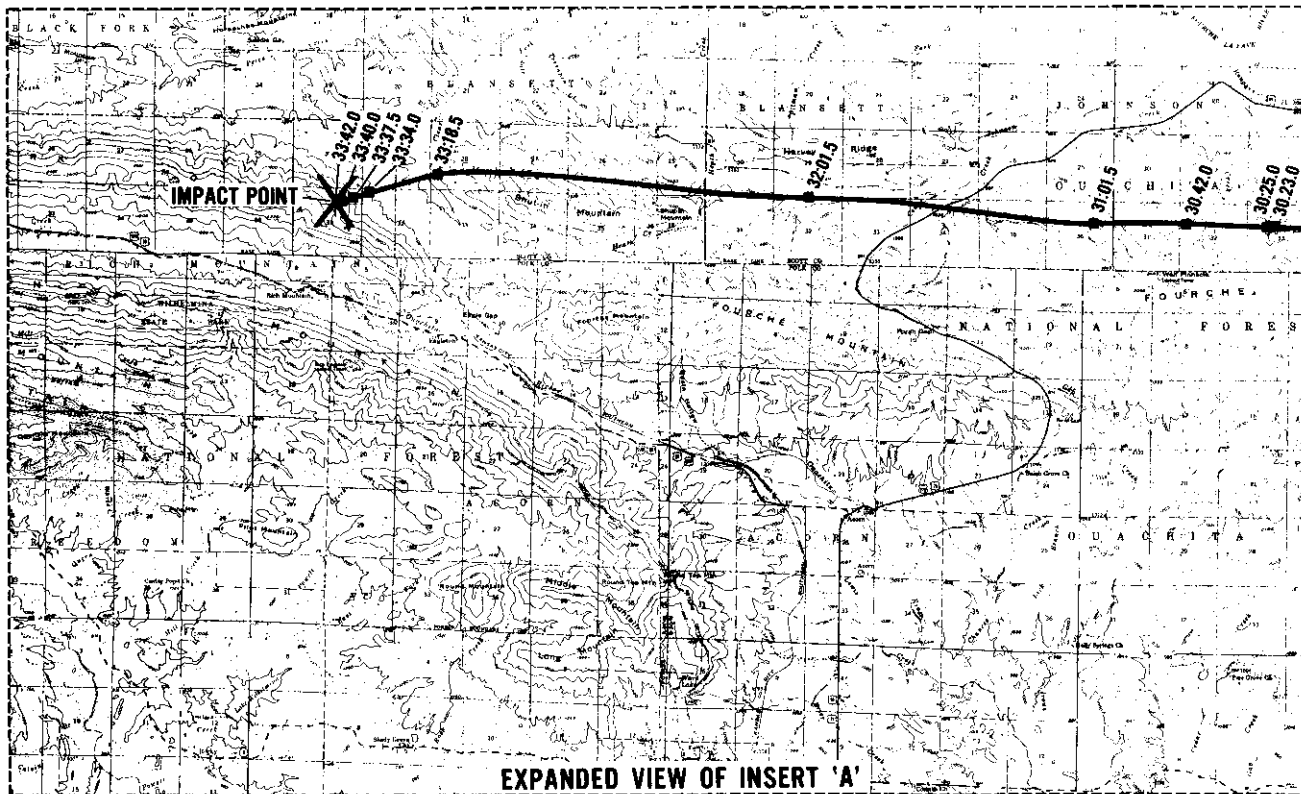
FLIGHT TRACK PRESENTATION  
TEXAS INTERNATIONAL AIRLINES  
CONVAIR CV-600, N94320  
FLIGHT NO. 655  
MENA, ARKANSAS  
September 27, 1973

After takeoff, the aircraft turned northwest and flew various headings until 2046:40. At that time, the heading trace indicated a turn toward the west. At 2051:45, the aircraft turned to  $240^{\circ}$ . This heading remained constant until impact, 34.8 seconds later. The turn toward the west began 100 nmi north of the direct course between El Dorado and Texarkana.

1. Times shown correspond to those relative times assigned to intra-cockpit conversation transcribed from the Aircraft Cockpit Voice Recorder. Sounds of impact occurred approximately 37 minutes 20 seconds after departure from El Dorado.
2. The Flight Track shown was derived from airspeed and heading data captured by the Aircraft Flight Data Recorder and estimated en route wind information.
