AIRCRAFT ACCIDENT REPORT

PIEDMONT AIRLINES
BOEING 737, N751N
GREENSBORO, N.C.
OCTOBER 28, 1973

NATIONAL TRANSPORTATION SAFETY BOARD
Washington, D.C. 20591
Report Number: NTSB-AAR-74-7

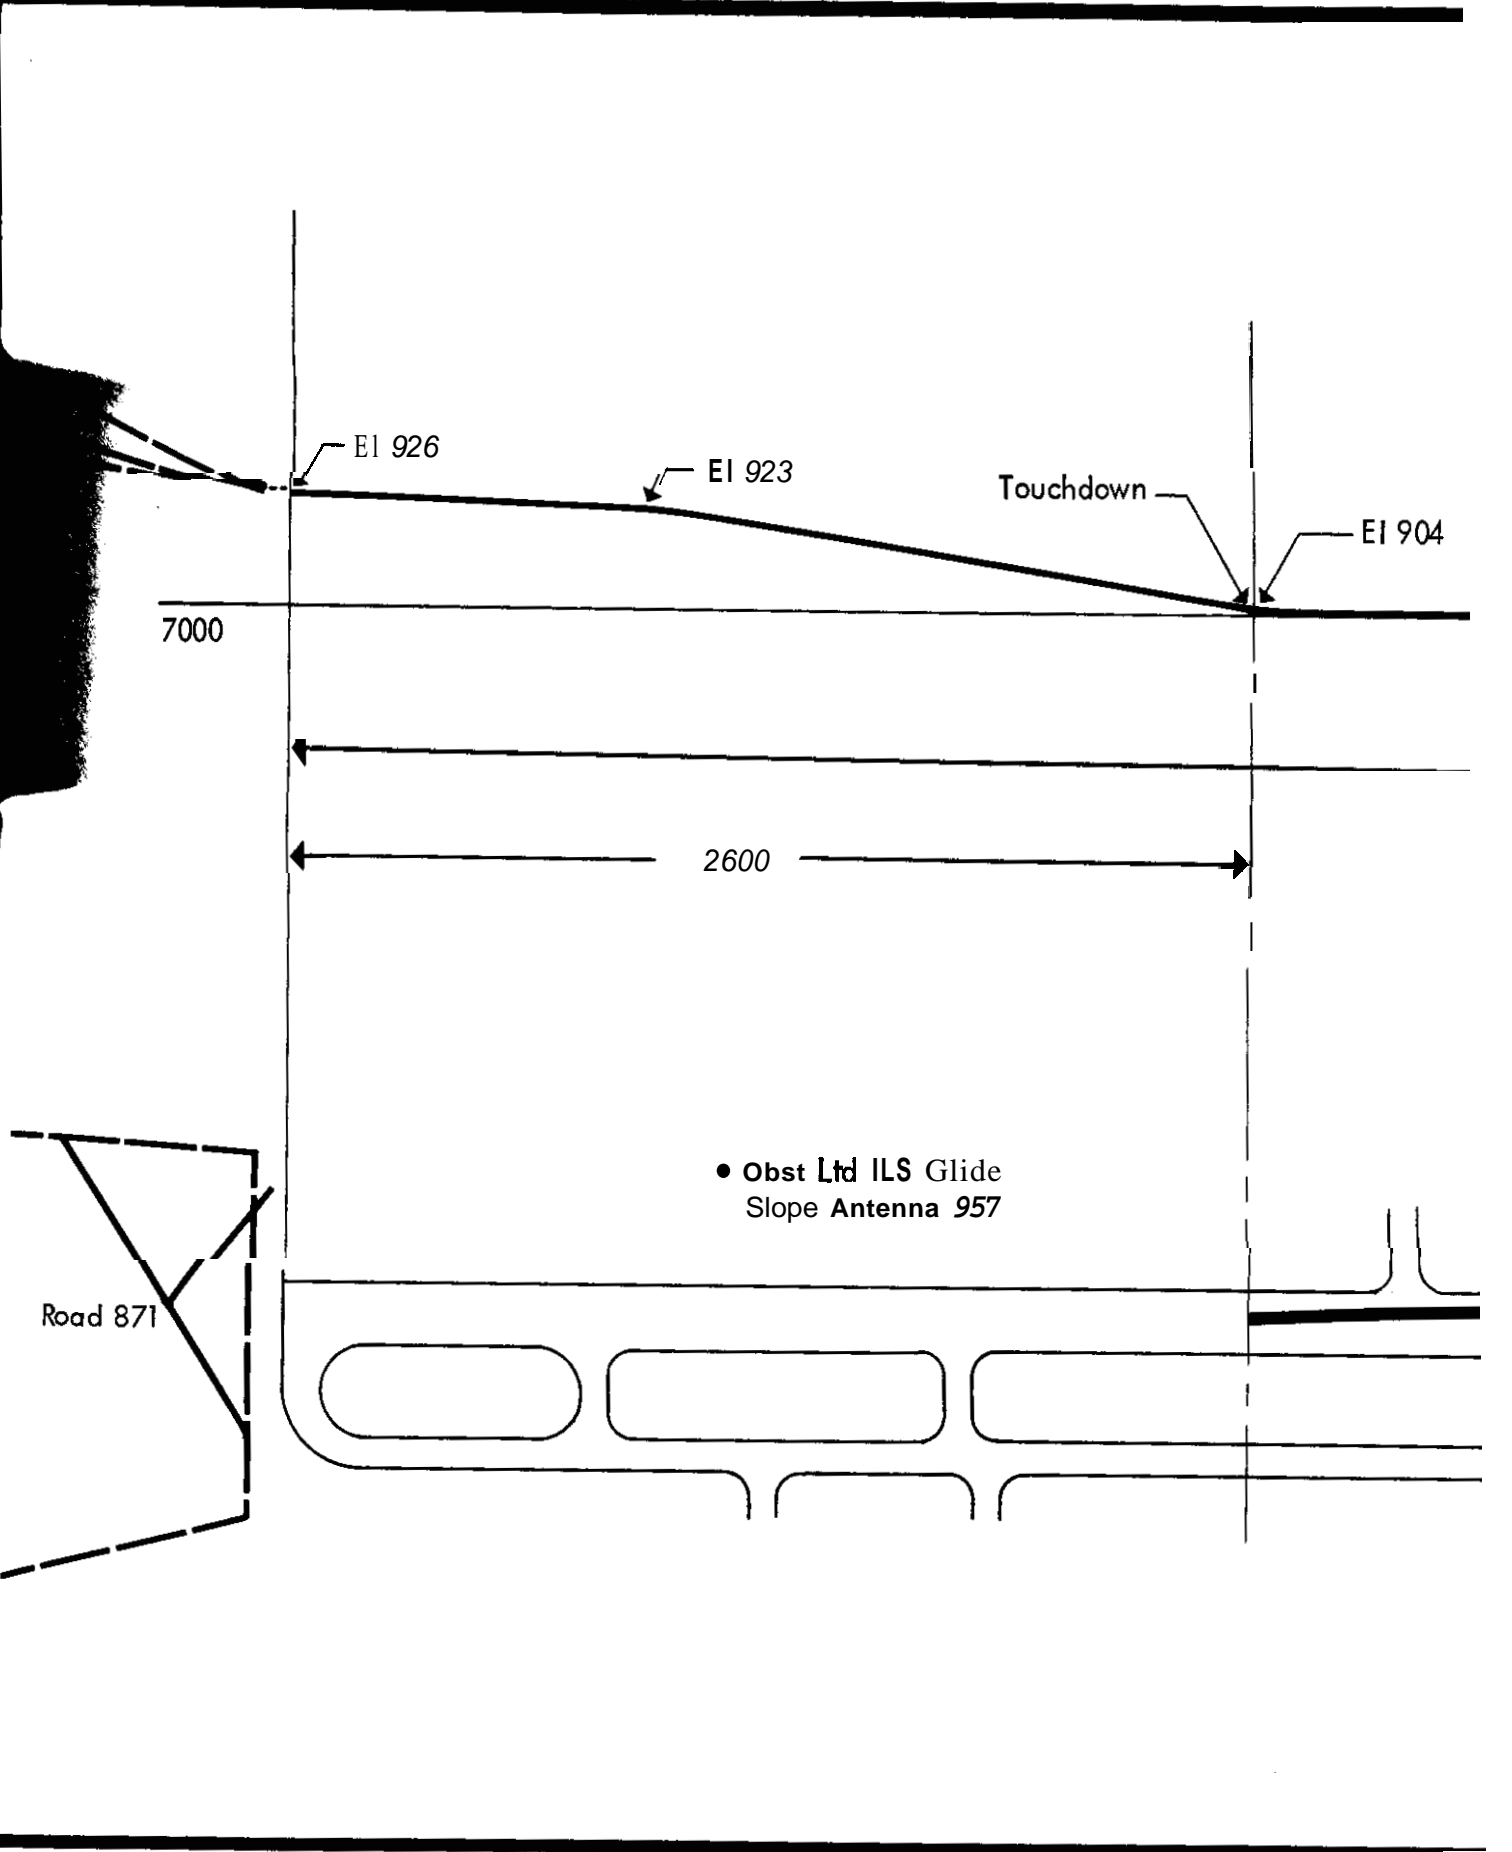
The aircraft continued about 640 feet, crossed a service road, and stopped on an incline 820 feet from the runway. (See Appendix D.)

Tire tracks began where the right main tires contacted the runway, 2,600 feet from the approach threshold and about 10 feet left of the centerline. Tracks of the nose wheel tires began 2,900 feet down the runway; tracks from the left main tires began at 3,000 feet. The left main wheels rolled to within 9 feet 10 inches of the left side of the runway, and 5,400 feet down the runway at which point the tracks turned toward the center of the runway. When the aircraft crossed the end of the runway, the tracks of the left main tires were 47 feet 6 inches from the left edge of the runway.

Aircraft developed right skid

Aircraft straightened
