AIRCRAFT ACCIDENT REPORT

PAN AMERICAN WORLD AIRWAYS, INC.

BOEING 707-321B, N454PA

REPORT NUMBER: NTSB-AAR-74-15

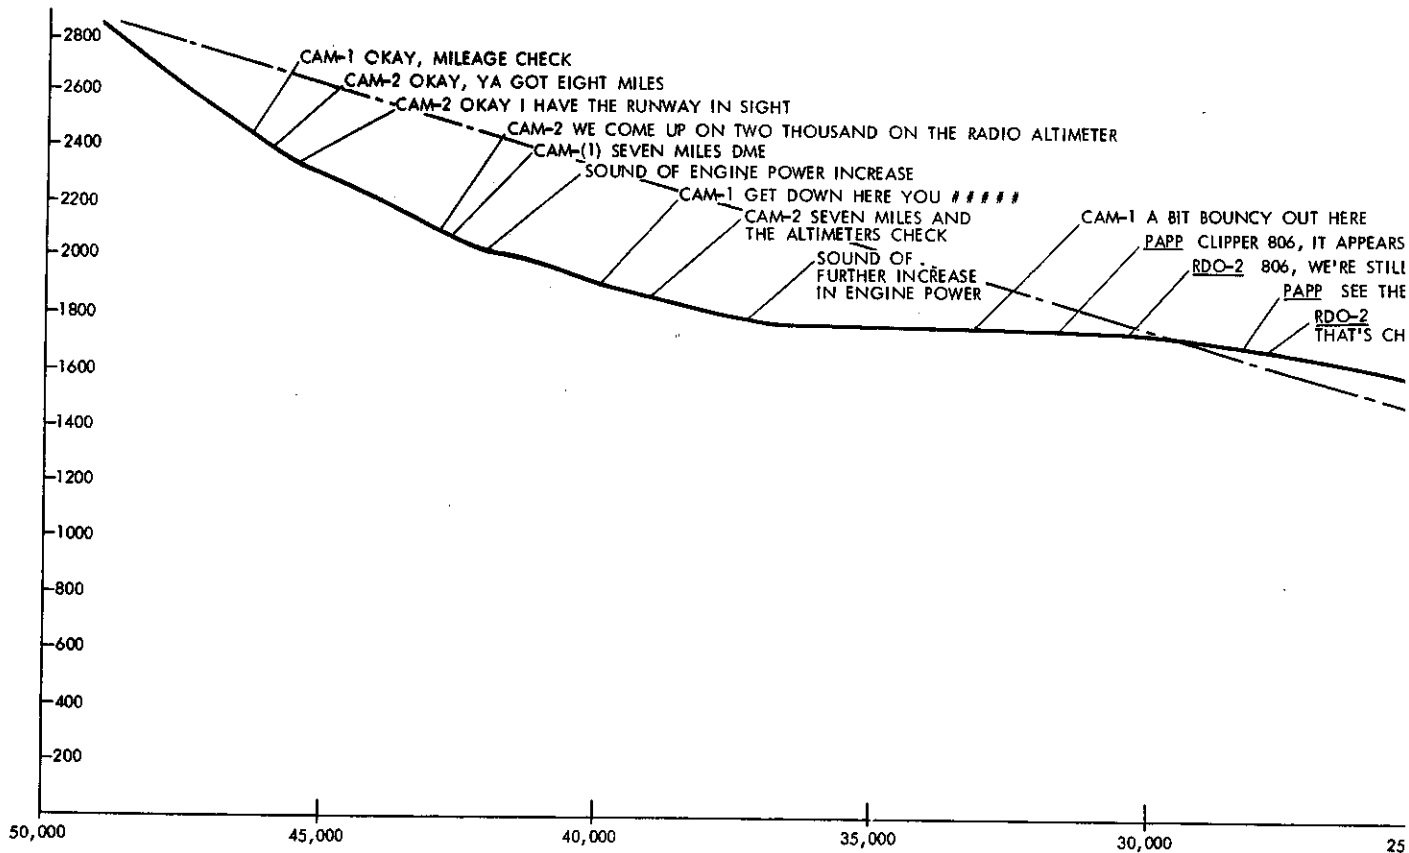
APPENDIX E

---GLIDE SLOPE
—DESCENT PROFILE
.....PROJECTED ACTUAL FLIGHT PATH
* AIRCRAFT INITIAL CONTACT WITH TREES 25 FEET ABOVE GROUND LEVEL

NOTE: GLIDE PATH INTERCEPTS RUNWAY 975 FEET BEYOND RUNWAY THRESHOLD
