AIRCRAFT ACCIDENT REPORT

SIERRA PACIFIC AIRLINES, INC.

CONVAIR 340/440, N4819C

MARCH 13, 1974

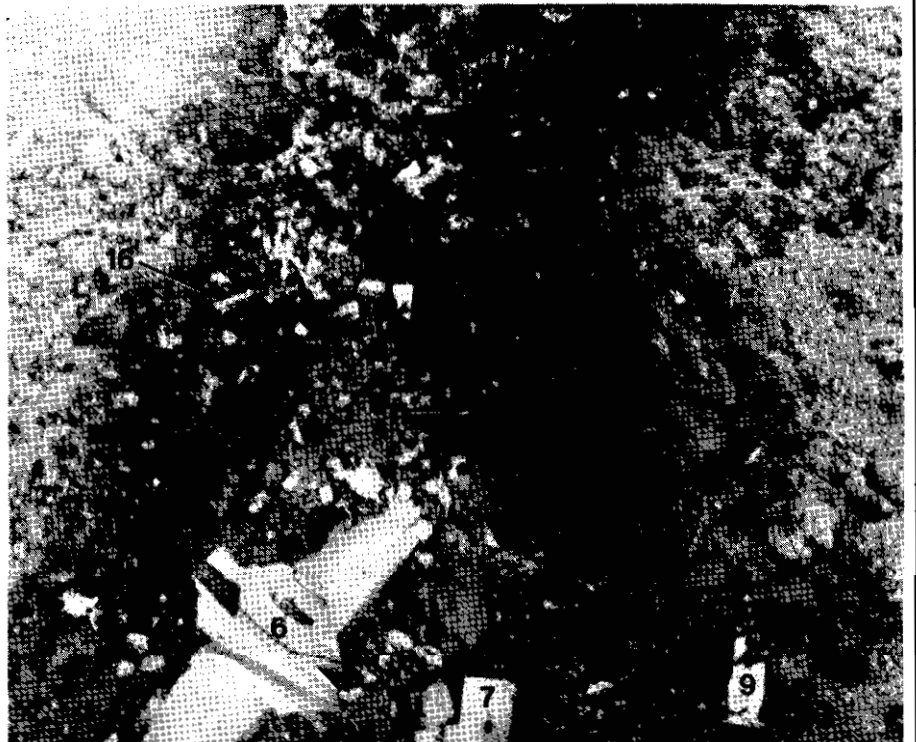
WRECKAGE DISTRIBUTION CHART
 SIERRA PACIFIC AIRLINES
 CONVAIR 340/440, N4819C
 DCA 74-A-18
 NEAR BISHOP, CALIFORNIA
 MARCH 13, 1974

The aircraft struck the north slope of a mountain ridge about 5.2 statute miles southeast of the Bishop Airport and at an elevation of 6,100 feet. The top of the ridge, which runs generally east to west, is 6,280 feet. Depressions in the earth made by the right wing leading edge and the right propeller and engine showed that, at impact, the aircraft was on a heading of 175° magnetic and in a 25° right wing-down attitude. The wreckage was scattered over an area 1,083 feet long and 120 feet wide. Parts of all major sections of the aircraft structure and flight control surfaces were found in the wreckage area. (See Appendix E.)

The breakup of the aircraft was extensive in all wing and fuselage areas. Portions of the fuselage main body, center wing section, and cockpit were consumed by ground fire.

The empennage had separated from the main fuselage body and had come to rest about 40 feet upslope from the initial impact point. The rudder was deflected to the right about 14 inches, and the trim tab was deflected to the right about 1 1/4 inches. The flight tab was in the neutral position. Both elevators were deflected upward about 6 inches. The left servo tab was deflected upward 7/8 inches; the right servo tab was faired.
