AIRCRAFT ACCIDENT REPORT

SIERRA PACIFIC AIRLINES, INC.

CONVAIR 340/440, N4819C

REPORT NUMBER: NTSB-AAR-75-1

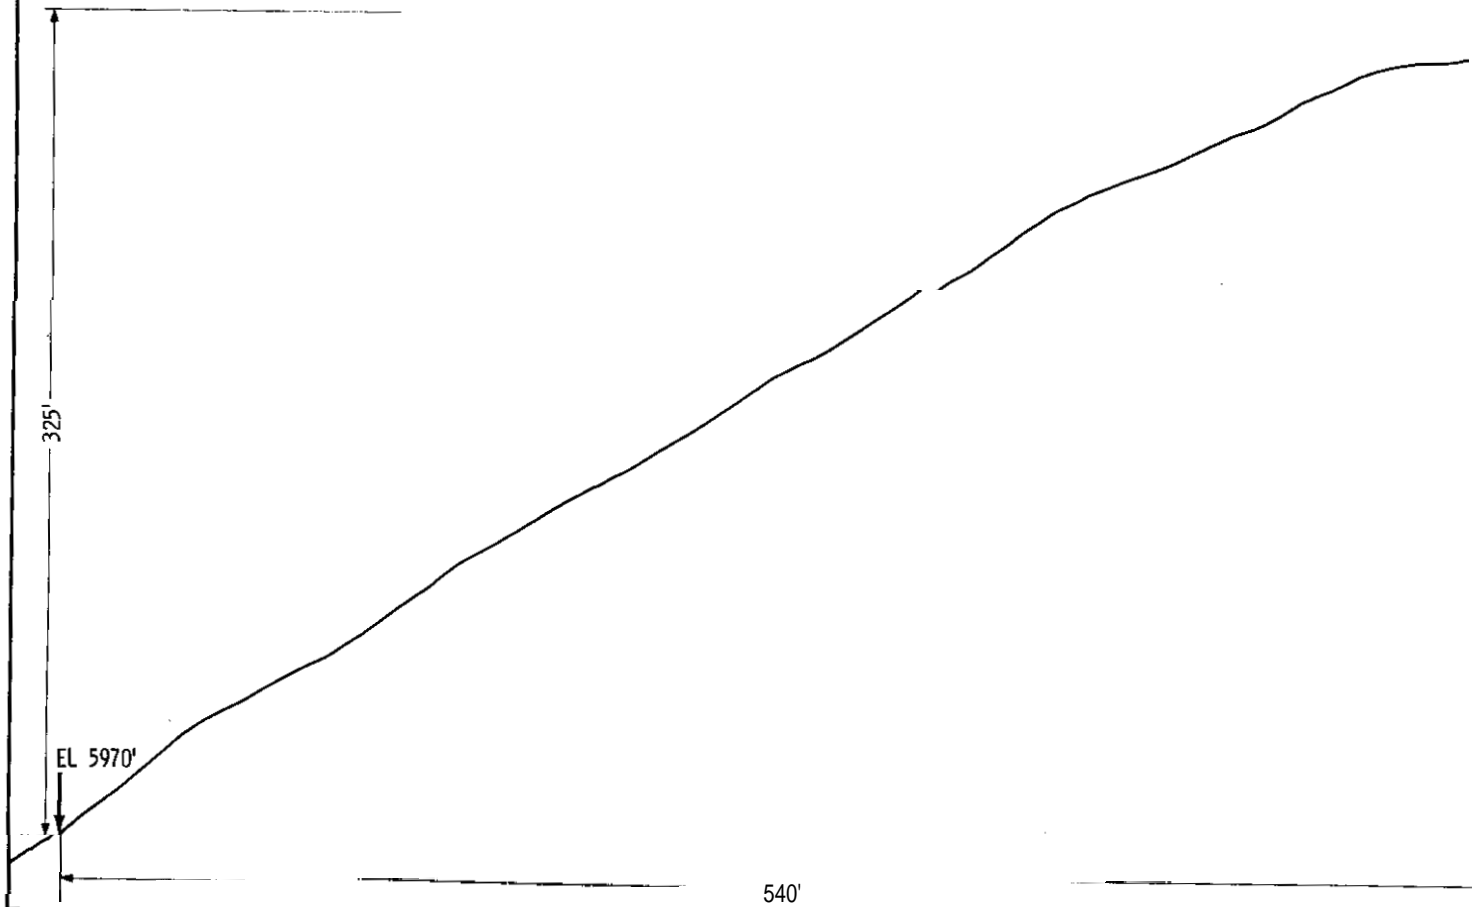
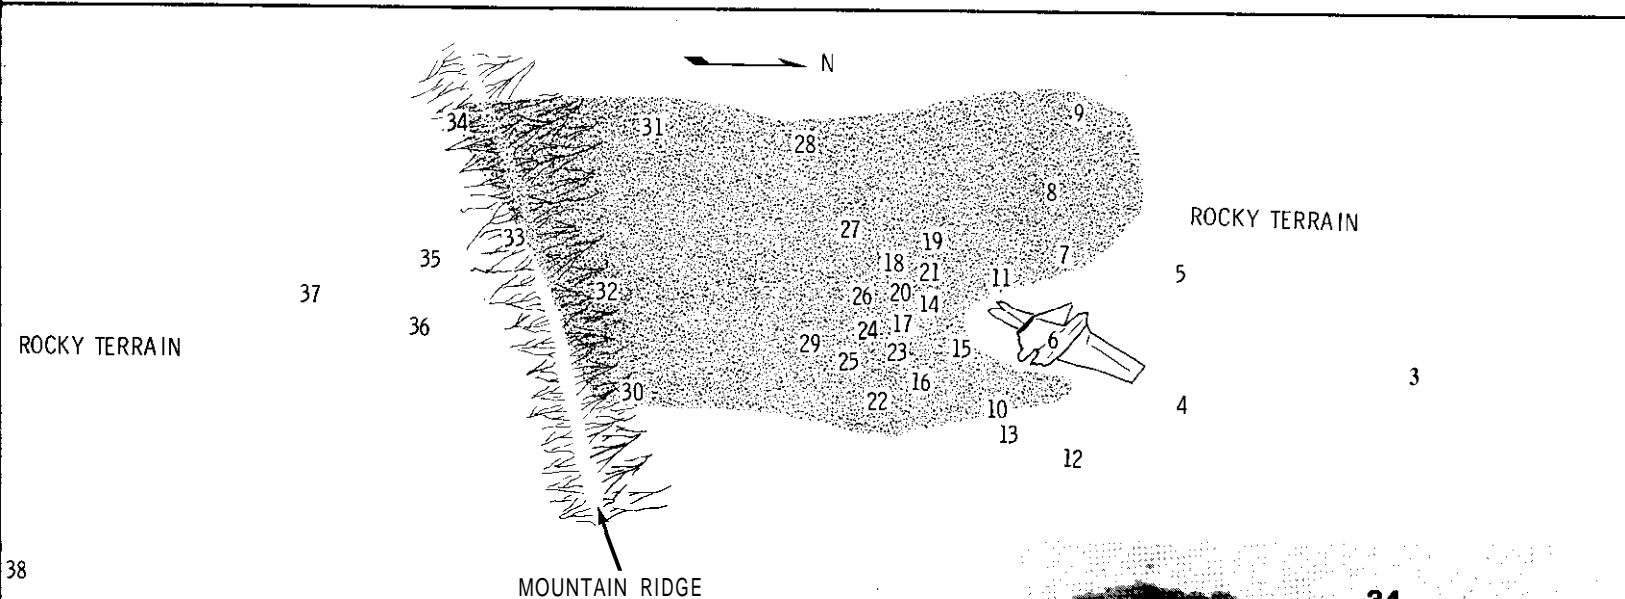
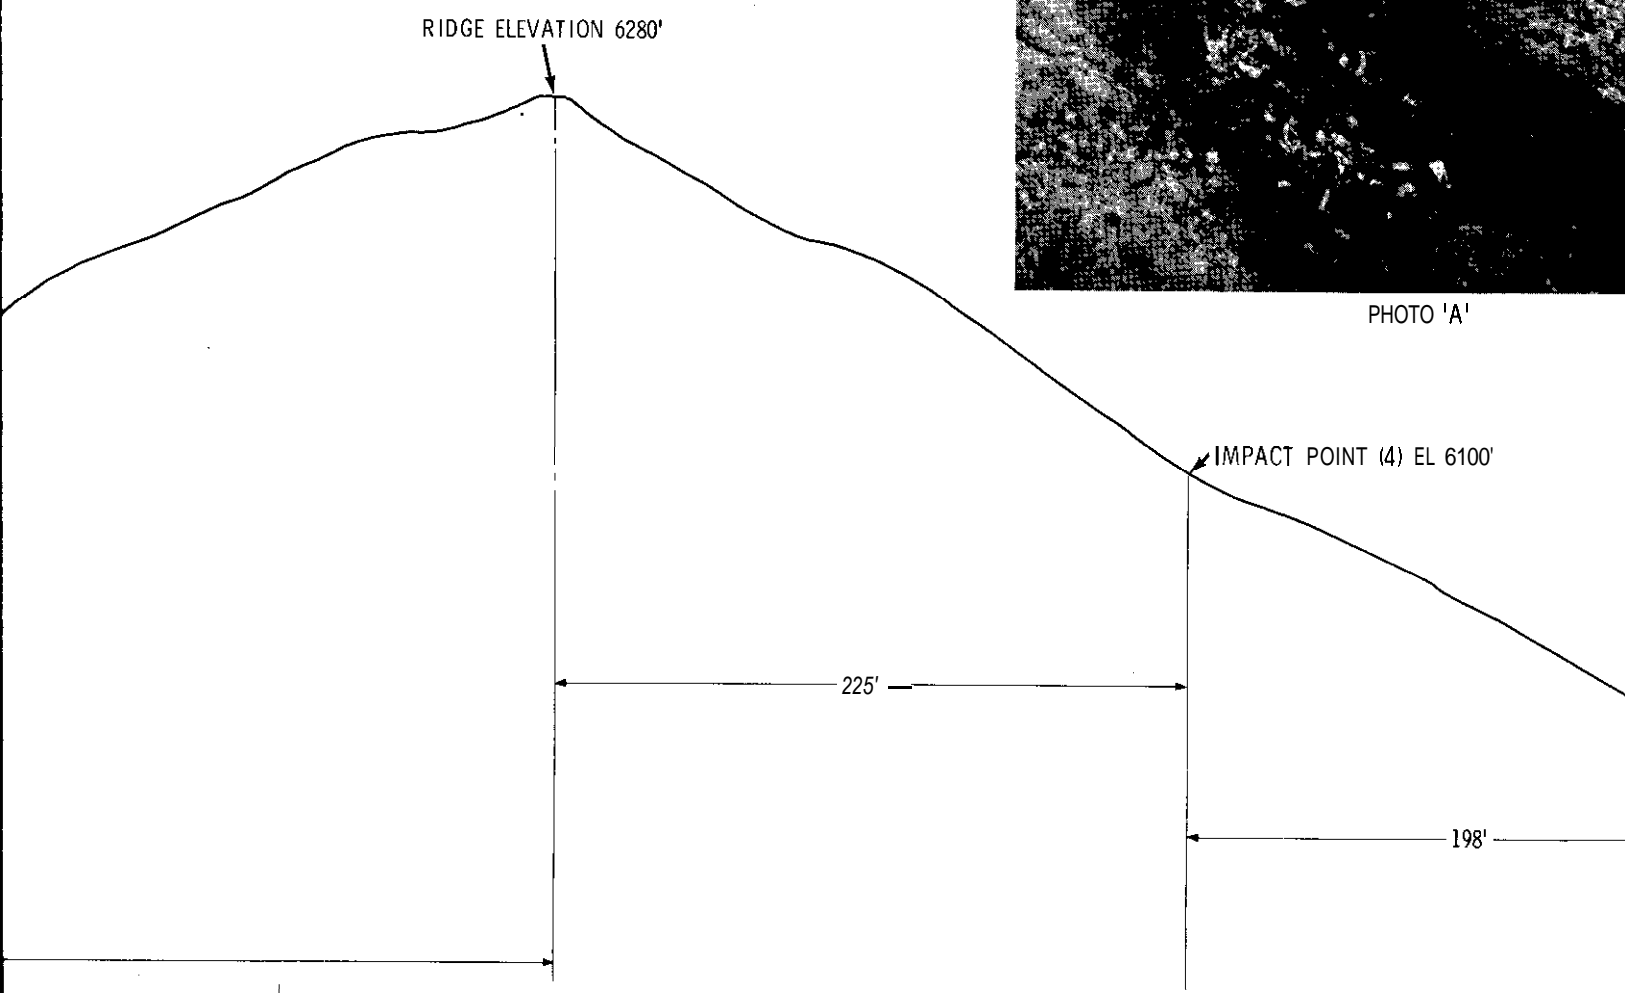
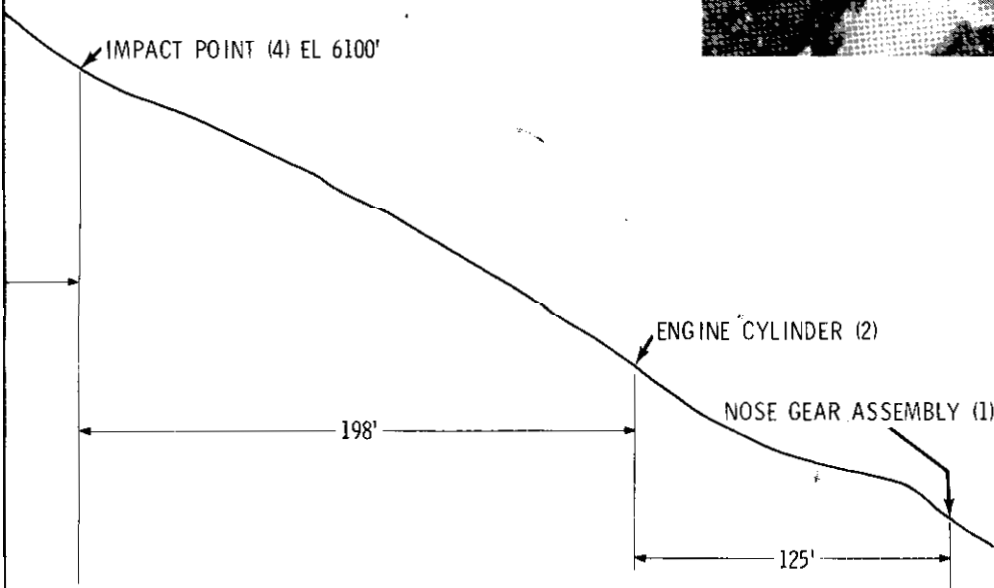
WRECKAGE DISTRIBUTION CHART
 SIERRA PACIFIC AIRLINES
 CONVAIR 340/440, N4819C
 DCA 74-A-18
 NEAR BISHOP, CALIFORNIA
 MARCH 13, 1974

The aircraft struck the north slope of a mountain ridge about 5.2 statute miles southeast of the Bishop Airport and at an elevation of 6,100 feet. The top of the ridge, which runs generally east to west, is 6,280 feet. Depressions in the earth made by the right wing leading edge and the right propeller and engine showed that, at impact, the aircraft was on a heading of 175° magnetic and in a 25° right wing-down attitude. The wreckage was scattered over an area 1,083 feet long and 120 feet wide. Parts of all major sections of the aircraft structure and flight control surfaces were found in the wreckage area. (See Appendix E.)

The breakup of the aircraft was extensive in all wing and fuselage areas. Portions of the fuselage main body, center wing section, and cockpit were consumed by ground fire.

The empennage had separated from the main fuselage body and had come to rest about 40 feet upslope from the initial impact point. The rudder was deflected to the right about 14 inches, and the trim tab was deflected to the right about 1 1/4 inches. The flight tab was in the neutral position. Both elevators were deflected upward about 6 inches. The left servo tab was deflected upward 7/8 inches; the right servo tab was faired.
