AIRCRAFT ACCIDENT REPORT

AIR FRANCE

BOEING 707-B-328B

NEAR O'NEILL, NEBRASKA

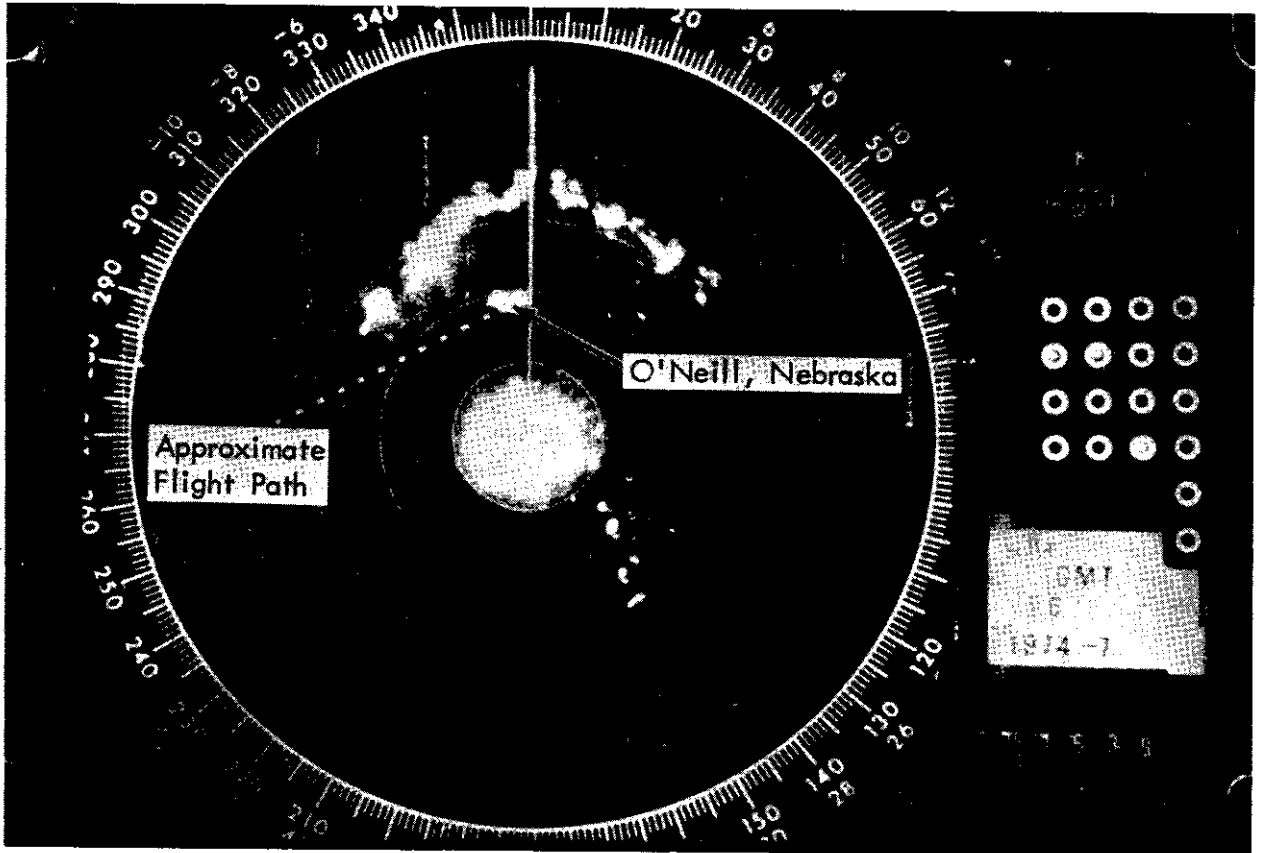
Frame No. : 1639
Date : May 13, 1974
Time : 07322 (0232 c.d.t.)
Range : 250 n mi
Range Markers: 50 n mi
Directions : $^{\circ}$ True

The Grand Island, Nebraska, 0235 radar weather observation (as well as the radarscope photographs taken about 0235 and 0242) showed, in part, an arch-shaped line of echoes 15 miles wide and extending from about 60 miles southwest of Ainsworth, Nebraska, to Mitchell, South Dakota, to 40 miles southeast of Sioux City, Iowa. That line was described as having 9/10 echo coverage, with the strongest cells just north of Ainsworth, near Mitchell, and north of Sioux City.

Additionally, this observation (and the photographs) showed a thunderstorm cell, 20 miles in diameter, near O'Neill. The thunderstorm cell was characterized as: Very strong, hail indicated, top 42,000 feet, moving from 260° at 50 kn. (See Appendices D and E.)

The flight data recorder disclosed that at the time of the turbulence encounter, the flight was at 33,000 feet and on a heading of 052° magnetic. Considering the magnetic variation (about 10° E) and applying a true track to the radarscope photographs, it is evident that no other echoes could have masked the one near O'Neill. On such a heading and at the aircraft's altitude, the frequent and intense lightning from the cell should have been visible for many miles. Therefore, even if the radar were inoperative, the thunderstorm activity near O'Neill should have been easily visible and could have been circumnavigated without difficulty.
