AIRCRAFT ACCIDENT REPORT

SATURN AIRWAYS, INC.
LOCKHEED L-382, N14ST
SPRINGFIELD, ILLINOIS

MAY 23, 1974

REPORT NUMBER: NTSB-AAR-75-5

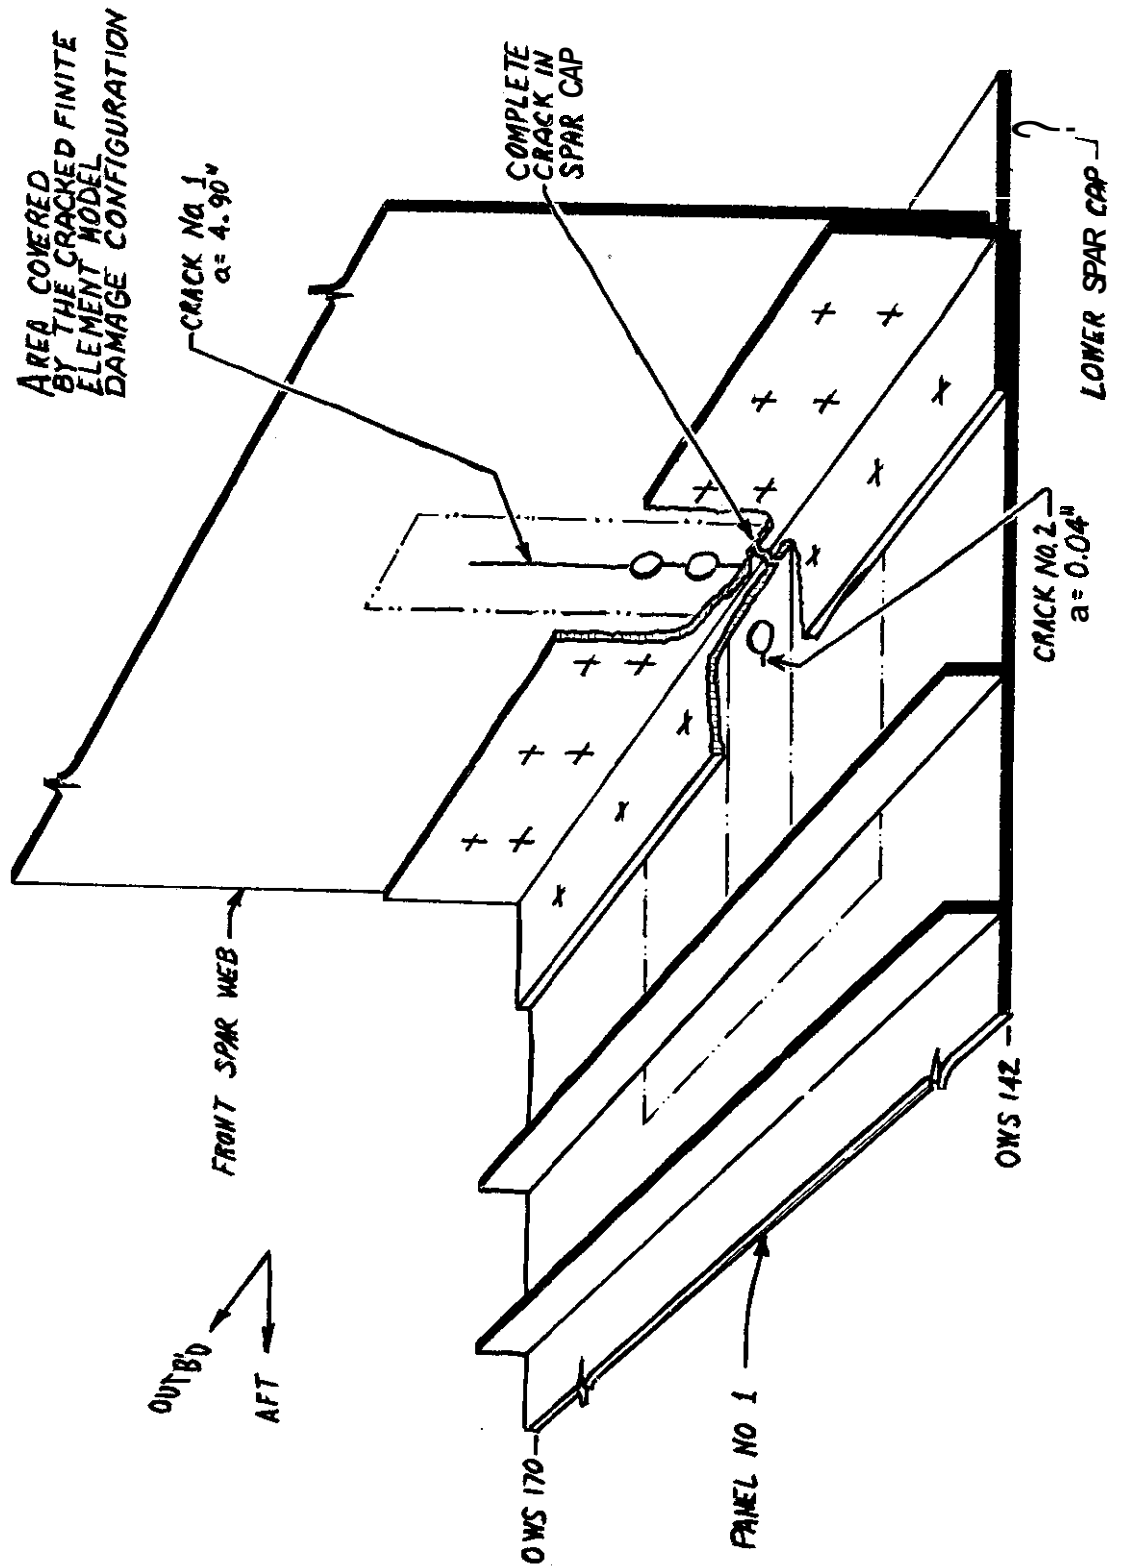
APPENDIX H

The left outer wing panel separated from the aircraft in the vicinity of the inboard rib which supported the No. 1 engine (about outer wing station 162). The panel, including the No. 1 engine and propeller assembly, was found inverted about 1.2 statute miles on a true bearing of 182° from the CAP. Investigation disclosed that the wing panel had failed in an upward or positive direction. The lower front spar cap was severed by a fracture which was dirty, contained many crack arrest marks, and displayed evidence of rubbing deformation on the mating surfaces. A crack in the front spar web progressed from the spar fracture upward for 4.9 inches. (See Appendix H.) The crack contained about 116 crack-arrest marks. There was no fire damage.

Metallurgical examination of the fractured surfaces of the left wing at outer station 162 revealed that the lower front spar cap fractured completely in fatigue. The spar cap was deformed at the primary origin area of the fatigue fracture. Hardness and electrical conductivity of the spar cap material were normal for 7075-T6511 aluminum alloy.

The lower portion of the front spar web contained an approximate 4.9-inch fatigue crack with intermittent tensile tearing.

The lower wing skin fracture stemmed from preexisting fatigue cracks at the first fastener hole which was located 3/4 inch outboard of the primary origin area at which the spar cap failed. Deformation and multiple cracks were noted at the origin of the skin fatigue fracture in the lower wing.
