1. Report No. NTSB-AAR-76-7		2. Government Accession No.		3. Recipient's Catalog No.	
4. Title and Subtitle Aircraft Accident Report - Campbell-Ewald Advertising Company, Rockwell Turbo Commander 690A, N847CE Nemaocolin, Pennsylvania, September 12, 1975				5. Report Date February 25, 1976

AIRCRAFT ACCIDENT REPORT

CAMPBELL-EWALD ADVERTISING COMPANY
ROCKWELL TURBO COMMANDER 690A, N847CE
NEMACOLIN, PENNSYLVANIA
SEPTEMBER 12, 1975

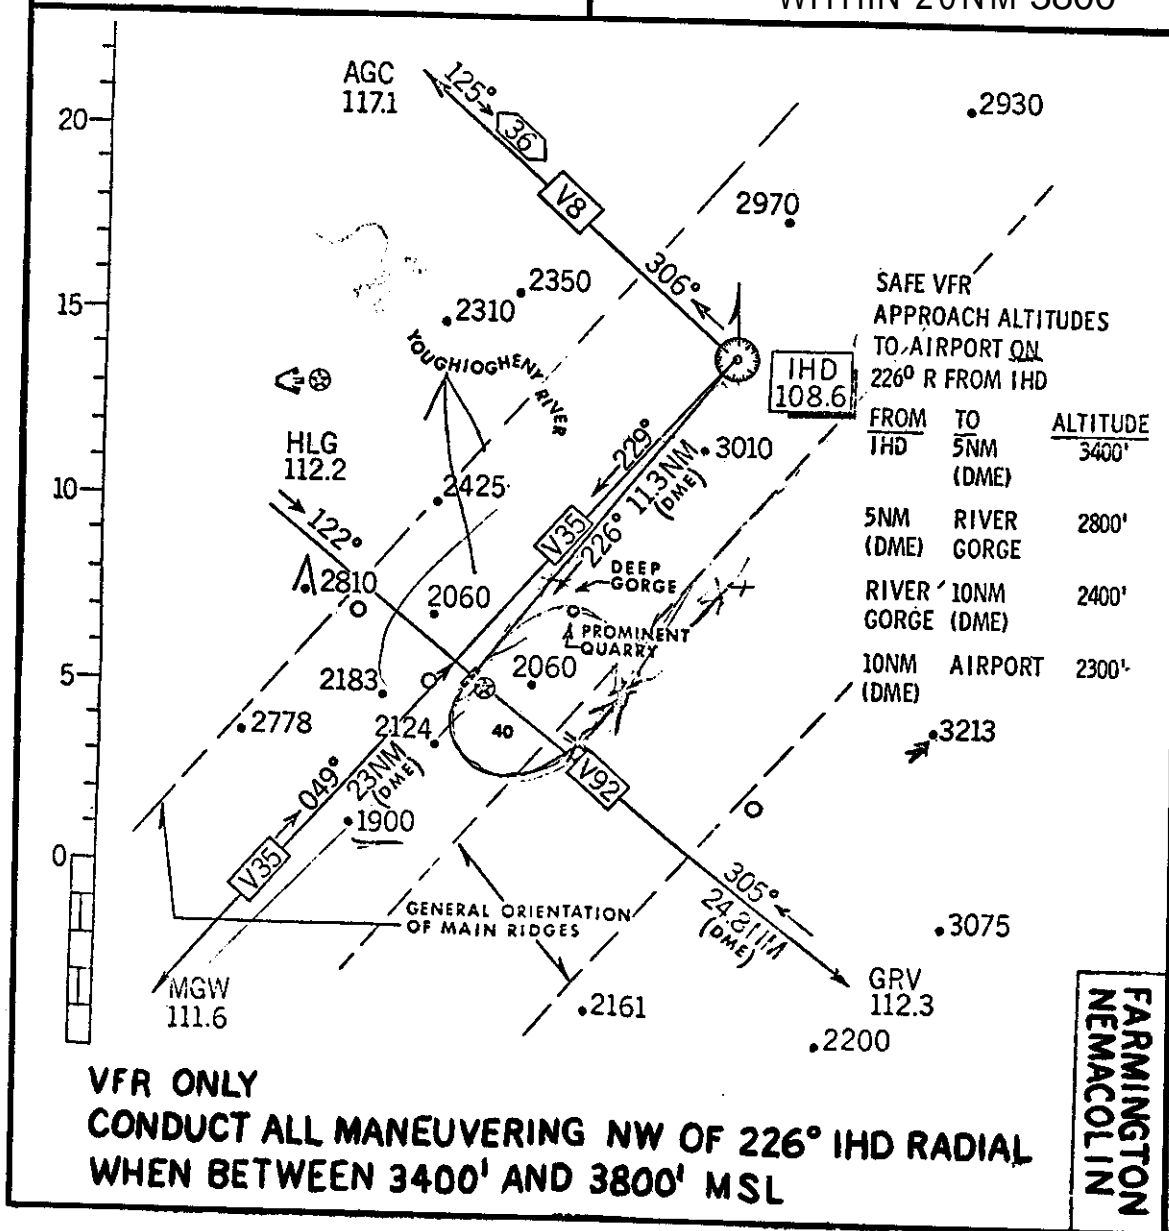
SAFE VFR
 APPROACH ALTITUDES
 TO AIRPORT ON
 226° R FROM IHD

During the investigation, the Safety Board obtained a copy of an unofficial and unapproved approach procedure for the Nemaocolin Airport entitled, "VFR safe altitude approach plate." The Safety Board could not determine who prepared the plate, but the investigation disclosed that aviation personnel of the Campbell-Ewald Company had access to the approach plate. Another pilot for the company stated that he was reasonably sure that a copy of the approach plate was aboard N847CE when it crashed.

The approach plate is constructed, using the Indian Head VORTAC and its distance measuring equipment to establish minimum safe altitudes below 5,000 feet between the VORTAC and Nemaocolin Airport. The approach plate depicts a 226° radial from the Indian Head VORTAC; the instructions on the approach plate read as follows: "Conduct all maneuvering NW of 226 IHD Radial when between 3400' and 3800' m. s. 1." Additionally, the instructions state that it should be used only in visual flight conditions.

The approach plate was not authorized by the FAA; there are no authorized instrument approaches to the Nemaocolin Airport. (See Appendix D.)

~~X~~ The unofficial VFR approach plate, which was reportedly on board the aircraft, showed the Nemaocolin Airport located on the **226°** radial of the Indian Head VORTAC. The flight instruments recovered from the aircraft wreckage showed a probable final heading of about **226°**. The aircraft wreckage was strewn along a path which was oriented about **230°**. Also, altitudes recorded by Cleveland Center during the aircraft's descent from Indian Head VORTAC correspond closely, in time and distance, to the "safe" altitudes depicted on the VFR approach plate. The Safety Board believes that these factors indicate that the flightcrew was using the VFR approach chart, for navigation.
