1. Report No. NTSB-AAR-76-9		2. Government Accession No.		3. Recipient's Catalog No.	
4. Title and Subtitle Aircraft Accident Report - Aerotransportes Entre Rios S.R.L. Canadair CL-44-6, LV-JSY, Miami International Airport, Miami, Florida, September 27, 1975				5. Report Date March 10, 1976

AIRCRAFT ACCIDENT REPORT

AEROTRANSPORTES ENTRE RIOS S.R.L.
CANADAIR CL-44-6, LV-JSY
MIAMI INTERNATIONAL AIRPORT
MIAMI, FLORIDA
SEPTEMBER 27, 1975

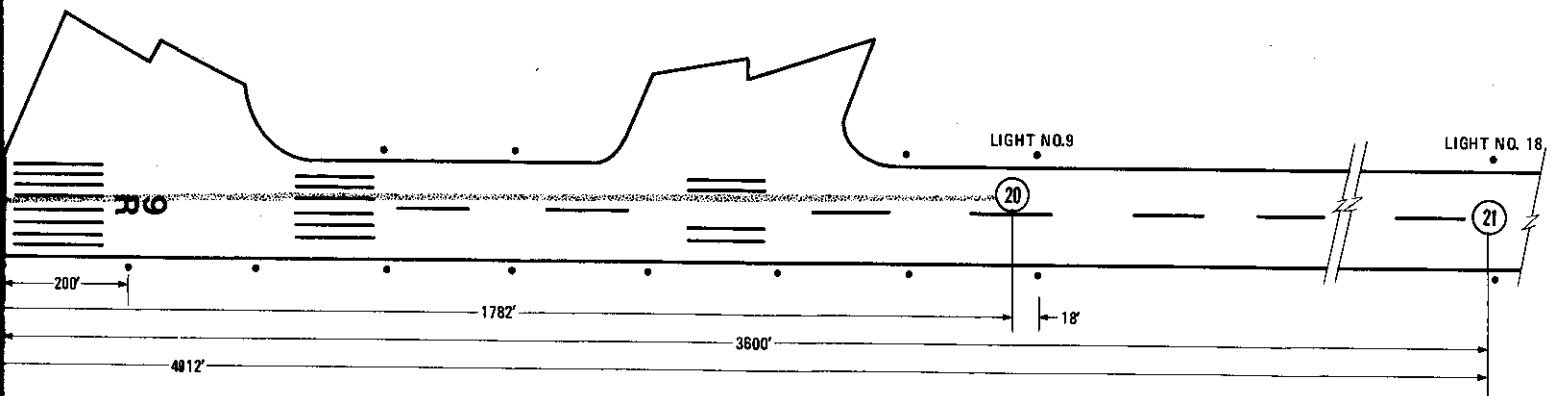
WRECKAGE DISTRIBUTION CHART
AEROTRANSPORTES ENTRE RIOS
CANADAIR CL-44-6, LV-JSY, S/N106925
MIAMI INTERNATIONAL AIRPORT
MIAMI, FLORIDA
SEPTEMBER 27, 1975
DCA 76-Ai!-005

The empennage came to rest on the east bank of a canal 961 ft. from the departure end of the runway. The fuselage was across the canal and the center section, wings and engines were on its west bank. The fuselage forward of the wing, the cargo in the cabin, and the occupants were found west of the canal. (See Appendix D.)

- EMPELLAGE WRECKAGE
- N. 3 PROPELLER ASSEMBLY
- N. 3 PROPELLER SPINNER
- RIGHT GEAR TIRE MARKS
- LEFT GEAR TIRE MARKS IN DIRT
- GOUGE IN ROAD
- GOUGE MARKS IN EMBANKMENT
- SECTION OF ILS PLATFORM
- SCATTERED PIECES OF ILS PLATFORM
- PIECES OF PROPELLER BLADE
- TWIN RIGHT GEAR TIRE MARKS, N. 9 LIGHT
- EAST OF 9R THRESHOLD.
- PIECES OF NOSE GEAR TIRE TREAD. N. 18
- LIGHT EAST OF 9R THRESHOLD
