1. Report No. NTSB-AAR-76-13	2. Government Accession No.	3. Recipient's Catalog No.	
4. Title and Subtitle Aircraft Accident Report - Puerto Rico International Airlines, Inc. DeHavilland DH-114, N5708R, San Juan, Puerto Rico July 11, 1975		5. Report Date April 14, 1976

AIRCRAFT ACCIDENT REPORT

PUERTO RICO INTERNATIONAL AIRLINES, INC.
DEHAVILLAND *DH-114*, N570PR
SAN JUAN, PUERTO RICO
JULY 11, 1975

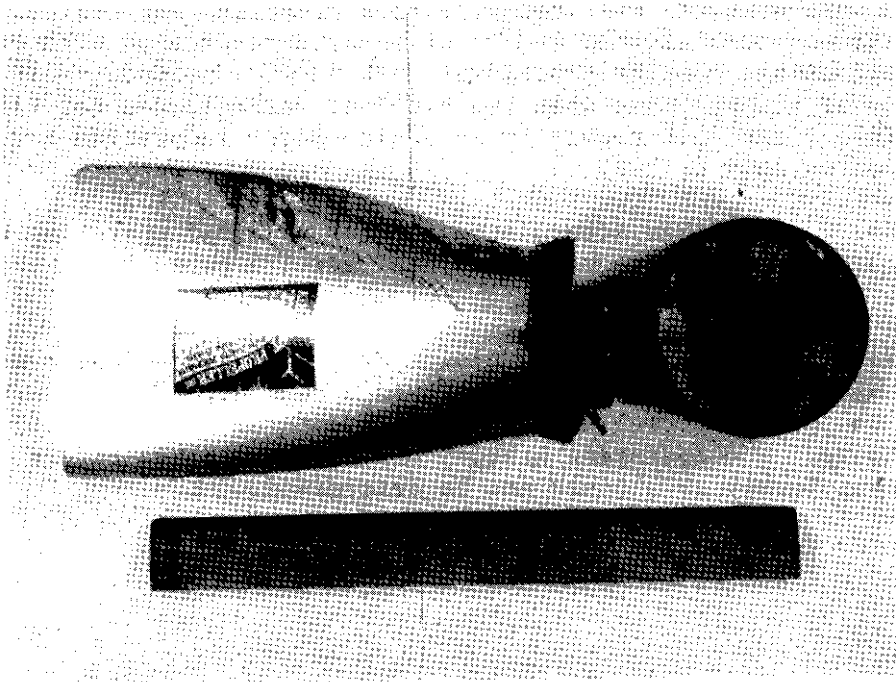
Figure 1. Shank end of the broken propeller, as received for examination.

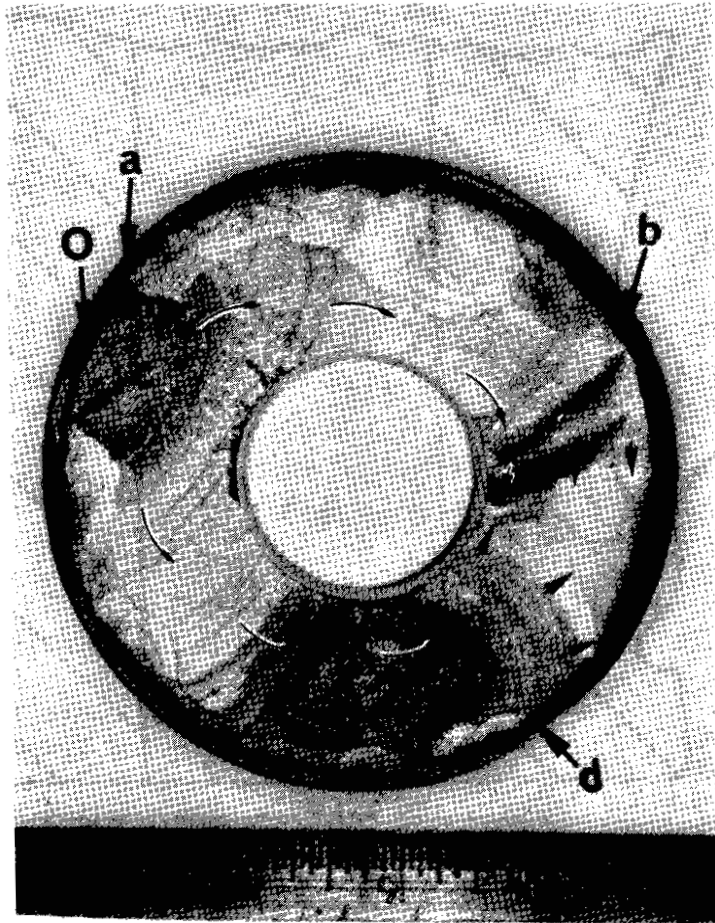
Metallurgical tests showed that the blade failed as a result of a fatigue crack that began in the hub fillet **on** the leading edge side of the blade and progressed across **90** percent of the shank cross section. (See Appendix D.) Numerous **small** secondary fatigue cracks were also found in **or** near the hub fillet.

A visual examination of the fracture disclosed several fatigue crack origins **in or** near the hub fillet. The primary fatigue crack probably originated in the fillet along the leading edge of the blade. The crack propagated outward and progressed to the overload zone. (See Appendix D.)

Initially, the crack progressed **on** a diagonal plane for a short distance inboard and then abruptly changed direction and progressed along a plane oriented transversely to the blade axis. Several small secondary fatigue cracks also originated along the hub fillet. These cracks progressed **on** diagonal planes radially inward until they intersected the primary fatigue crack, where they terminated.

The fractured surface and the area in which the primary fatigue crack originated were examined with the aid of the scanning electron microscope. No evidence of a material defect **or** mechanical damage, such as fretting, was found at the fracture's origin. The crack originated in an area that had been shot peened.

Feigure 2. Closeup view of the inboard fracture surface in the propeller shank. The primary fatigue crack originated at the approximate location denoted by arrow "0" and propagated to the overload zone shown within the arrowheads. Secondary fatigue cracks were found along the radius at locations between arrows "a" and "b," and "c" and "d," The curved arrows indicated the propagation direction of the primary fatigue crack.

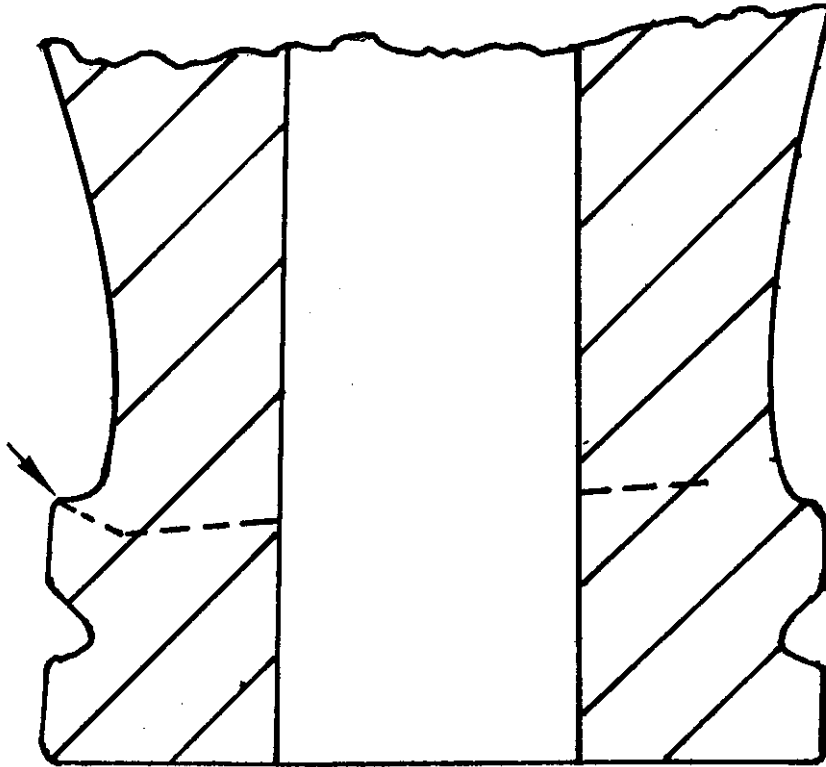
Figure 3. Sketch to illustrate the approximate location of the primary fatigue crack which is indicated by the dashed line. The arrow denotes the approximate origin site.
