1. Report NO. NTSB-AAR-76-15		2. Government Accession No.		3. Recipient's Catalog No.	
4. Title and Subtitle Aircraft Accident Report -- Eastern Air Lines, Inc. Boeing 727, N8838E, Raleigh, North Carolina, November 12, 1975				5. Report Date May 19, 1976

AIRCRAFT ACCIDENT REPORT

EASTERN AIR LINES, INC.
BOEING 727-225, N8838E
RALEIGH, NORTH CAROLINA
NOVEMBER 12, 1975

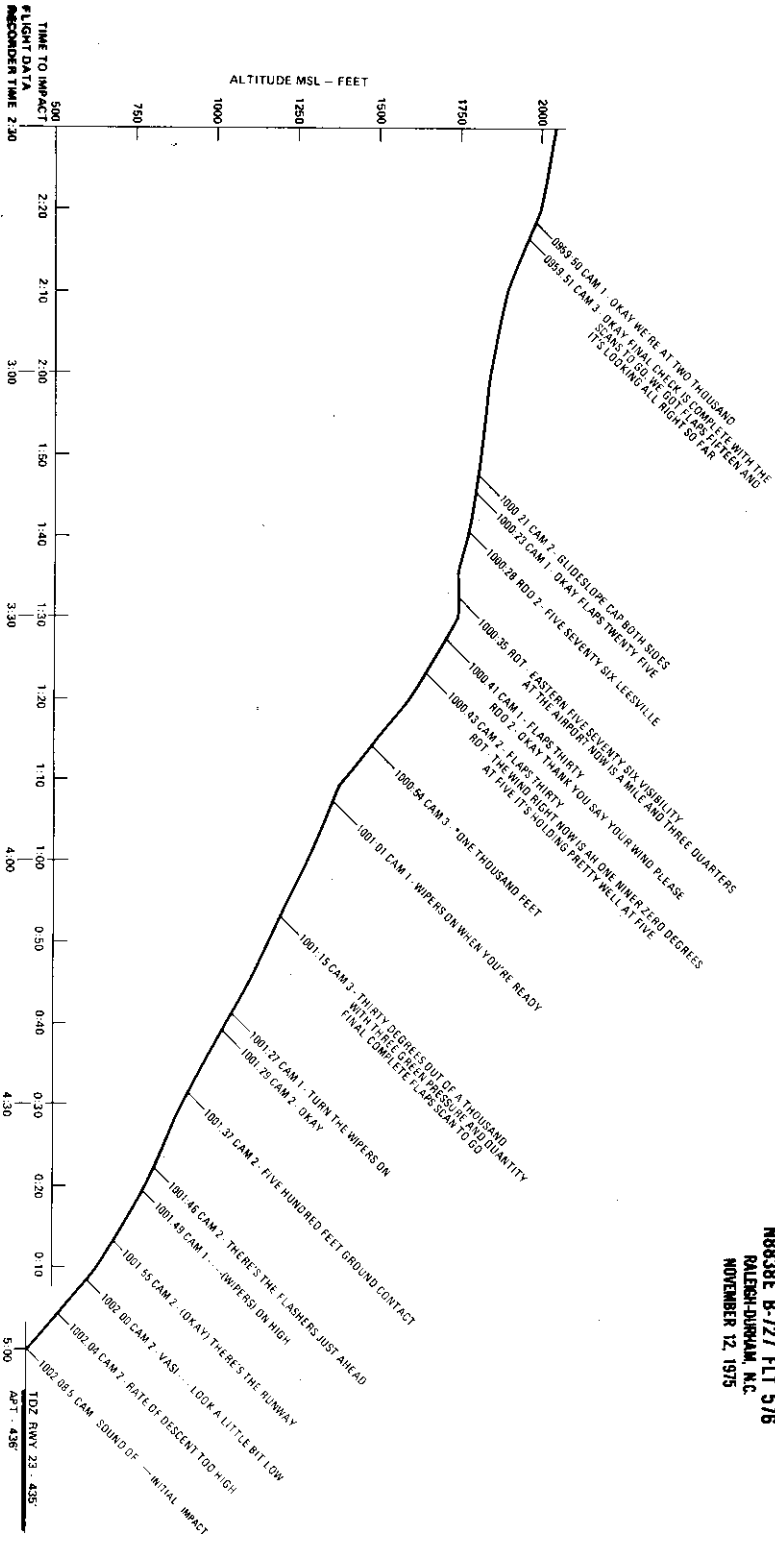
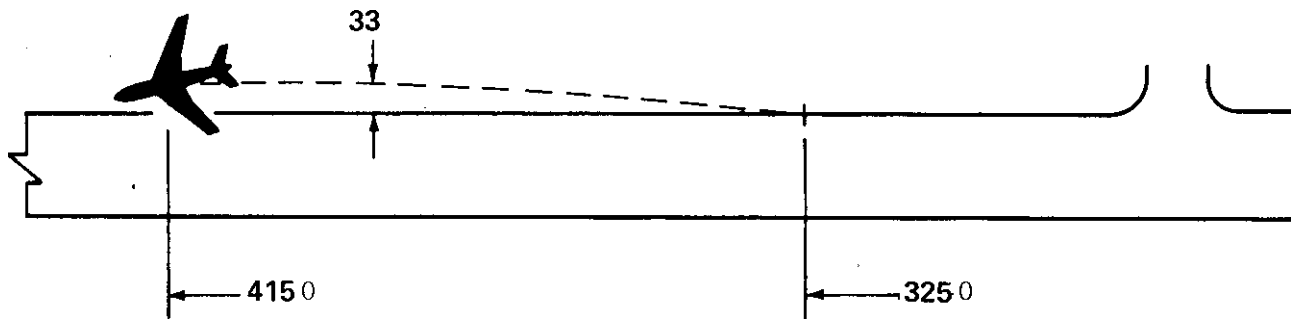
DESCENT PROFILE
EASTERN AIRLINES
N8838E B-727 FLT 576
RALEIGH-DURHAM, N.C.
NOVEMBER 12, 1975

The FDR showed that the airspeed on the final approach varied from 140 kn to 145 kn until about 300 feet where it increased to about 147 kn at initial impact. The rate of descent remained fairly constant at between 650 fpm and 700 fpm until about 100 feet where it increased to 1,250 fpm. At 3.6 seconds before touchdown, the descent rate increased to an average of 1,400 fpm.

The flightcrew recalled that the rate of descent was about 700 fpm during the approach; however, the FDR trace shows rates as high as 1,400 fpm during the last 3.6 seconds of flight. About 4 seconds before the initial impact, the first officer made the descent rate callout "rate of descent too high." He did not specify the numerical rate as required. Had he done so, the captain may have been alerted and consequently may have considered a missed approach. Because of the low voice volume of the callout and the high noise level caused by the operation of the windshield wipers and the rain striking the aircraft, the captain did not understand the first officer's alerting call. This callout was the only rate-of-descent call made during the approach.

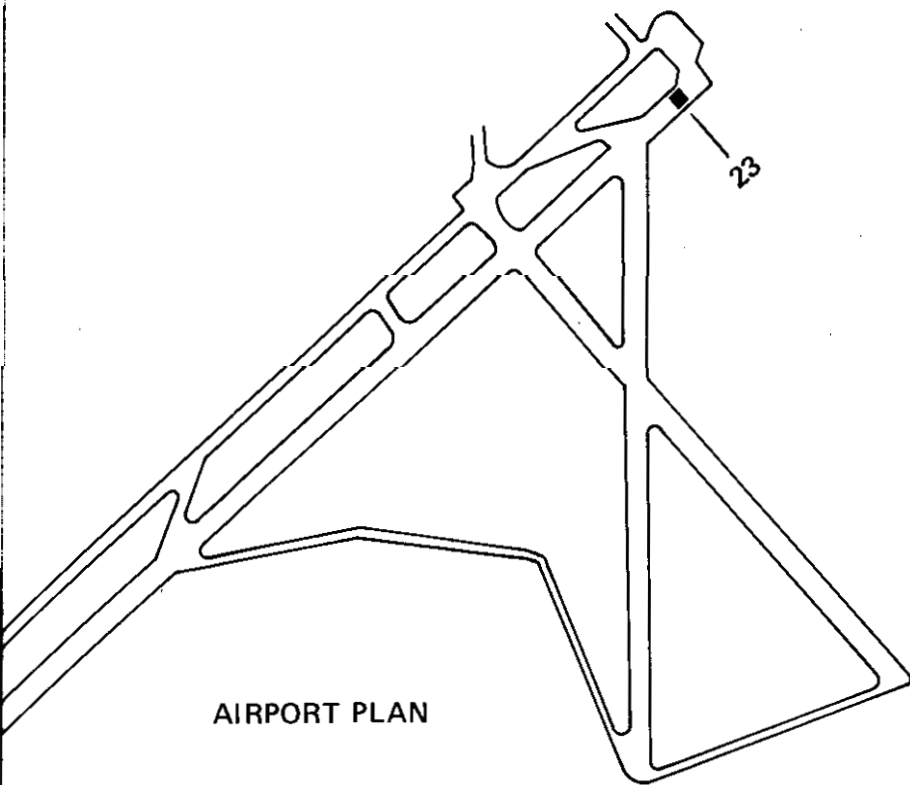
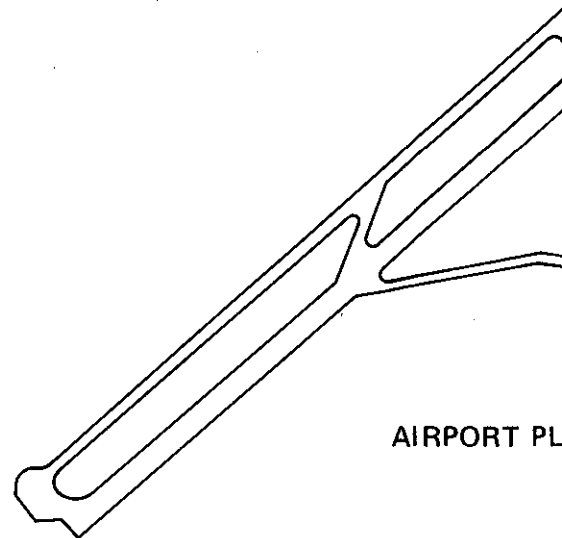
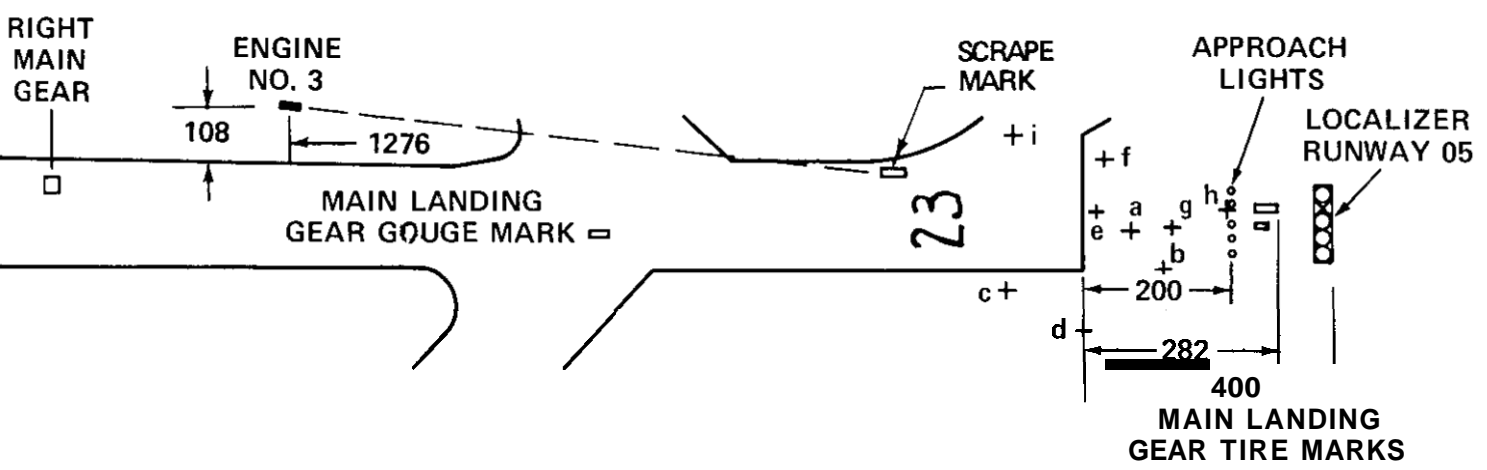
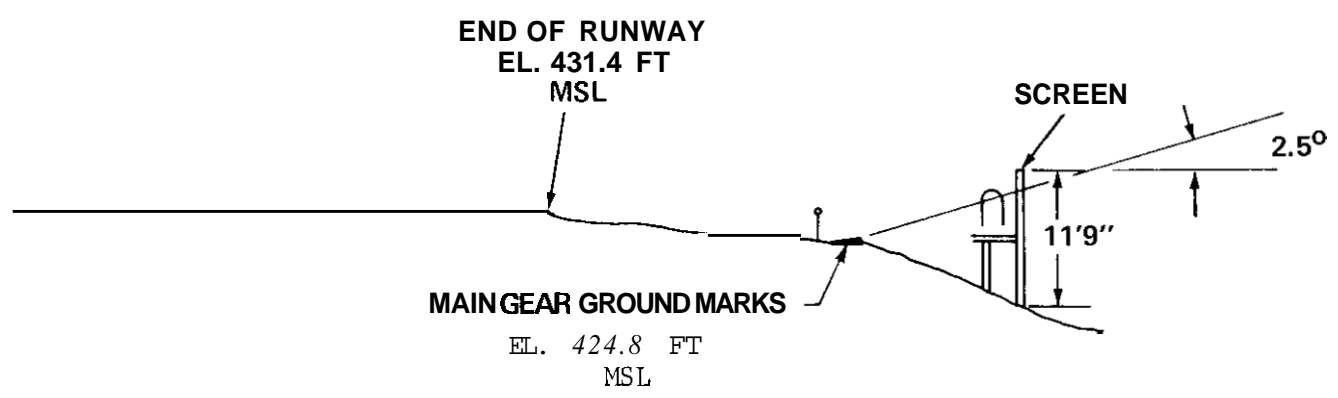
WRECKAGE DISTRIBUTION CHART
EASTERN AIRLINES FLIGHT 576
Raleigh-Durham N.C.
12 November 1975

The aircraft first struck the ILS localizer antenna screen for runway 05, which is located 400 feet before the threshold of runway 23. The top 2 feet of the parallel antenna screen wires were severed. The elevation of the top wire was about 430 feet m.s.l., about 1.5 feet below the runway threshold elevation and about 5 feet below the touch-down zone elevation. An antenna dome was also damaged. (See Appendix E.)

The main landing gear tires hit the ground first--about 282 feet short of the runway 23 threshold. The elevation of the ground marks was about 425 feet m.s.l., about 3.5 feet below the elevation of the runway threshold, and about 6 feet below the elevation of the touch-down zone. The aircraft's angle of descent between the broken ILS localizer antenna domes and the ground marks was about 2.5".

The nose landing gear remained on the aircraft; the tires were flat. Portions of both main landing gear support structures, the left inboard, mid-inboard, and the mid-trailing edge flaps; the airstair handrails; and airstair control access panel were found between the point of the first ground contact and the runway threshold.
