1. Report No. NTSB-AAR-77-1		2. Government Accession No.		3. Recipient's Catalog No.	
4. Title and Subtitle Aircraft Accident Report -- American Airlines, Inc., Boeing 727-95, N1963, St. Thomas, Virgin Islands, April 27, 1976		5. Report Date December 16, 1976		6. Performing Organization Code

AIRCRAFT ACCIDENT REPORT

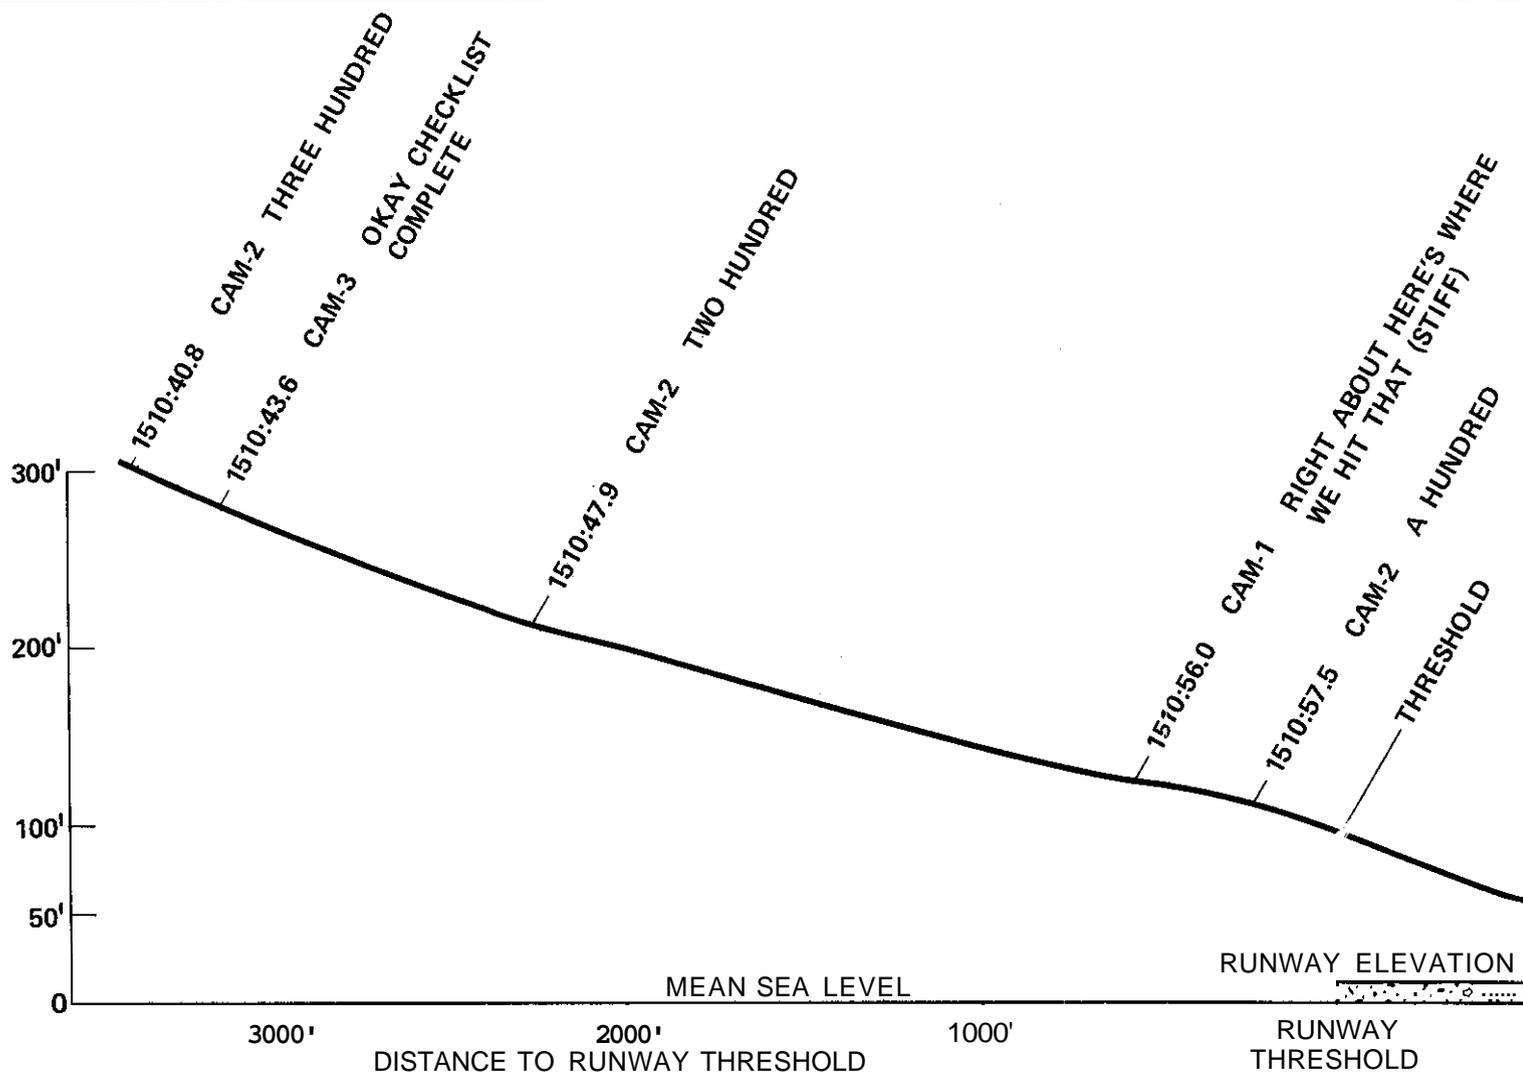
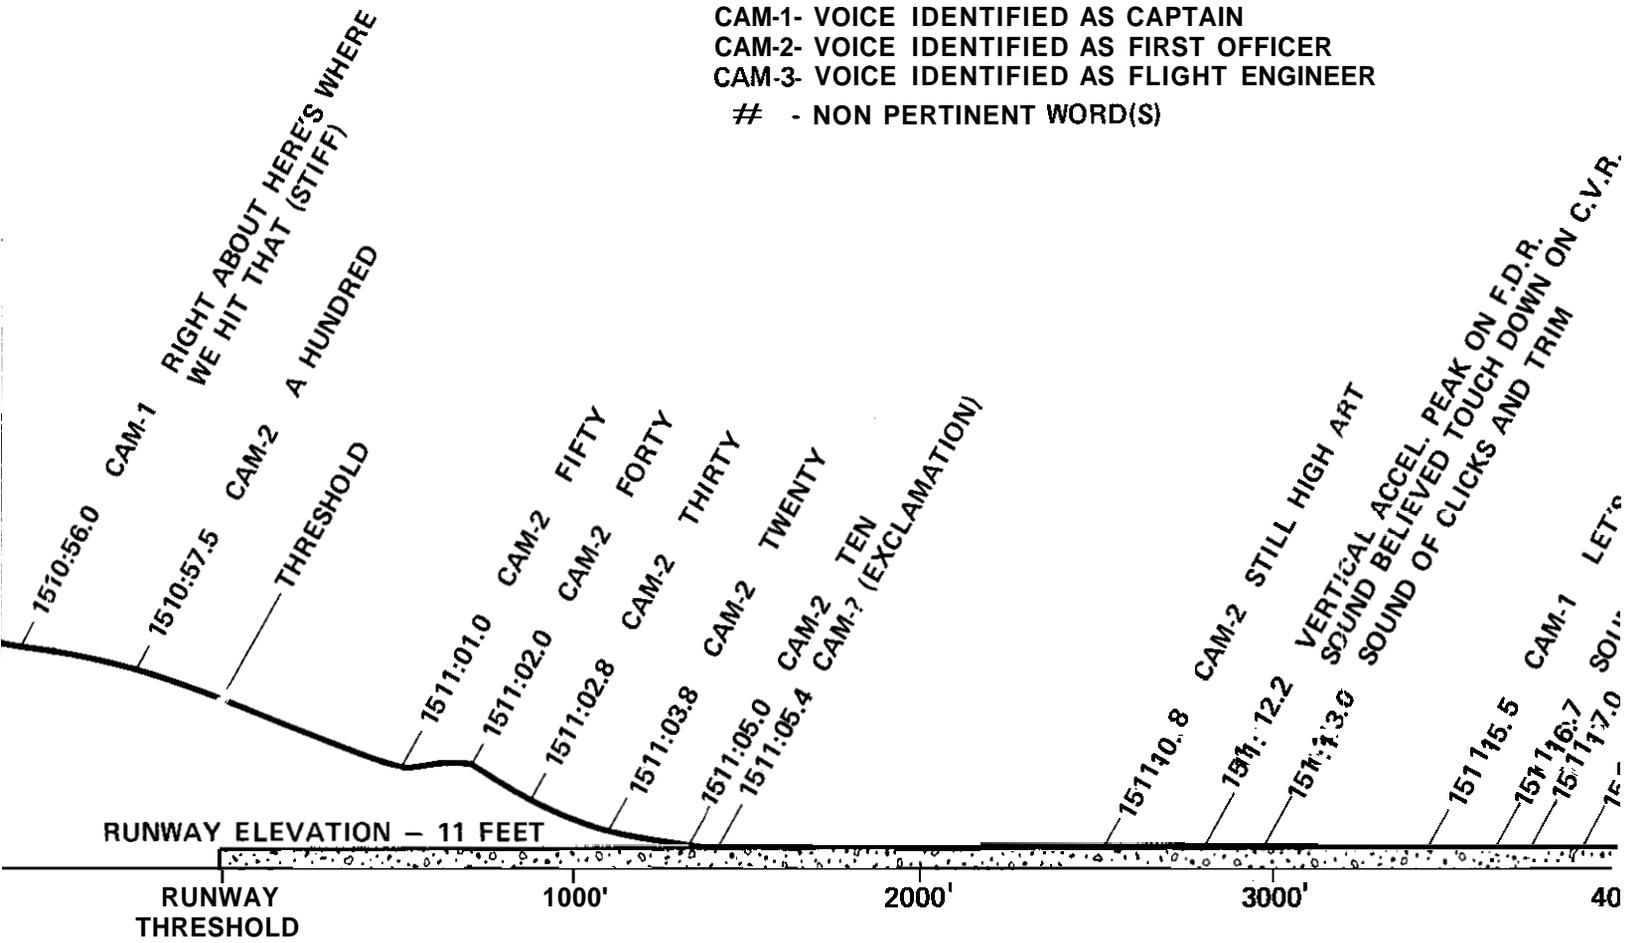
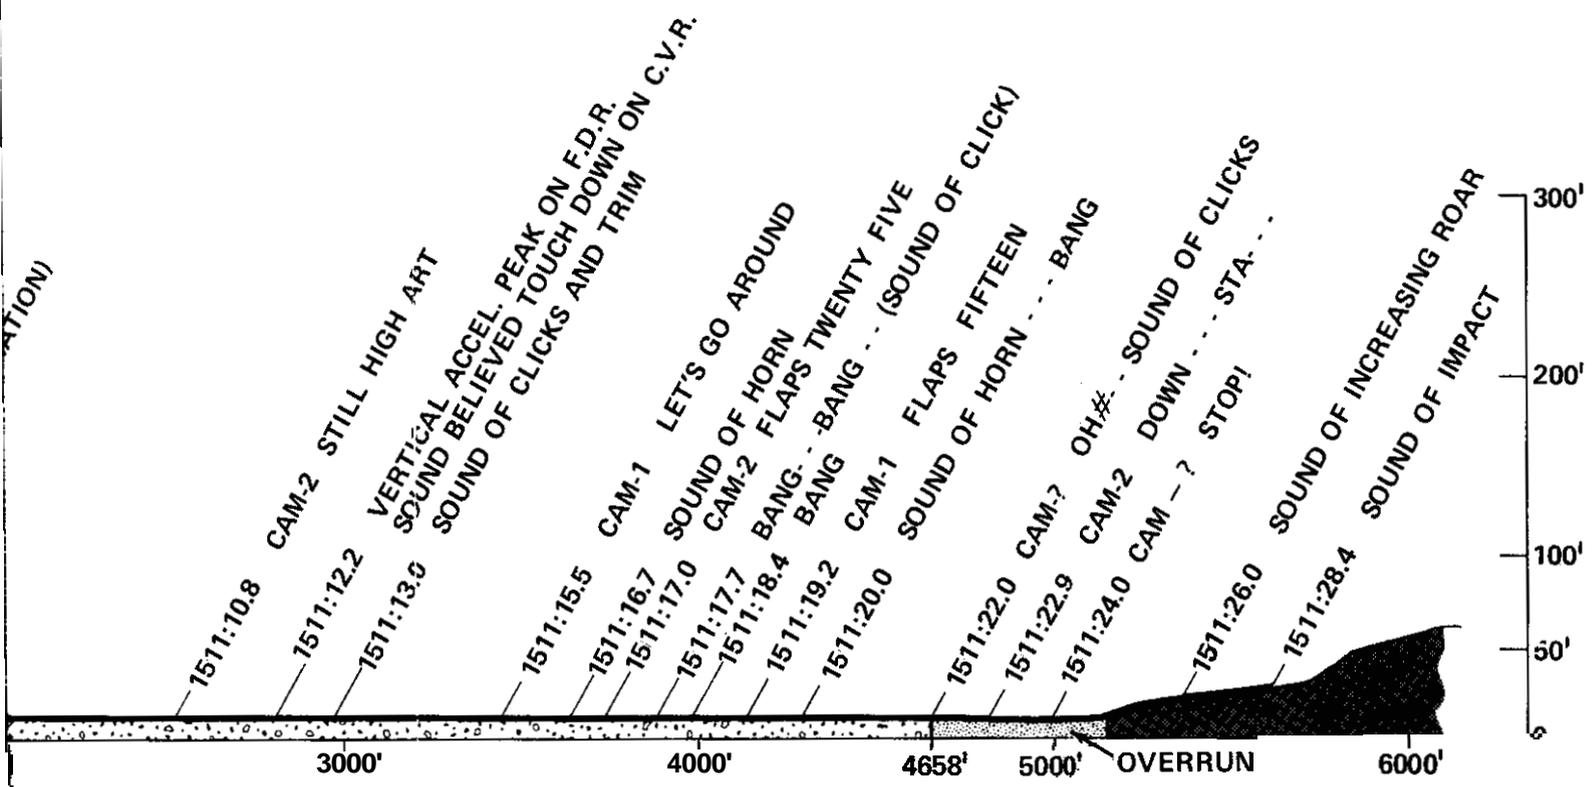
APPROACH PROFILE
 AMERICAN AIRLINES, BOEING 727-95 N1963
 HARRY S TRUMAN AIRPORT, ST. THOMAS, VIRGIN ISLANDS
 APRIL 27, 1976

The profile shown in Appendix D was prepared using assumptions which seemed to be most logical to the investigators. These assumptions are noted thereon. This profile shows that the aircraft crossed the threshold at an airspeed of 131 knots and an altitude of about 80 feet. The touchdown was calculated to be about 2,800 feet beyond the threshold. At touchdown, about 1,850 feet of runway and 500 feet of overrun were available on which to stop the aircraft. When the captain stated "Let's go around," the aircraft was about 3,450 feet beyond the threshold, or 1,200 feet of runway and 500 feet of overrun remained.

1. THE DISTANCE PLOT WAS DEVELOPED FROM THE F.D.R. AIRSPEED MEASUREMENT CORRECTED FOR DENSITY ALTITUDE AND WIND. THE FOLLOWING ASSUMPTIONS WERE USED
 - SEA LEVEL BAROMETRIC PRESSURE - 30.00 IN. HG.
 - SEA LEVEL TEMPERATURE - 84° F.
 - WIND - CONSTANT - 120° TRUE/ 10 KNOTS
2. THE TIME CORRELATION BETWEEN THE FLIGHT RECORDER DATA AND THE C.V.R. TRANSCRIPT IS BASED UPON THE ASSUMPTION THAT A VERTICAL ACCELERATION PEAK THREE SECONDS BEFORE THE END OF THE F.D.R. TRACE CORRESPONDS WITH A SOUND OF THE INCREASING ROAR RECORDED ON THE C.V.R.
3. THE CORRELATION OF THE PLOT TO THE RUNWAY THRESHOLD IS BASED UPON THE ASSUMPTION THAT THE PREVIOUSLY MENTIONED ACCELERATION PEAK AND SOUND OF ROAR OCCURRED WHEN THE AIRCRAFT STRUCK AN EMBANKMENT 5369 FEET BEYOND THE RUNWAY THRESHOLD.

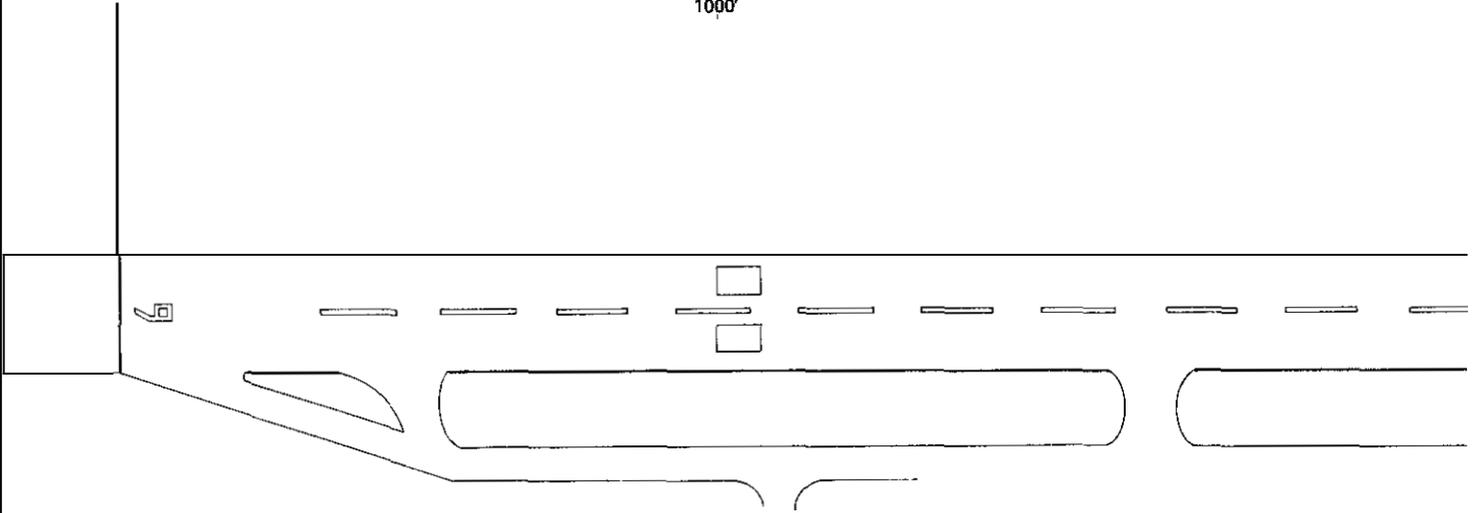
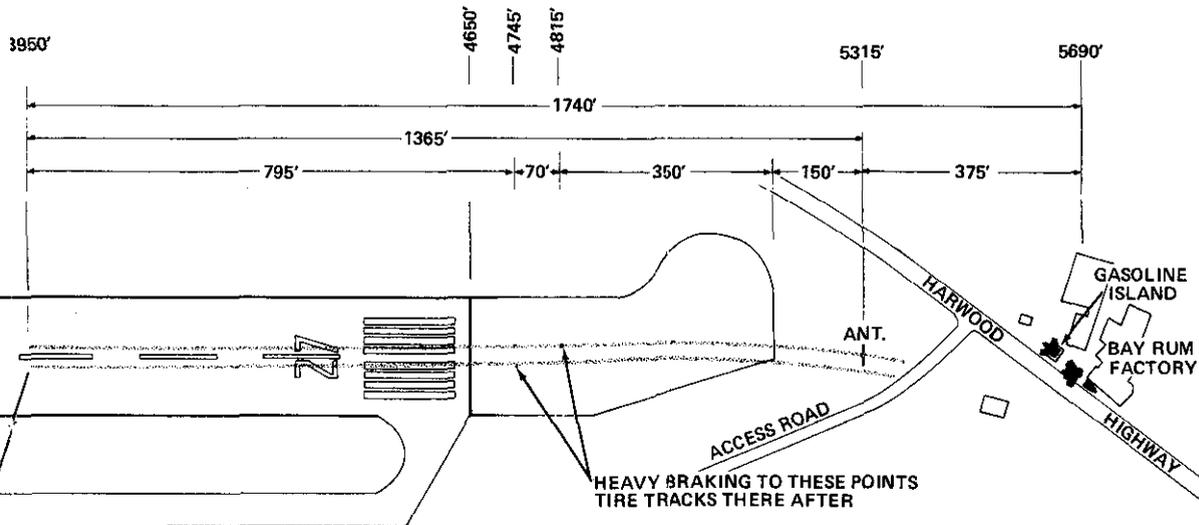
RUNWAY EXAMINATION CHART
 AMERICAN AIRLINES, BOEING 727-95, N1963
 HARRY S TRUMAN AIRPORT
 CHAROLETTE AMALIE, ST. THOMAS, VIRGIN ISLANDS
 APRIL 27. 1976

TWO SETS OF MAIN GEAR TOUCH DOWN MARKS.
THESE MARKS MEASURE THE CORRECT WIDTH OF
A B-727 MAIN GEAR. THE TIRE TREADS ARE SIMILAR
TO THOSE OF THE ACCIDENT AIRCRAFT. THERE WAS
NO VISUAL LINK BETWEEN THESE MARKS AND THE
START OF THE MAIN GEAR TIRE MARKS LOCATED
3,950 FEET FROM THE THRESHOLD.

START OF LEFT AND RIGHT MAIN GEAR TIRE MARKS
WHICH ARE INDICATIVE OF HEAVY BRAKING.
WHEEL NO. 1 SHOWS ANTI SKID RELEASES OR SKIPS.
WHEEL NO. 2 SHOWS UNBROKEN SOLID LINE.
WHEEL NO. 3 SHOWS ANTI SKID RELEASES OR SKIPS.
WHEEL NO. 4 SHOWS ANTI SKID RELEASES OR SKIPS.

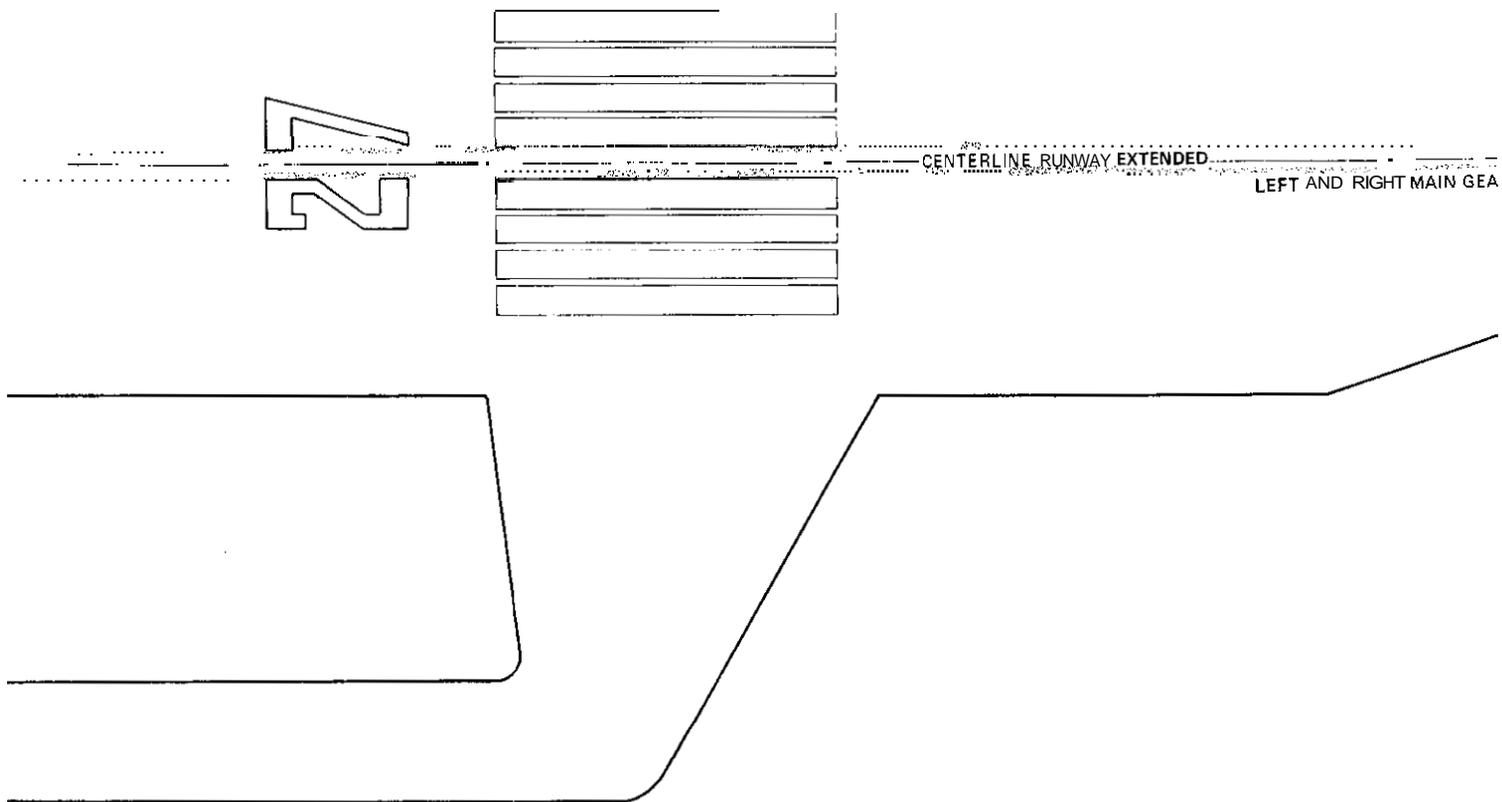
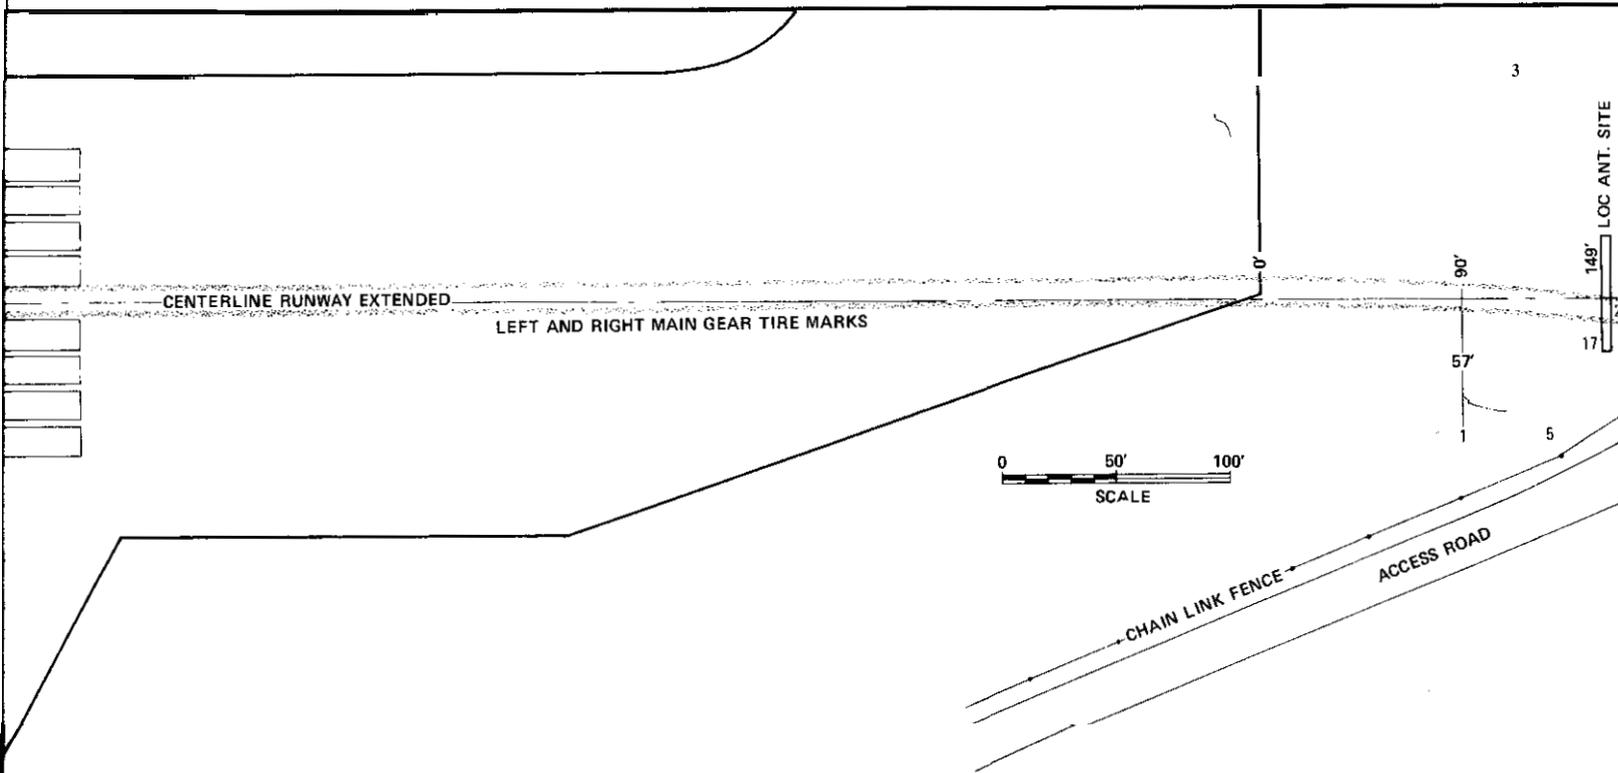
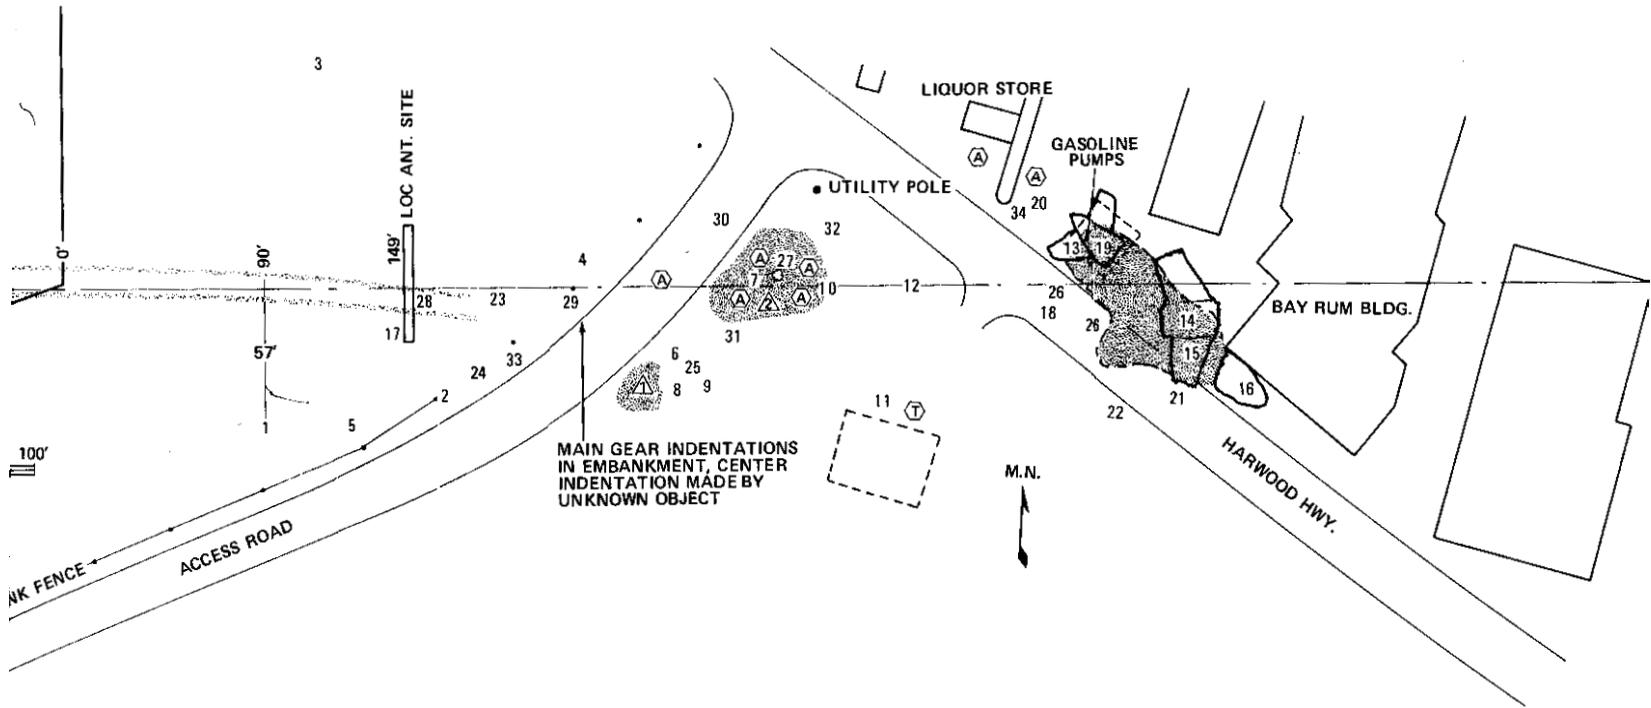
WRECKAGE DISTRIBUTION CHART
AMERICAN AIRLINES, BOEING 727-N196:
HARRY S TRUMAN AIRPORT
CHARLOTTE AMALIE, ST. THOMAS, VIRGIN ISLANDS
APRIL 27, 1976

1. PIECES OF RIGHT WING TIP NAV. LIGHT PLEXIGLAS BLUE AND CLEAR - FIRST POINT OF FUSELAGE IMPACT APPROX. 8 FEET ABOVE OVERRUN ELEVATION
2. IMPACT WITH CHAIN LINK FENCE

27. TREE BROKEN APPROX. 8 FEET ABOVE GROUND
28. HONYCOMB FOUND IN LOCALIZER ANTENNA SUPPORT STRUCTURE
29. PIECES OF LEADING EDGE SLAT TRACK
30. LEFT MAIN LANDING GEAR AFT TRUNION BEARING SLEEVE
