1. Report No. NTSB-AAR-77-2		2. Government Accession No.		3. Recipient's Catalog No.	
4. Title and Subtitle Aircraft Accident Report - Midair Collision, Reeds Aviation, Inc., Piper PA-28R-200, N7941C and Piper PA-28-181, N8592C, near Huntsville, Missouri, July 24, 1976				5. Report Date April 14, 1977

AIRCRAFT ACCIDENT REPORT

MIDAIR COLLISION
REEDS AVIATION, INC., PIPER PA-28R-200, N7941C
AND
PIPER PA-28-181, N8592C
NEAR HUNTSVILLE, MISSOURI
JULY 24, 1976

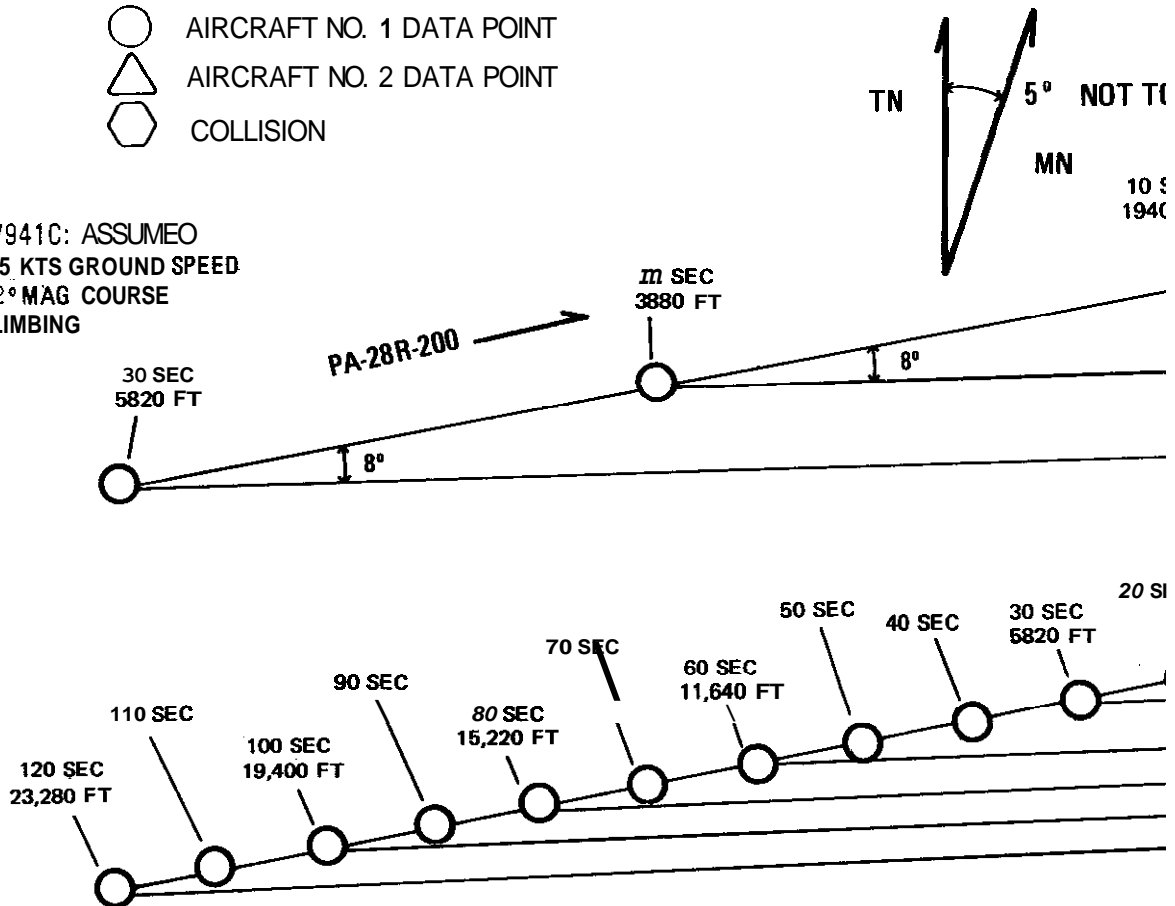
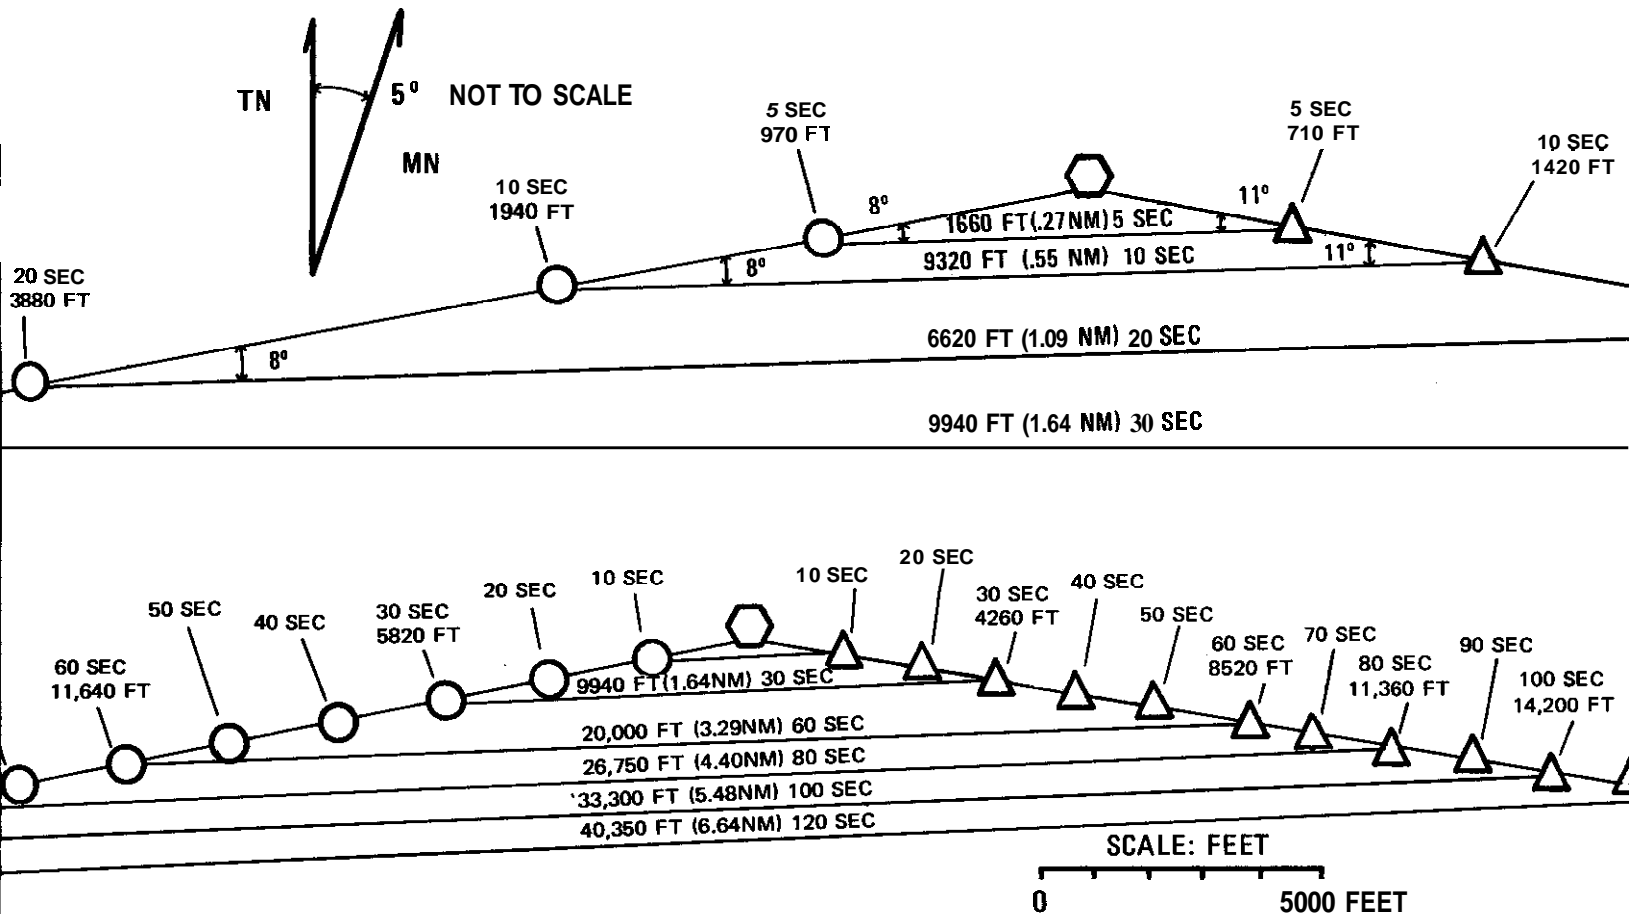
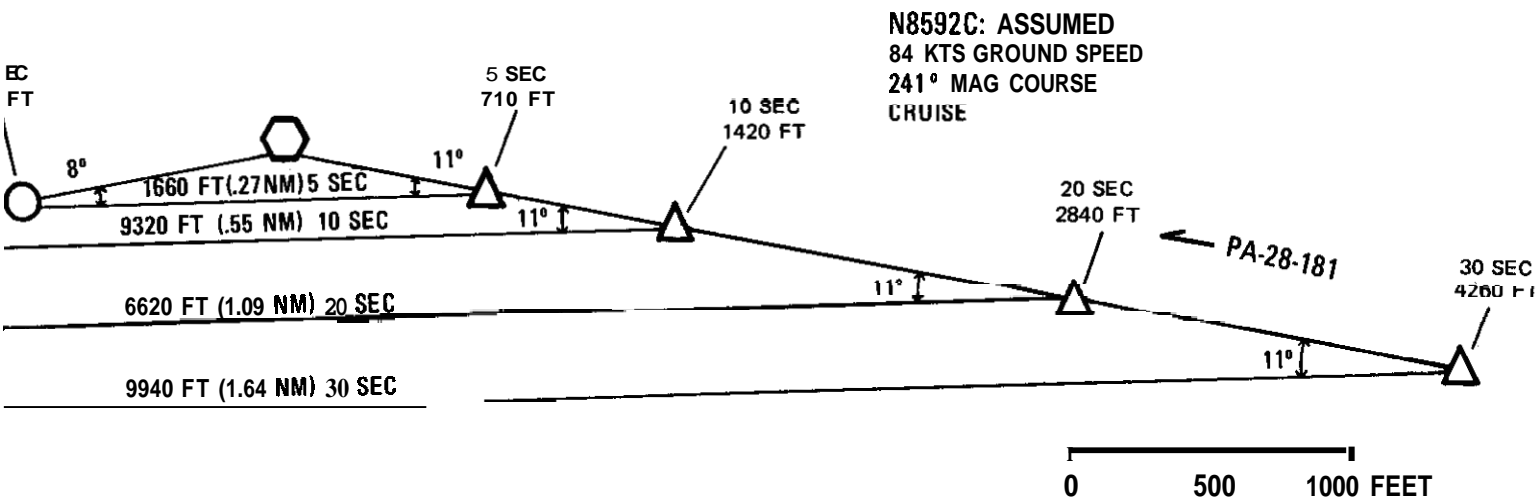
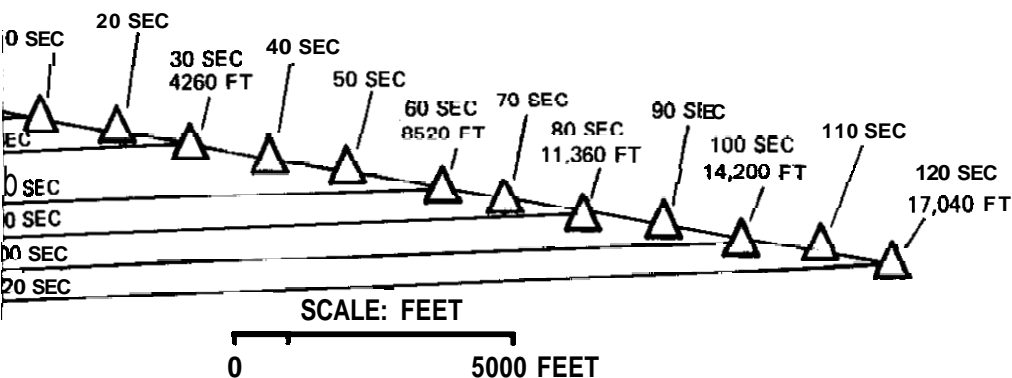
NATIONAL TRANSPORTATION SAFETY BOARD WASHINGTON, O.C.
RECONSTRUCTED PROBABLE COLLISION GEOMETRY
PA 28R-200 N7941C & PA 28-181 N8592 C NEAR HUNTSVILLE, MISSOURI, JULY 24, 1976

The probable collision geometry was reconstructed from data contained in the Kansas City ARTCC's **D-LOG** for the time of the accident. The only data available were a precollision radar target of N7941C (aircraft No. 1) and a DPICT of the flightpath of N8592C (aircraft No. 2), both derived from the **D-LOG**.

For aircraft No. 1, a magnetic course of 42° was assumed, based upon the approximate magnetic course from Arnsperger Airport to the collision point. It was assumed that the collision occurred on, or near, the 241° radial from the MACON **VOR**. The groundspeed of aircraft **No. 1** was assumed to be 115 kn.

From the DPICT of aircraft No. 2, a groundspeed of 84 kn was derived with the aircraft on a magnetic course of 241°. The aircraft's altitude was **6,000** feet m.s.l. (See Appendix **E**.)

N7941C: ASSUMEO
 115 KTS GROUND SPEED
 42° MAG COURSE
 CLIMBING

CALCULATED RATE OF CLOSURE WAS 196 KNOTS
 THIS CHART IS BASED UPON ASSUMEO HEADINGS,
 SPEEDS AND ALTITUDES FOR BOTH AIRCRAFT.
 THE PROBABLE COLLISION GEOMETRY AS SHOWN
IS INTENDED TO ILLUSTRATE ONLY THE RELATIVE
 PATHS OF BOTH AIRCRAFT AND NOT INTENDED TO
 ILLUSTRATE ABSOLUTE DATA FOR EITHER AIRCRAFT.

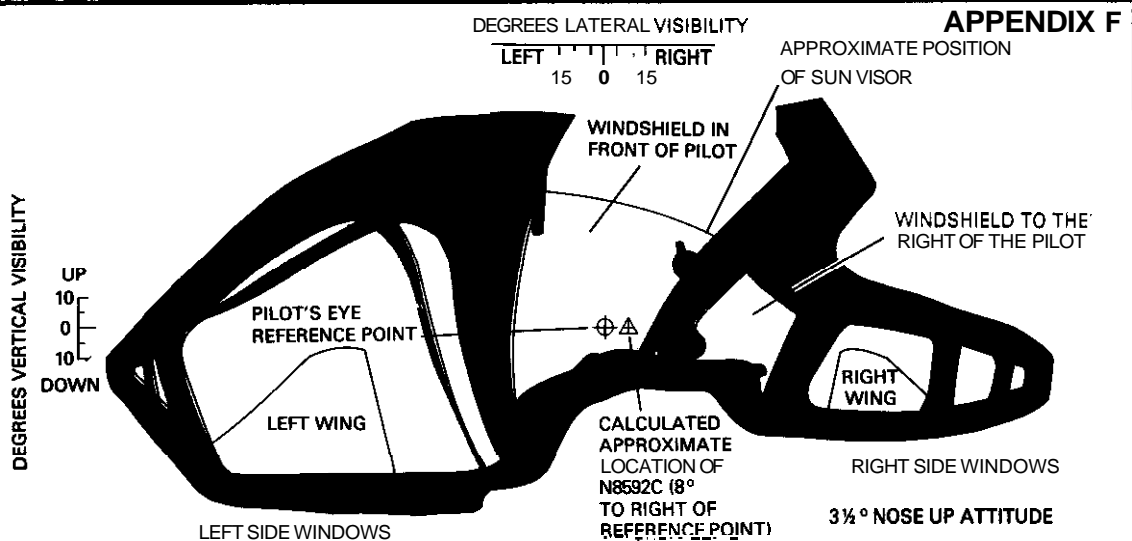
**VISIBILITY FROM PA-28R-200 PILOT'S SEAT
REPRESENTS POSSIBLE VISIBILITY FROM N7941C**

A visibility study was conducted to determine the field of visibility from each cockpit. The FAA provided binocular photographs taken of similar aircraft which illustrated the external visibility available from each aircraft's left front seat. These photographs do not account for movement or displacement of the occupant's head, eyes, or torso. Therefore, these movements either singularly or in combination will affect the occupant's external vision with regard to cockpit window structure and protuberance. The visibility study indicated that neither pilot's outside view would have been obstructed in the vicinity of the other aircraft's target.

14. Regardless of the deficient distant vision of the pilot of N8592C, he should have been able to detect N7941C in time to avoid the collision.
15. Neither pilot's outside view would have been masked by cockpit structures in the vicinity of the other aircraft's target.
