| 4. Title and Subtitle Aircraft Accident Report -<br>New York Airways, Inc., Sikorsky S-61L, N619PA<br>Pan Am Building Heliport, New York, New York<br>May 16, 1977 | | | | 5. Report Date<br>October 13, 1977 | |

AIRCRAFT ACCIDENT REPORT

NEW YORK AIRWAYS, INC.  
SIKORSKY S-61L, N619PA  
PAN AM BUILDING HELIPORT  
NEW YORK, NEW YORK  
MAY 16, 1977

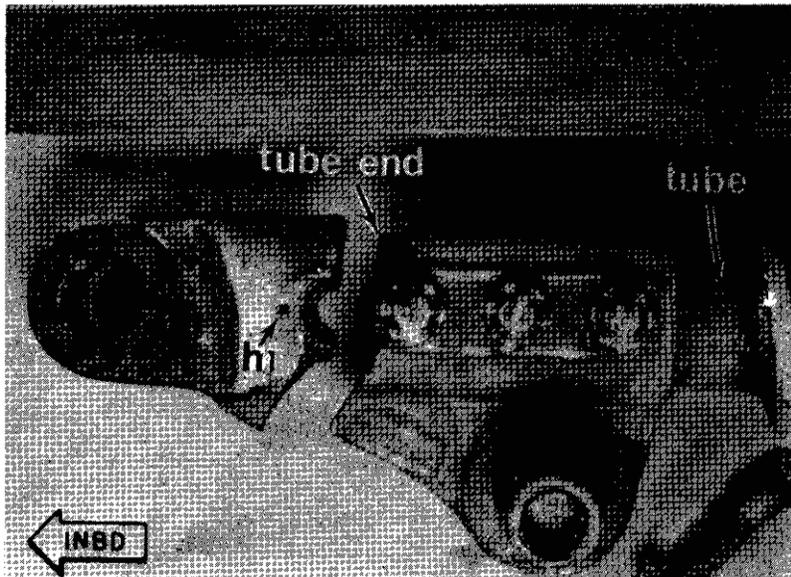
Examination of the right forward main landing gear P/N 56125-50333-22 fitting showed that it fractured near where the end of the tube assembly is located within the fitting (See figure 2, Appendix F). This was near the bottom of a 1.498/1,500-inch diameter hole which is drilled in the fitting to accommodate the tube. Fractography of the fractured features indicated that a fatigue crack had begun along the 0.12-inch radius near the bottom of the hole where the hole changes from a cylindrical to a conical shaped section. (See figure 4, Appendix F.)

Figure 2. Right hand main landing gear fitting (P/N 56125-50333-2) with the fractures (arrows "a" figure 1) placed relative to each other as if intact. Inboard attachment bolt was removed from the hole.

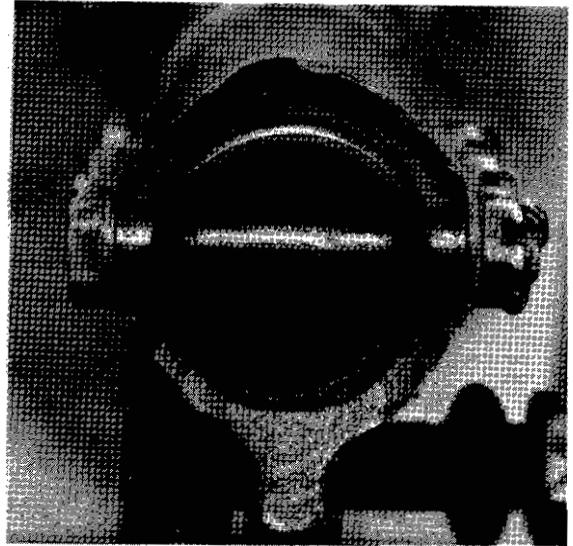
The missing area on the forward side was seen by comparing the mating fracture halves and noting that the fracture on the inboard half went through the small hole used to locate the tube in the fitting while on the outboard half the fracture in the same area progressed through the bolt hole. (See Figure 3, Appendix F.)

Figure 3. Mating fracture surfaces on the P/N S6125-50333-2 fitting. Both photographs approximately X1 1/4

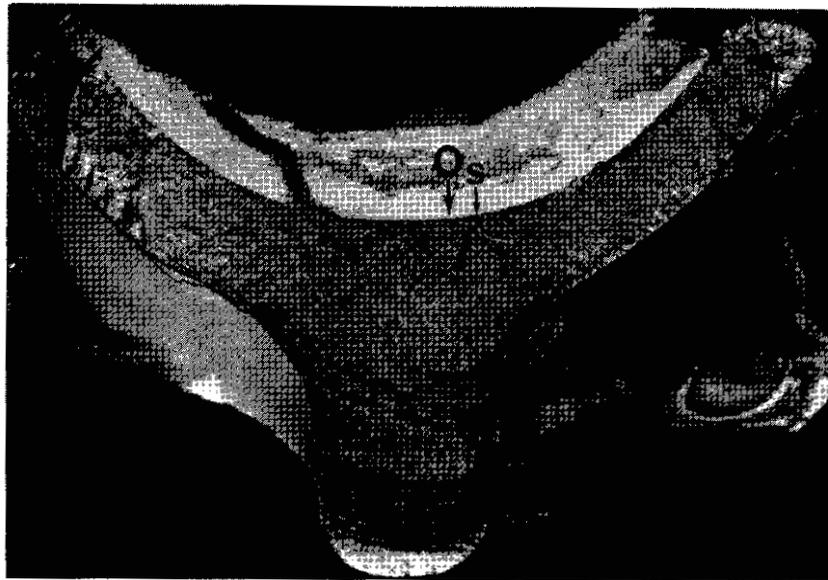
Figure 4. Portion of inboard fracture surface removed for detailed fractographic examination. Arrow "0" denotes main origin and arrow "S" locates secondary origin while dashed lines indicate approximate extent of fatigue propagation from these origins.

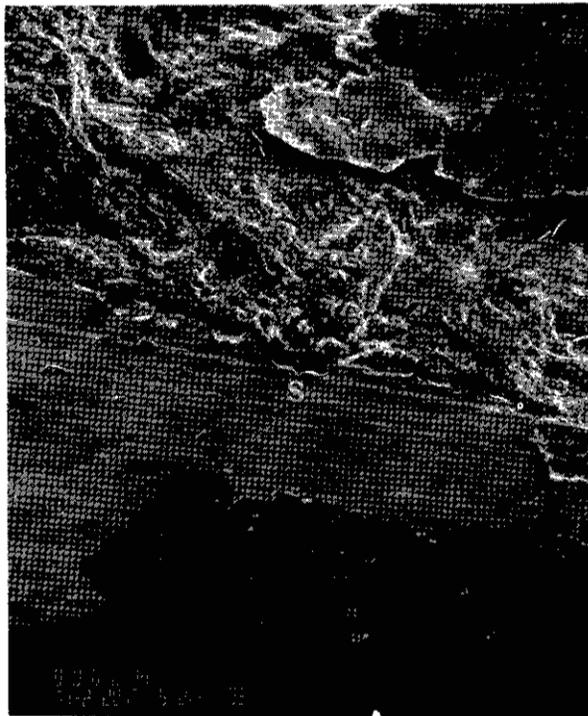
Detailed examination of the fracture origin area disclosed two origin sites, both of which appeared to be at discontinuities in the radius (See Figures 5 and 6, Appendix F). The two origins produced two planes of fatigue fracture slightly offset from one another. The two fatigue cracks grew into one large crack a short distance out from the radius. Because of the extent and symmetry of the crack arrest markings and the locations of the origins with respect to a ratchet mark (step-like portion of the fracture connecting the fatigue planes), one origin was considered secondary and the other was considered the main origin. A substance was found which completely filled the discontinuity at the secondary origin and partially filled the discontinuity at the main origin. (See Figures 5 and 6, Appendix F.) Energy dispersive X-ray analysis of the substance at the main origin area disclosed elements normally associated with the fitting alloy system along with an appreciable amount of sulfur and small amounts of calcium and potassium all of which are foreign elements. The silicon energy peak was strong indicating silicon as a primary element of the substance; the fitting alloy normally contains less than 0.4 by percent weight of silicon.

Figure 5. SEM photograph showing secondary origin bracket "S" (see arrow "S" in figure 4 for location). Fracture surface is above origin and hole radius is below. Arrowheads depict fatigue propagation direction. X100

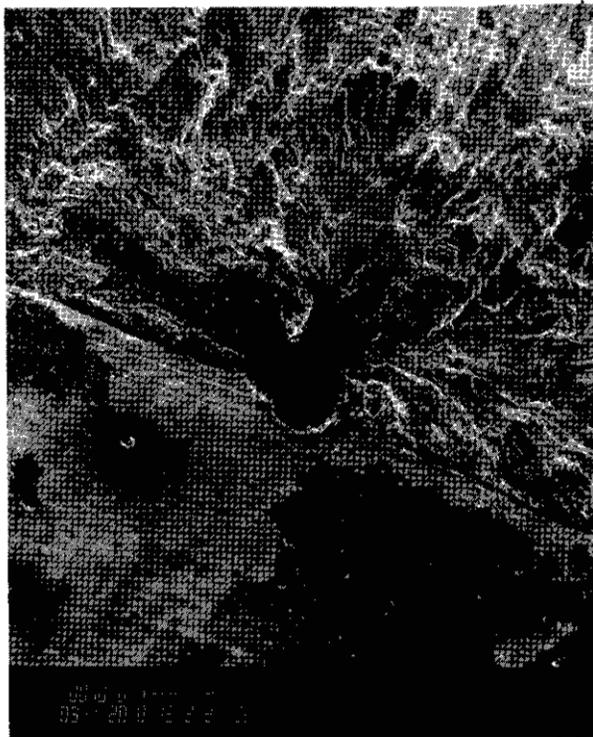
Examination of the fracture using a scanning electron microscope (SEM) disclosed fracture features typical of high cycle fatigue propagation from these origin areas. Fatigue had propagated down and through the bottom of the fitting and out. (See Figure 4, Appendix F.) Approximately 40 percent of the fractured cross sectional area of the fitting appeared cracked. The remaining sections of fracture away from this fatigue region were typical of overload separations.

Figure 6. SEM photograph of main fatigue origin area (see arrow "O" figure 4 for location). Arrowheads indicate fatigue propagation directions. X90

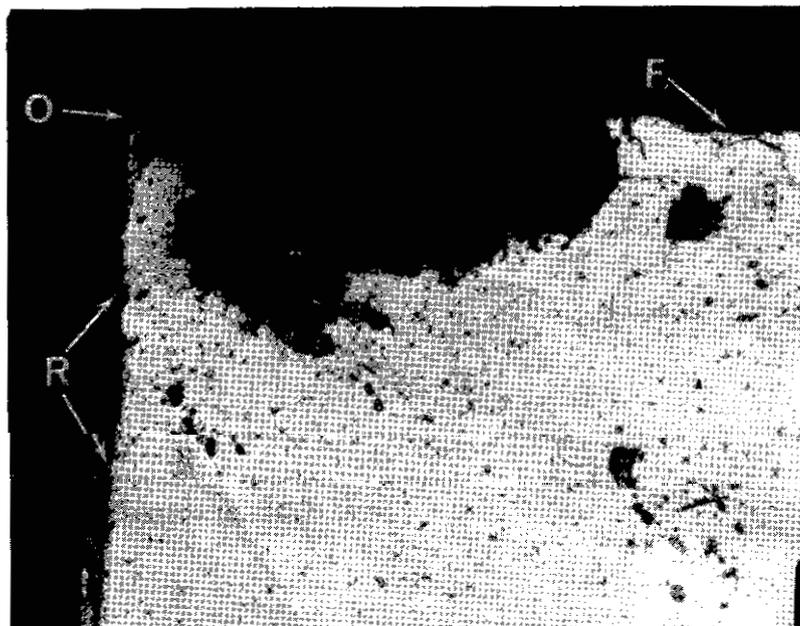
Figure 8. Longitudinal metallographic microsection through the main origin area showing the discontinuity in profile. Arrows "R" and "F" indicate the radius and fracture profile respectively. X375 Kellers etch

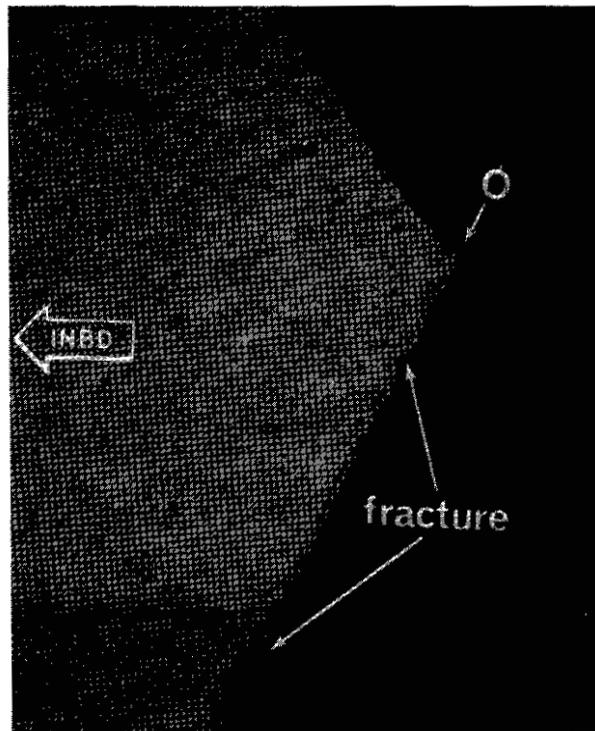
Figure 10. Longitudinal section through the main fatigue origin area. Arrow "O" indicates same area depicted by arrow "O" in figure 8. X10 nital etched
