NATIONAL TRANSPORTATION SAFETY BOARD

AIRCRAFT ACCIDENT REPORT

PACIFIC SOUTHWEST AIRLINES, INC.,
B-727, N533PS AND

GIBBS FLITE CENTER, INC.,
CESSNA 172, N7711G

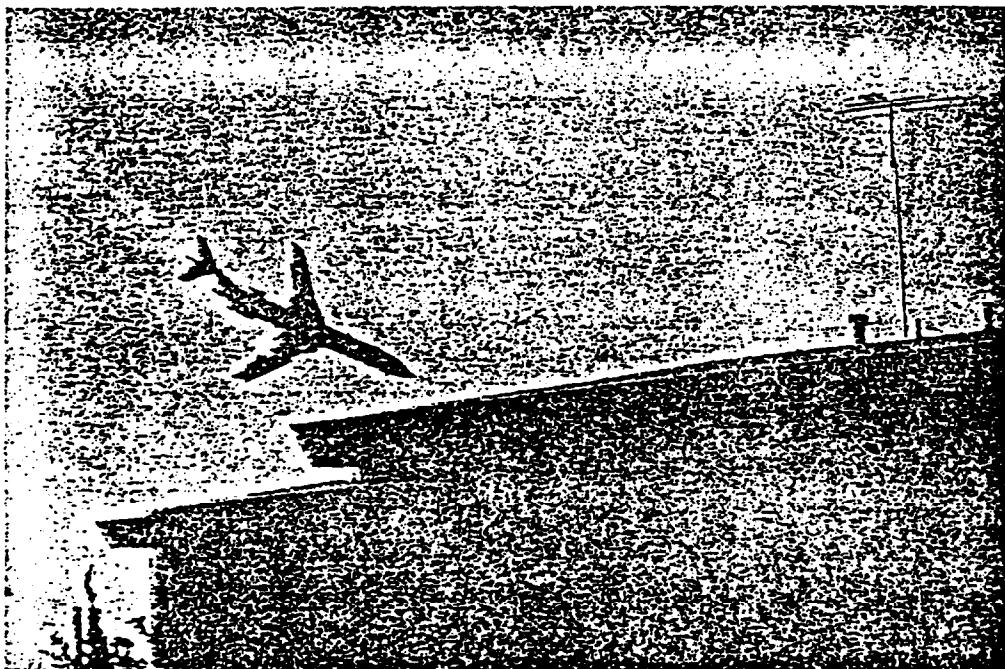
The right wing, as shown in Figure 2, was studied. The examination revealed that **the** Nos. 5 and 6 leading edge flaps were missing, a portion of the No. 5 leading edge slat was missing, and a large portion of the wing's leading edge back to about the front spar was peeled off the aircraft.

Hydraulic tubing from both the System A and the standby hydraulic systems was routed **to** the leading edge devices forward of the front spar. It was not possible to determine from the photographs if the tubes **were** broken **or** flattened. The B **hydraulic system's** tubing was located just aft of the rear spar of the wing. Because the extent of damage that could have existed in that area could not be determined, the status of the tubing could not be determined.

Fuel lines from the fuel pumps to the fuel pressure sensors were located immediately behind the leading edge flaps. These lines contain fuel under pressure and, if **severed, would** spray fuel out as **long** as the fuel pumps were operating. Because of fire which covered the aft section of the wing in the area of the inboard aileron, it was not possible to ascertain whether any of the **surfaces** in that area were missing.

Figure 2. Flight 182 descending. (Photo taken after Figure 1)

The study of the two photographs showed that the structural damage to the Boeing 727's right wing leading edge extended from the No. 4 inboard leading edge flap outboard to, and including, the No. 3 leading edge slat--a distance of 30 feet or more. The **chordwise** penetration of this damage appeared to extend rearward to the front spar of the wing. The calculated positions of the flight controls in Figure 2 show almost full deflection in the proper direction to arrest the abnormal attitude and to restore controlled flight. The deflected position of the flight controls and the left wing flight spoiler surfaces indicated that at least partial hydraulic pressure was available from system A and system B.
