NATIONAL TRANSPORTATION SAFETY BOARD

ALLEGHENY AIRLINES, INC.
WORD 262, MOHAWK/FRAKES 298, N29824
BEWEDUM AIRPORT
CLARKSBURG, WEST VIRGINIA
FEBRUARY 12, 1979

NTSB-AAR-79-12

AIRCRAFT ACCIDENT REPORT

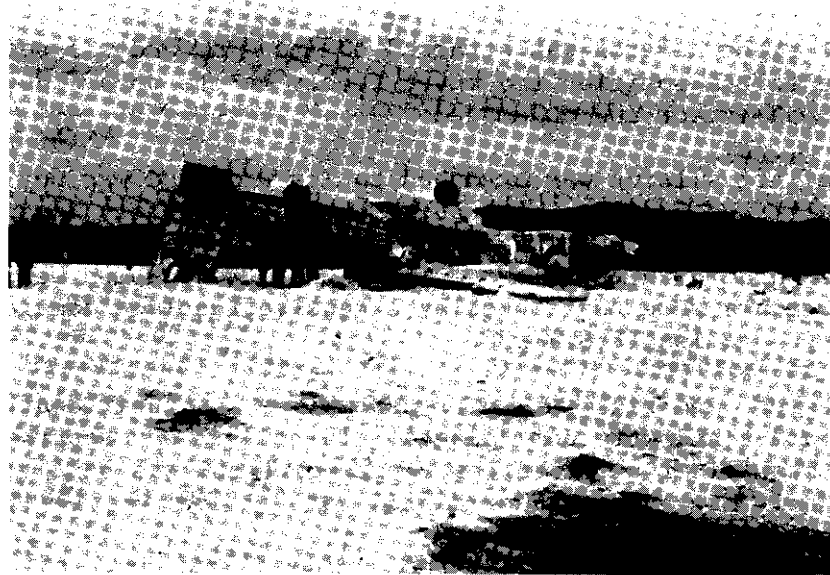
The aircraft crashed within the airport boundary. Shortly after liftoff, the right wingtip contacted the left side of the runway, 4,398 ft from the takeoff end of the runway, and the outboard portion of the right wing broke off; the wing came to rest 192 ft from the point of first contact. The aircraft fuselage hit the runway in an inverted position, slid down the runway, and came to rest off the right side of the departure end of runway 21, 60 ft from the end of the runway and 137 ft to the right of the runway centerline. There was no fire. (See figure 1 and Appendix E.)

Examination of the aircraft structure disclosed no evidence of preimpact structural damage. Both engines remained with the center section of the wings. The left engine and nacelle remained in place, and the right engine mount separated from the wing. The right engine came to rest adjacent to the center section.

Figure 1. The Nord 262 as it came to rest at the end of runway 21.
