AIRCRAFT ACCIDENT REPORT

CHAMPION HOME BUILDERS COMPANY
GATES LEARJET 25B, N999HG
SANFORD, NORTH CAROLINA
SEPTEMBER 8, 1977

NTSB-AAR-79-15

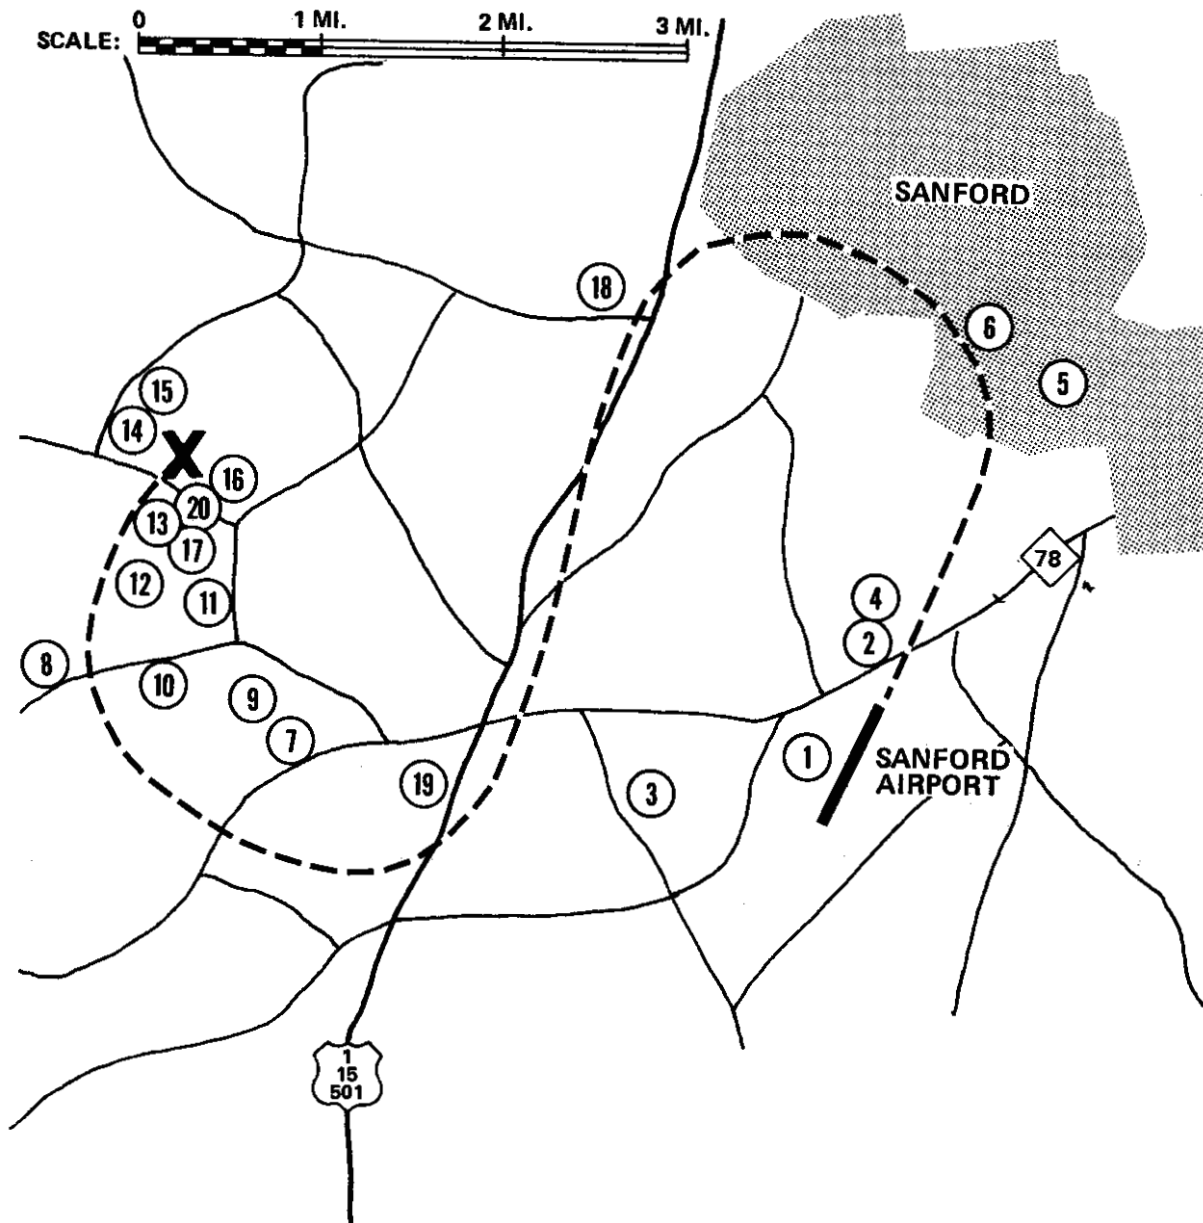
APPENDIX D
WITNESS LOCATION CHART AND PROBABLE FLIGHTPATH

Other witnesses who saw the aircraft during its last mile of flight also stated that the aircraft was on fire. One witness described the fire as coming from below and to the rear of the aircraft with the flames extending toward the ground. This witness' account suggests that fuel was escaping from the aircraft and was burning as it fell to the ground.

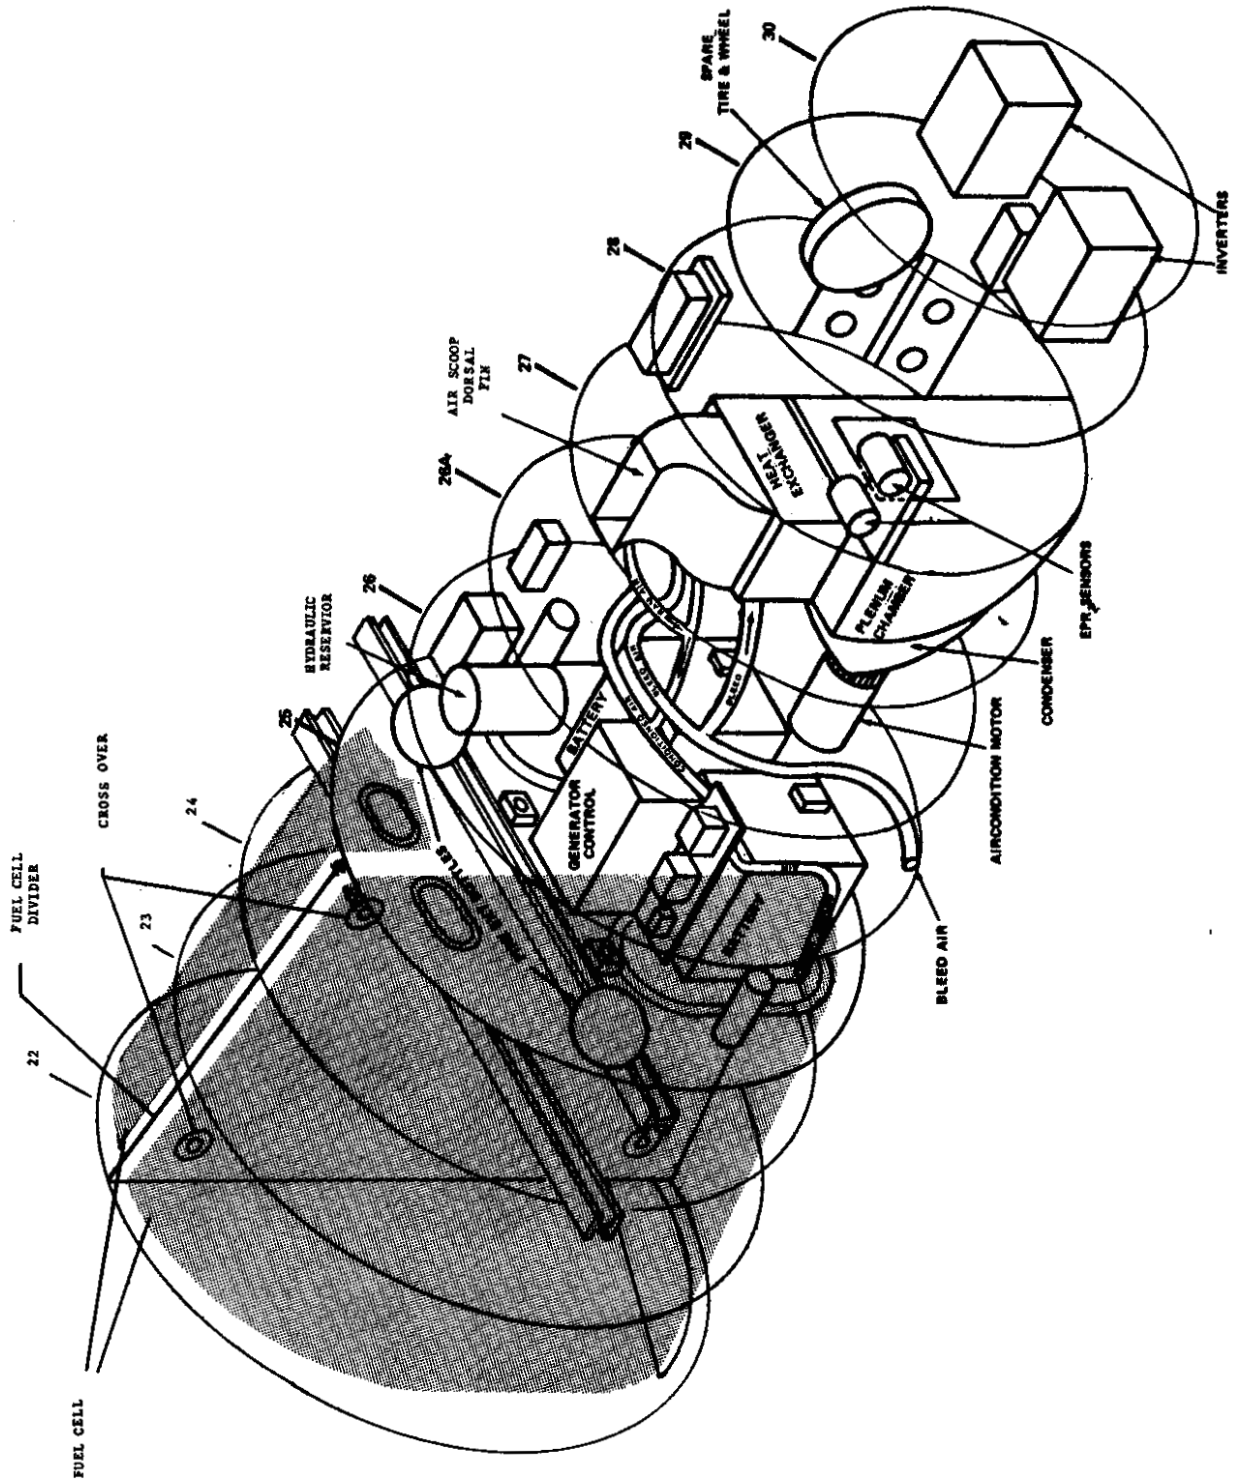
APPENDIX E
DIAGRAM OF FUSELAGE AFT SECTION

The fuselage fuel tank compartment was located between FF 22 and FF 25. (See appendix E.) The compartment contained two bladder-type fuel cells which were interconnected. The compartment was fragmented extensively. Some pieces of fuselage skin and stringers surrounding the compartment were damaged and sooted by heat and fire; other pieces were clean. A piece of the top left portion of the tank compartment just forward of FF 25 was torn in a sawtooth pattern. It was not damaged by fire or sooted. Another piece which mated with the sawtooth tear was burned. Also, a 12-in piece of stringer from the top right portion of the fuselage between FF 22 and FF 23, with attached pieces of fuselage skin, intercostal, and compartment liner was burned and sooted except for the forward 5 in of the stringer; this stringer mated with another piece of burned fuselage skin.

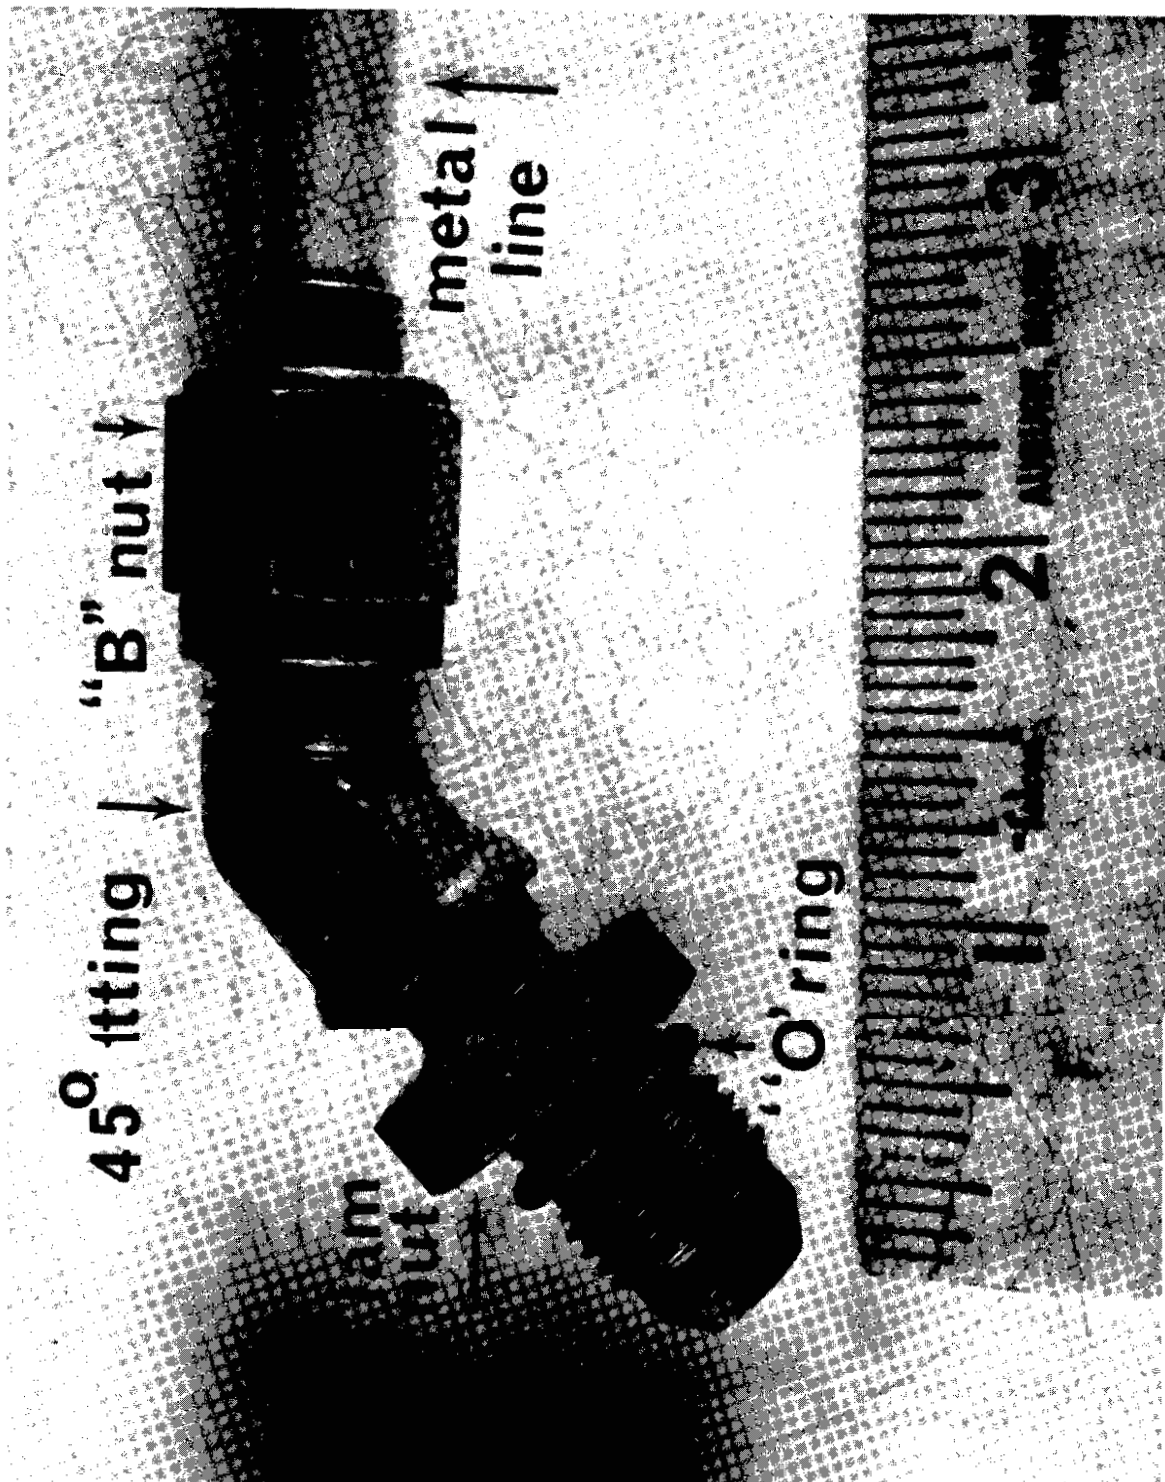
PHOTOGRAPH OF MOTIVE FLOW CONTROL VALVE

The left and right motive flow control valves remained partially attached to the aft face of the FF 25 bulkhead. Both valves were in the open position. On the left valve, the inlet line was disconnected from the inlet port and the O-ring seal was not located. The threads of the attachment fitting were not stripped or scored; they were discolored from heat and were sooted slightly. The right valve was broken into two pieces; both pieces were damaged by fire.

The Safety Board was not able to determine conclusively the initial source of the combustible material. However, two possible sources were identified. The first possible source involves a disconnected fuel inlet line on the left motive flow control valve. Tests established that the line could not have been disconnected when the left engine was started and that it was not likely that the line was disconnected before takeoff. However, it is possible that the jamnut was loose, that it backed off after takeoff, and that fuel escaped from the loosened connection into the compartment aft of FF 25. Fuel escaping into this section would have vaporized in the comparatively warm air there, and although tests showed that during flight, the airflow in the tailcone area was sufficient to totally displace the volume of air in the area about 11 times per minute, the Safety Board believes that a progressively larger fuel leak into the area could have formed an explosive mixture. Furthermore, the mixture would have been in close proximity to many electrical components in the area, such as the air conditioner motor, which could have provided ignition.
