AIRCRAFT INCIDENT REPORT

EASTERN AIRLINES, INC.,
BOEING 727-25 N8139
ATLANTA HARTSFIELD INTERNATIONAL AIRPORT,
ATLANTA, GEORGIA

AUGUST 22, 1979

NTSB-AAR-80-6

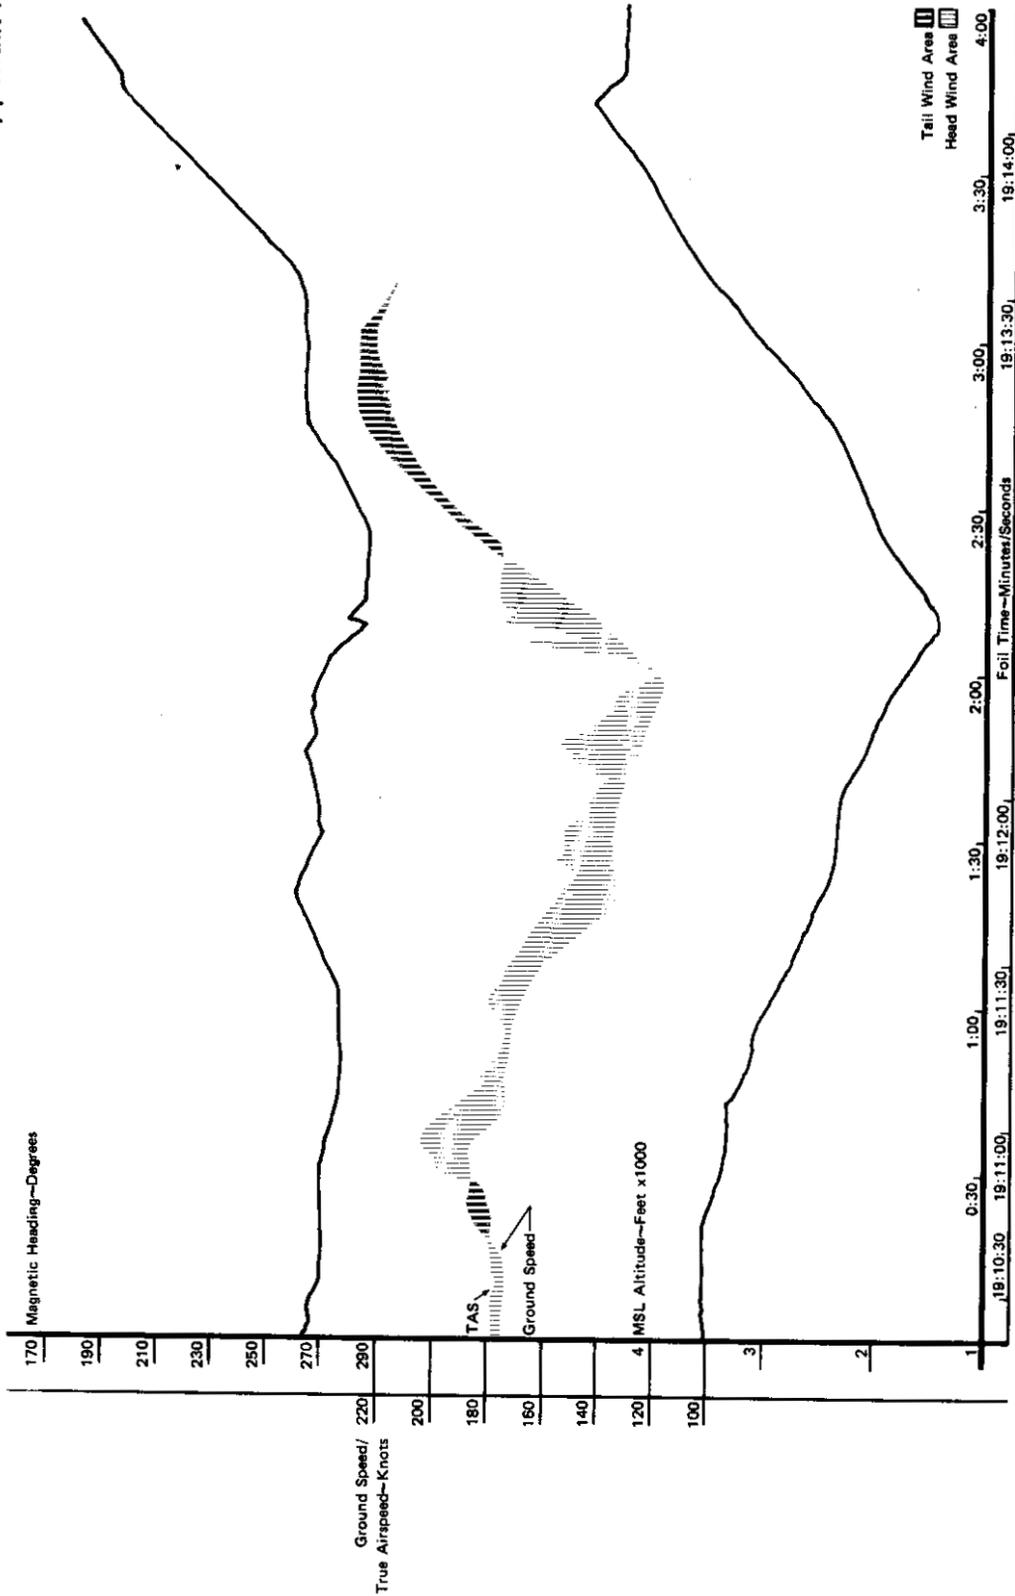
Appendix A

NTSB Washington, D.C. FDR Heading & Altitude True Airspeed & ARTS III Groundspeed
EAL, Boeing B-727, N8139 FLT 893, Atlanta, Georgia
August 22, 1979

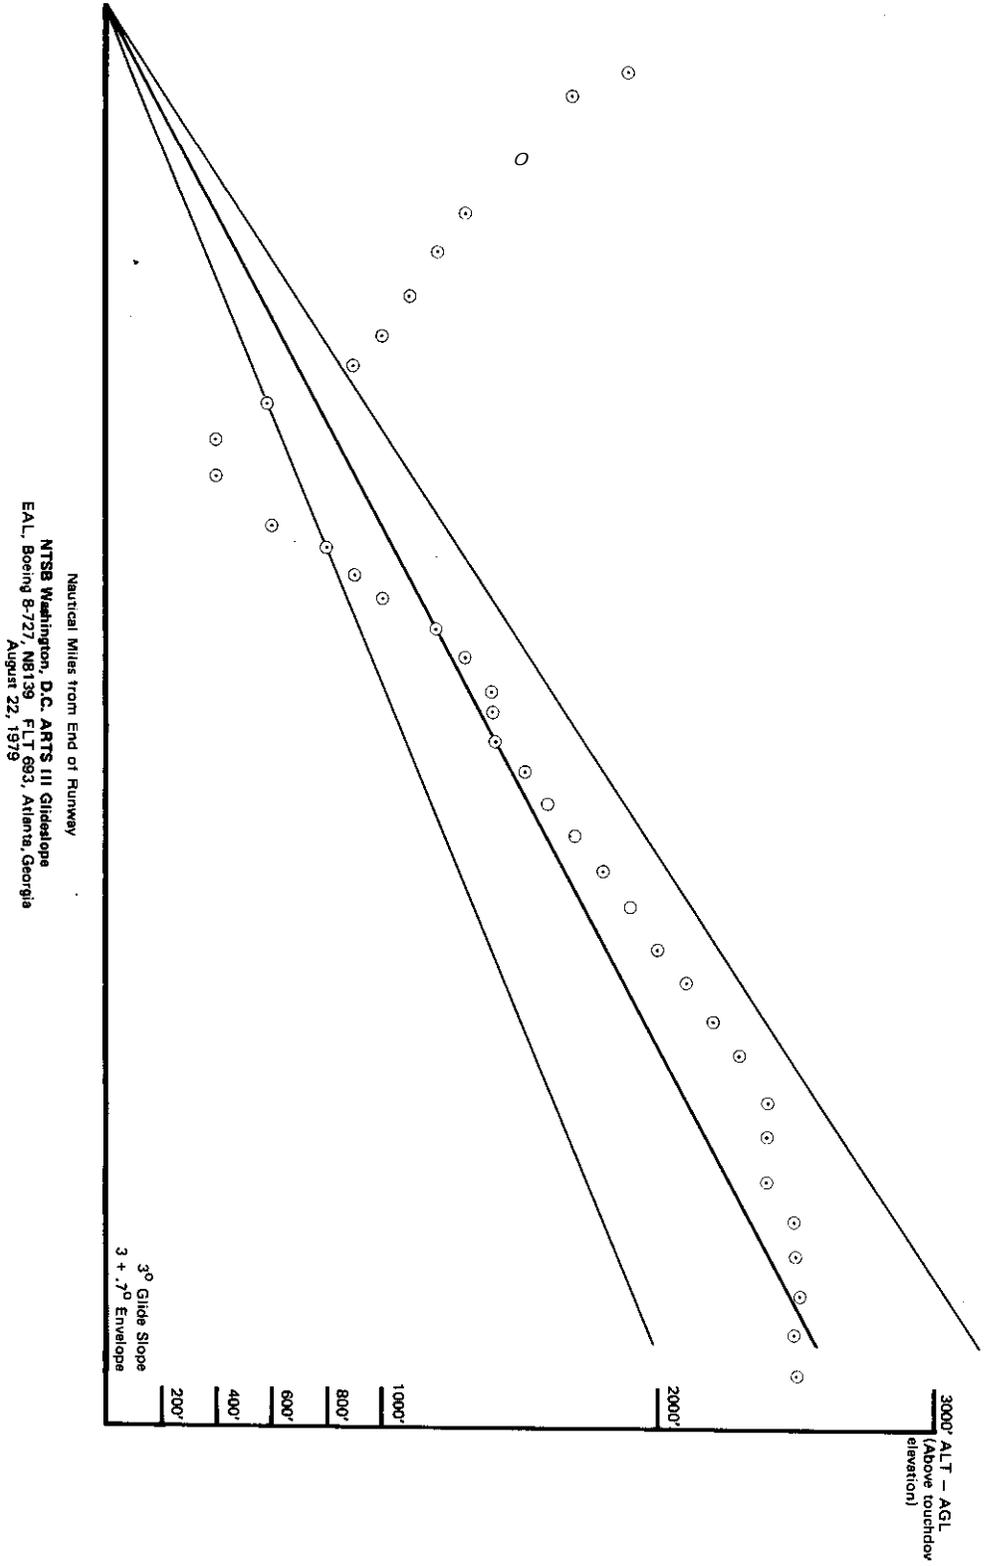
Appendix B

Correlation of the groundspeed and altitude trace with the ILS glidepath showed that the aircraft began its initial descent about 340 ft above the glidepath, and then began a descent correction to intercept it. At the OM, the aircraft was 200 ft above the glidepath. At about 4.25 nmi from the end of the runway, the glidepath was intercepted; however, the aircraft rose above the glidepath again and the descent continued to about 375 ft a.g.l. About 3.4 nmi from the end of the runway, the aircraft intercepted the glidepath, descended through it, and descended to about 375 ft a.g.l. About 2.3 nmi from the end of the runway, the aircraft began to climb out. (See appendix B.)

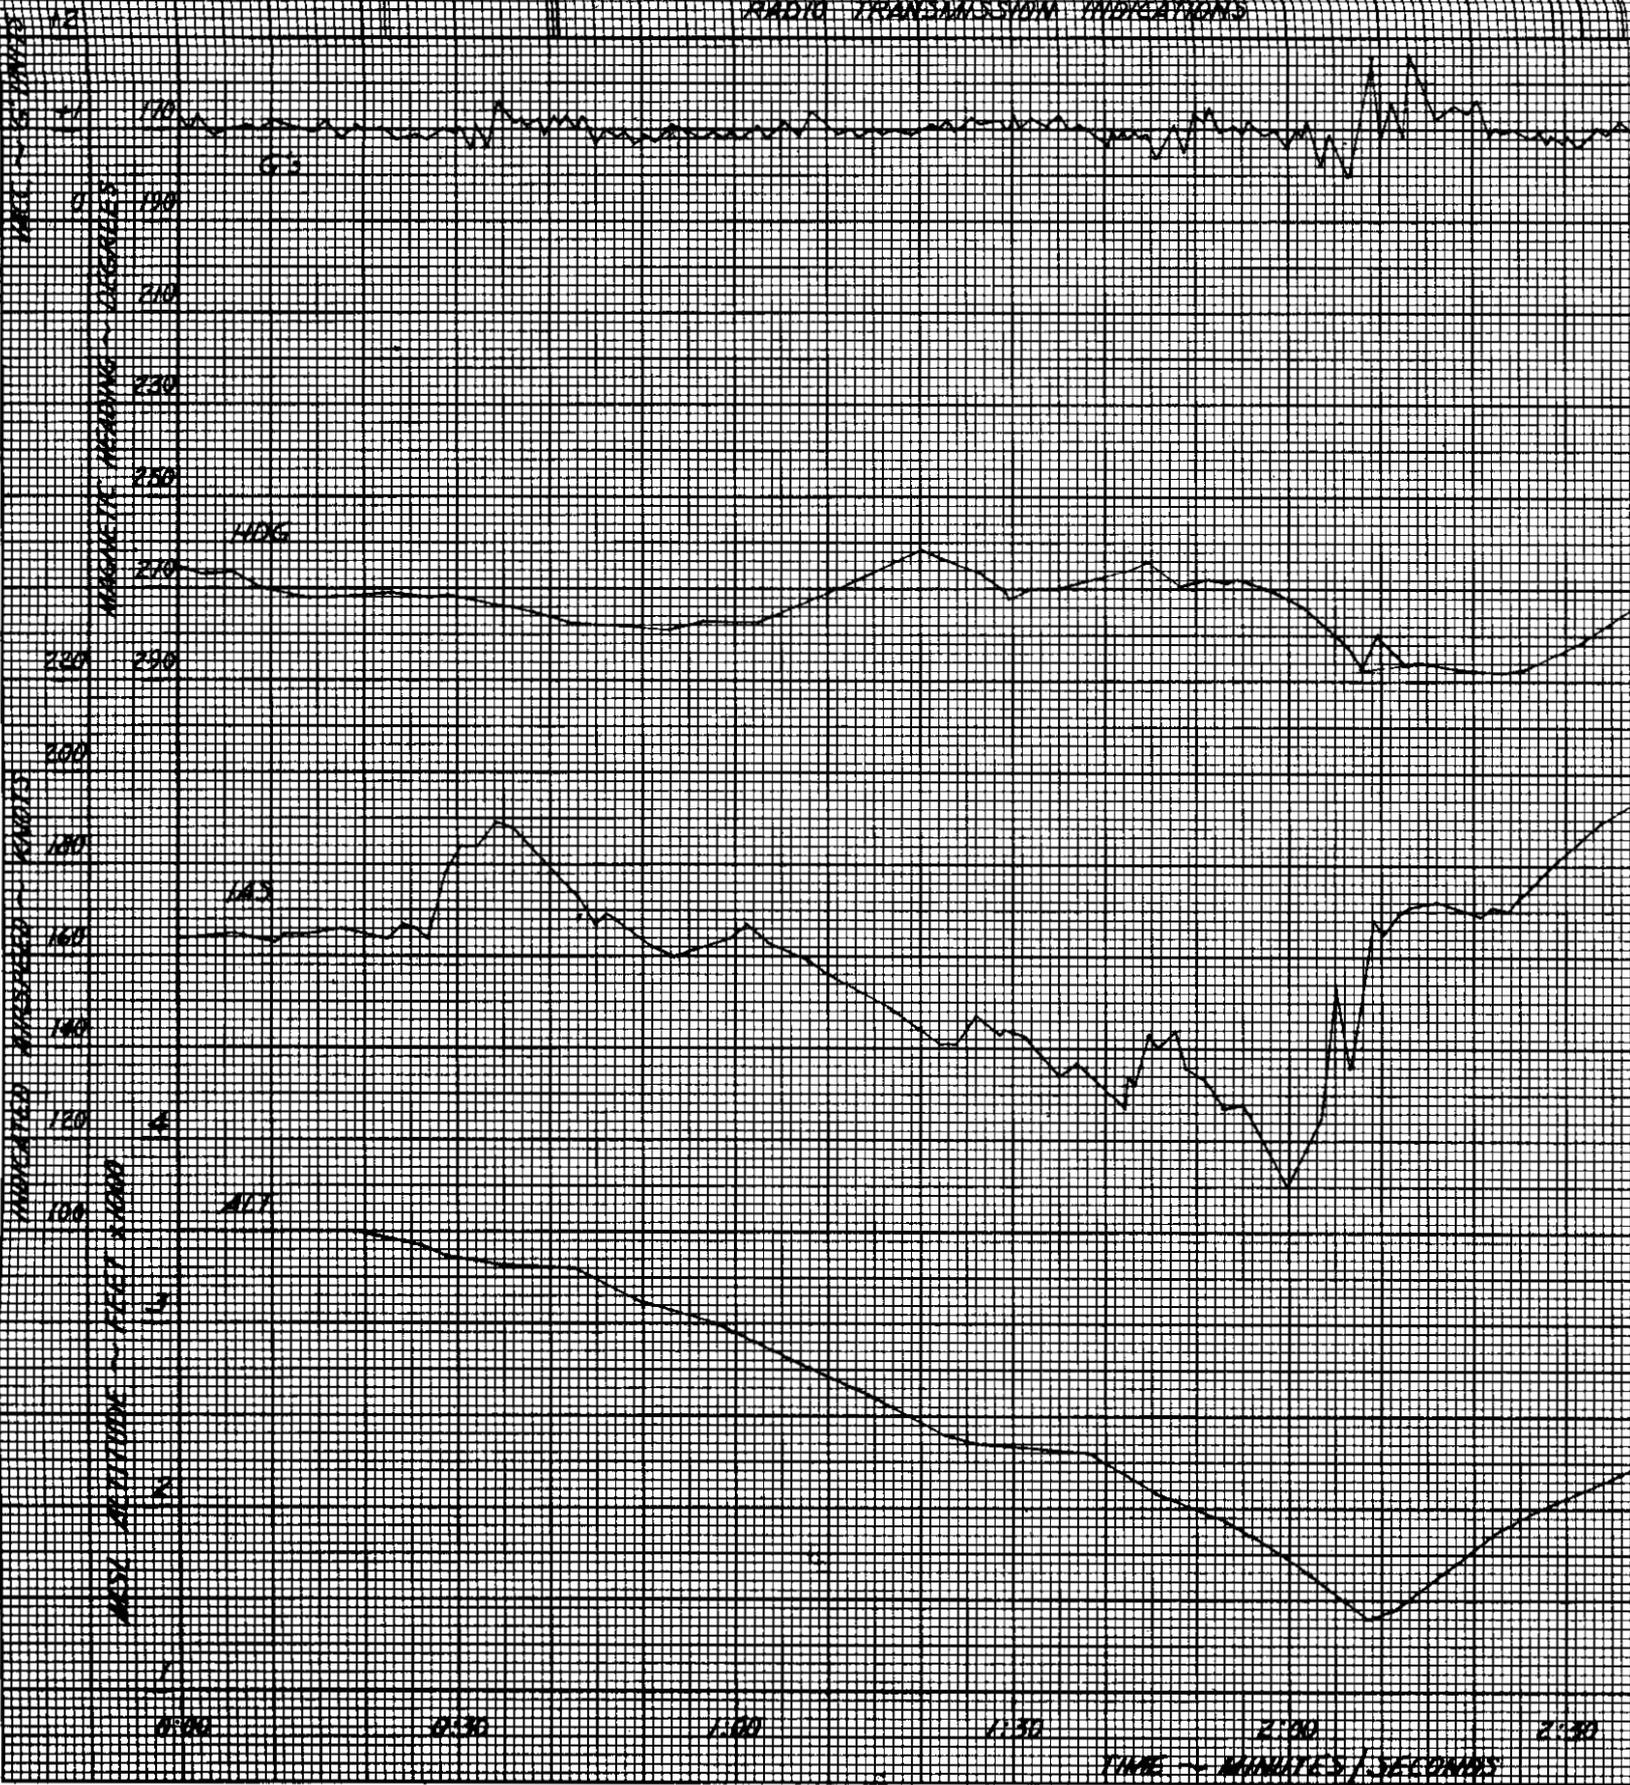
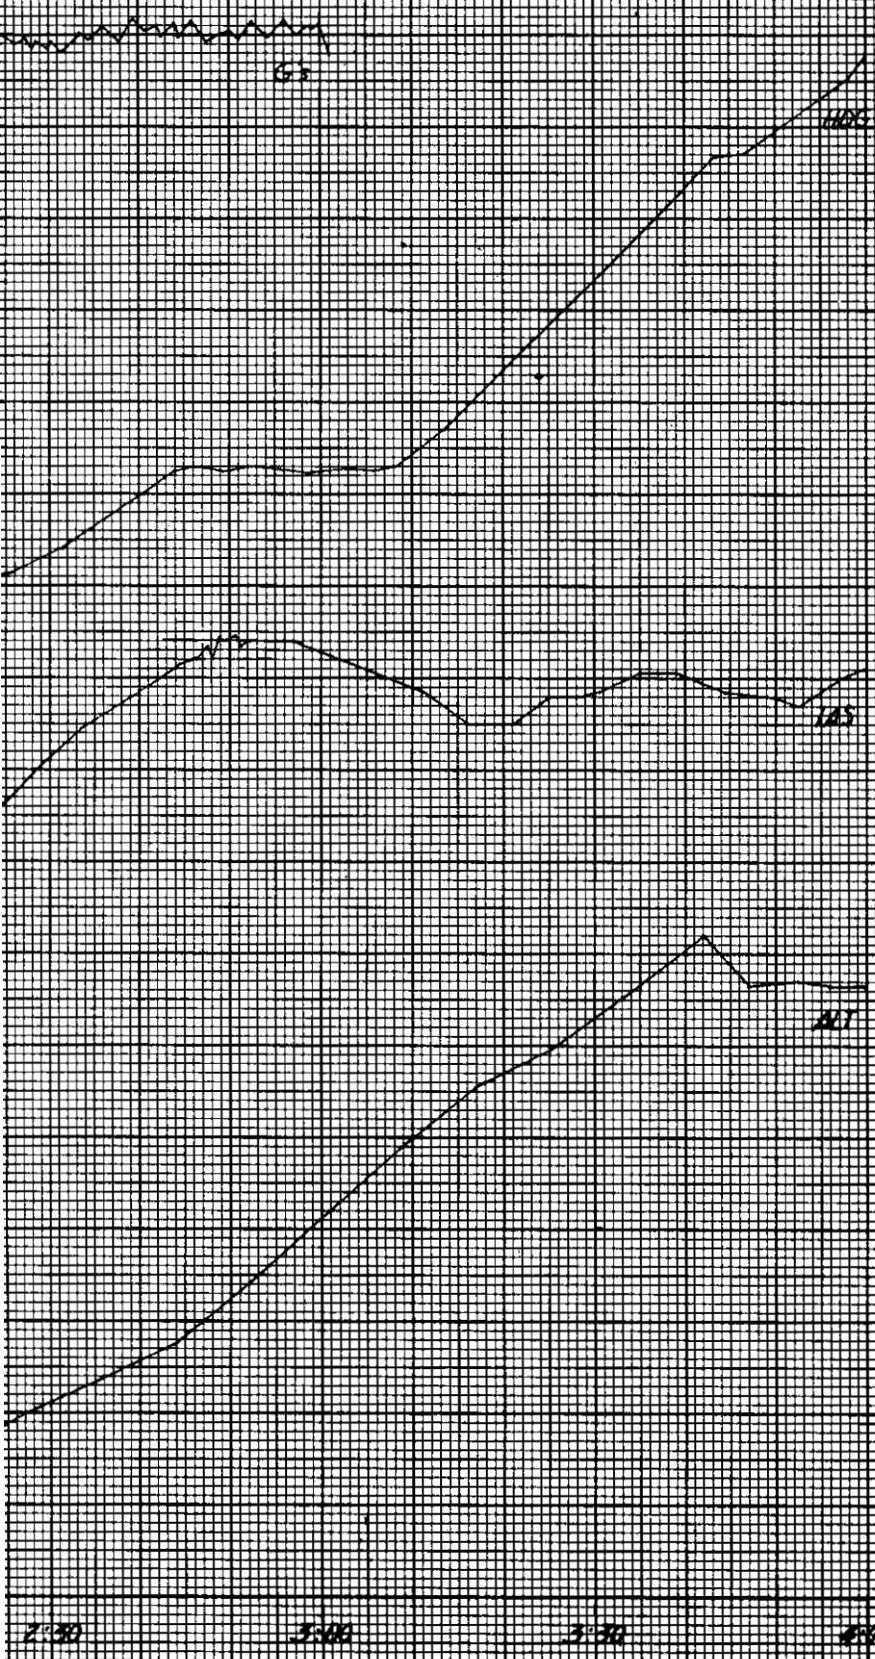
Flight 693's FDR foil was undamaged and a readout of the 2 min before and the 2 min after the indicated low point of the altitude trace was made. (See appendix C.) The OM, which is 5 nmi from the threshold of runway 27L, was passed about 58 sec on the readout's time baseline; the lowest altitude--1,400 ft (about 375 ft a.g.l.)--occured at 2 min 9 sec.

Twenty seconds after the start of the readout, the pilot began to descend from 3,500 ft. Between 20 sec and 98 sec, the aircraft descended at an average rate of 923 fpm to 2,300 ft. Between 98 sec and 113 sec, the aircraft descended at an average 1,500 fpm to 1,925 ft, and between 113 sec and 129 sec, it descended at an average 1,969 fpm to 1,400 ft. Thereafter, the aircraft began to climb and achieved a rate of climb of about 2,064 fpm.

During the first 27 sec of the readout, the airspeed was stabilized at 162 KIAS. About 30 sec before crossing the OM, the airspeed began to increase, reaching 184 KIAS within 8 sec and then restabilizing about 162 KIAS as the OM was crossed. Between 70 sec and 100 sec, while the aircraft was descending at 923 fpm to 2,300 ft, the airspeed decreased to 128 KIAS. Over the next 5 sec, the airspeed increased to 144 KIAS and then decreased. The lowest airspeed--110 KIAS--was recorded 9 sec before the lowest altitude was recorded. Beginning at 120 sec, the airspeed began to increase and reached 209 KIAS at 170 sec. The most erratic movements and maximum variations of the airspeed trace occurred between 102 sec and 130 sec. These coincided with the maximum descent rates noted on the altitude trace and the largest excursions noted on the vertical acceleration trace.
