# NATIONAL TRANSPORTATION SAFETY BOARD

## AIRCRAFT ACCIDENT REPORT

NEVADA AIRLINES, INC.  
MARTIN 404, N40438,  
TUSAYAN, ARIZONA

NOVEMBER 16, 1979

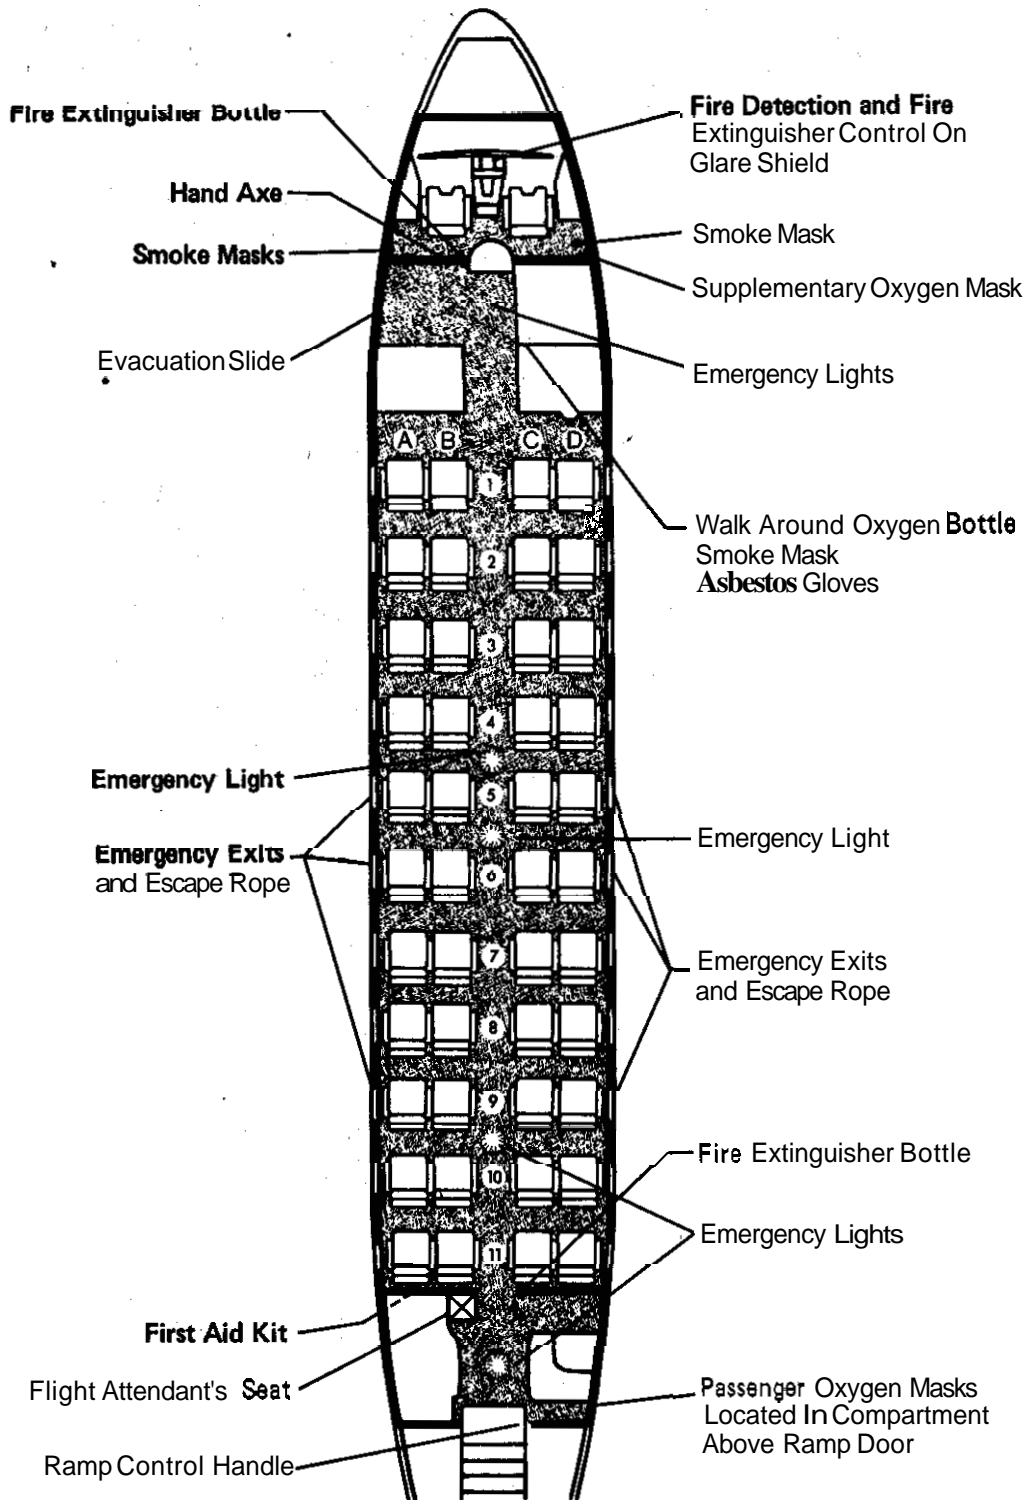
**Figure 1.—Floor Plan and Location of  
Emergency Equipment of the Martin 404.**

The flight attendant's seat was mounted in a baggage area separate from the main passenger cabin and on the back left side of the rear cabin bulkhead. (See figure 1.) The seat was not damaged. The seatbelt was found unfastened and undamaged after the accident. The fabric had not been abraded when the knurled bar slipped.

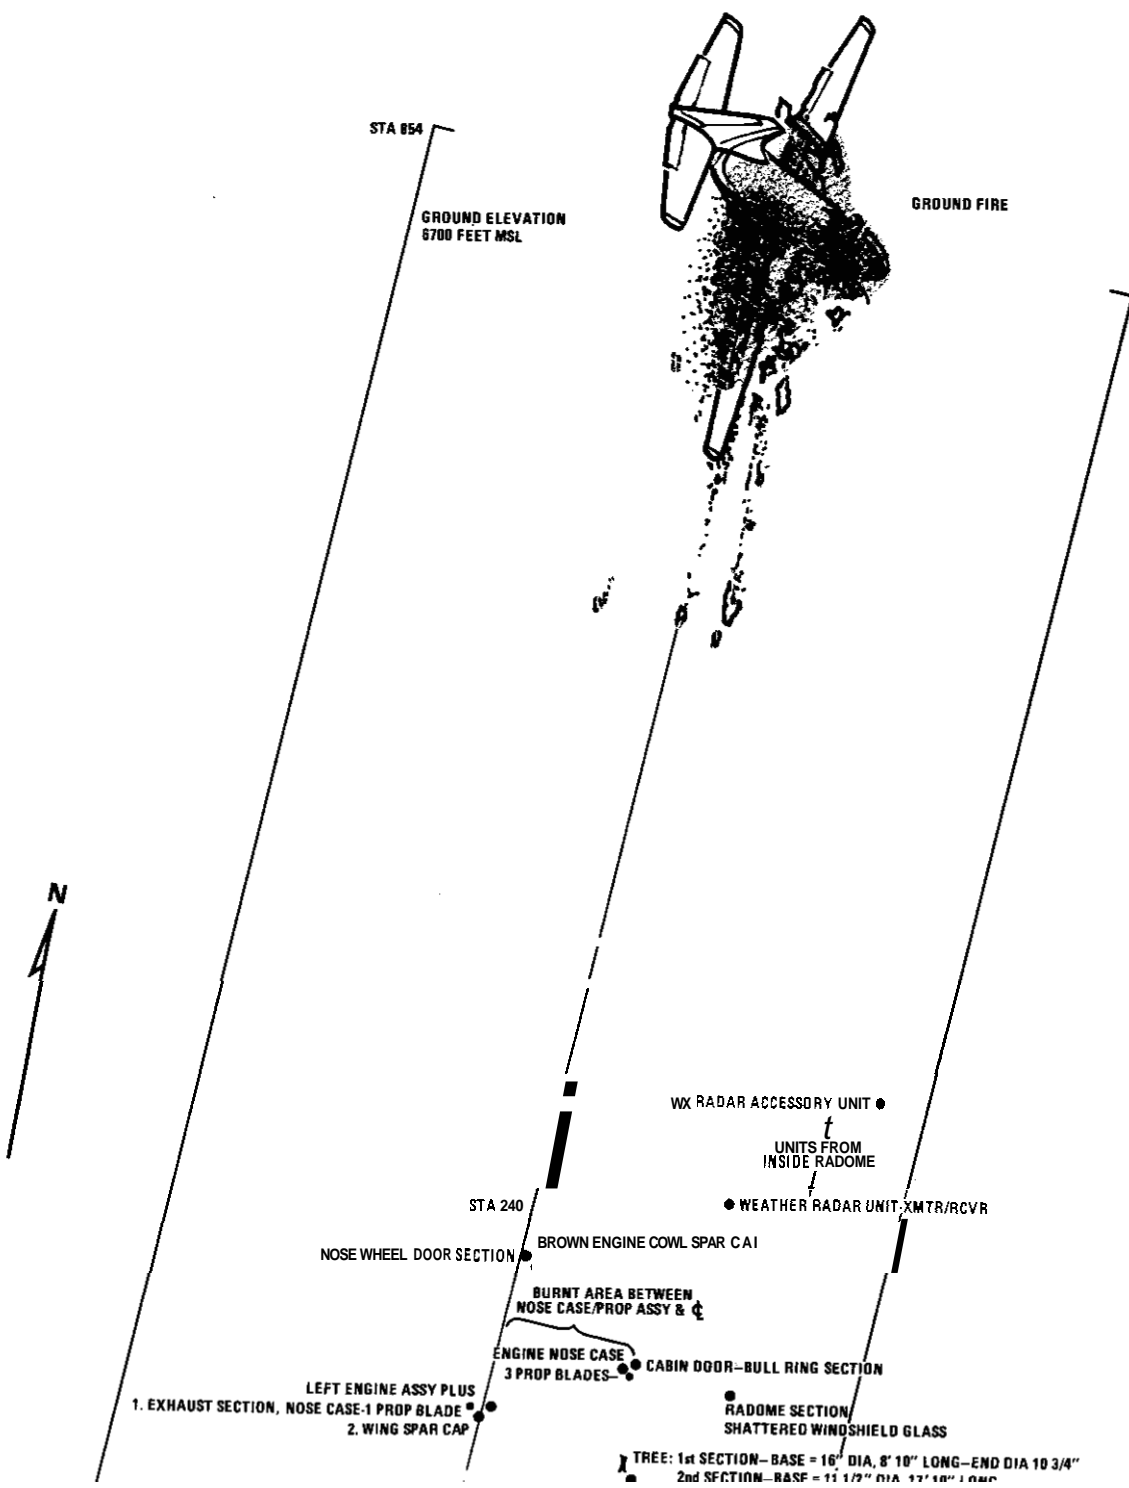
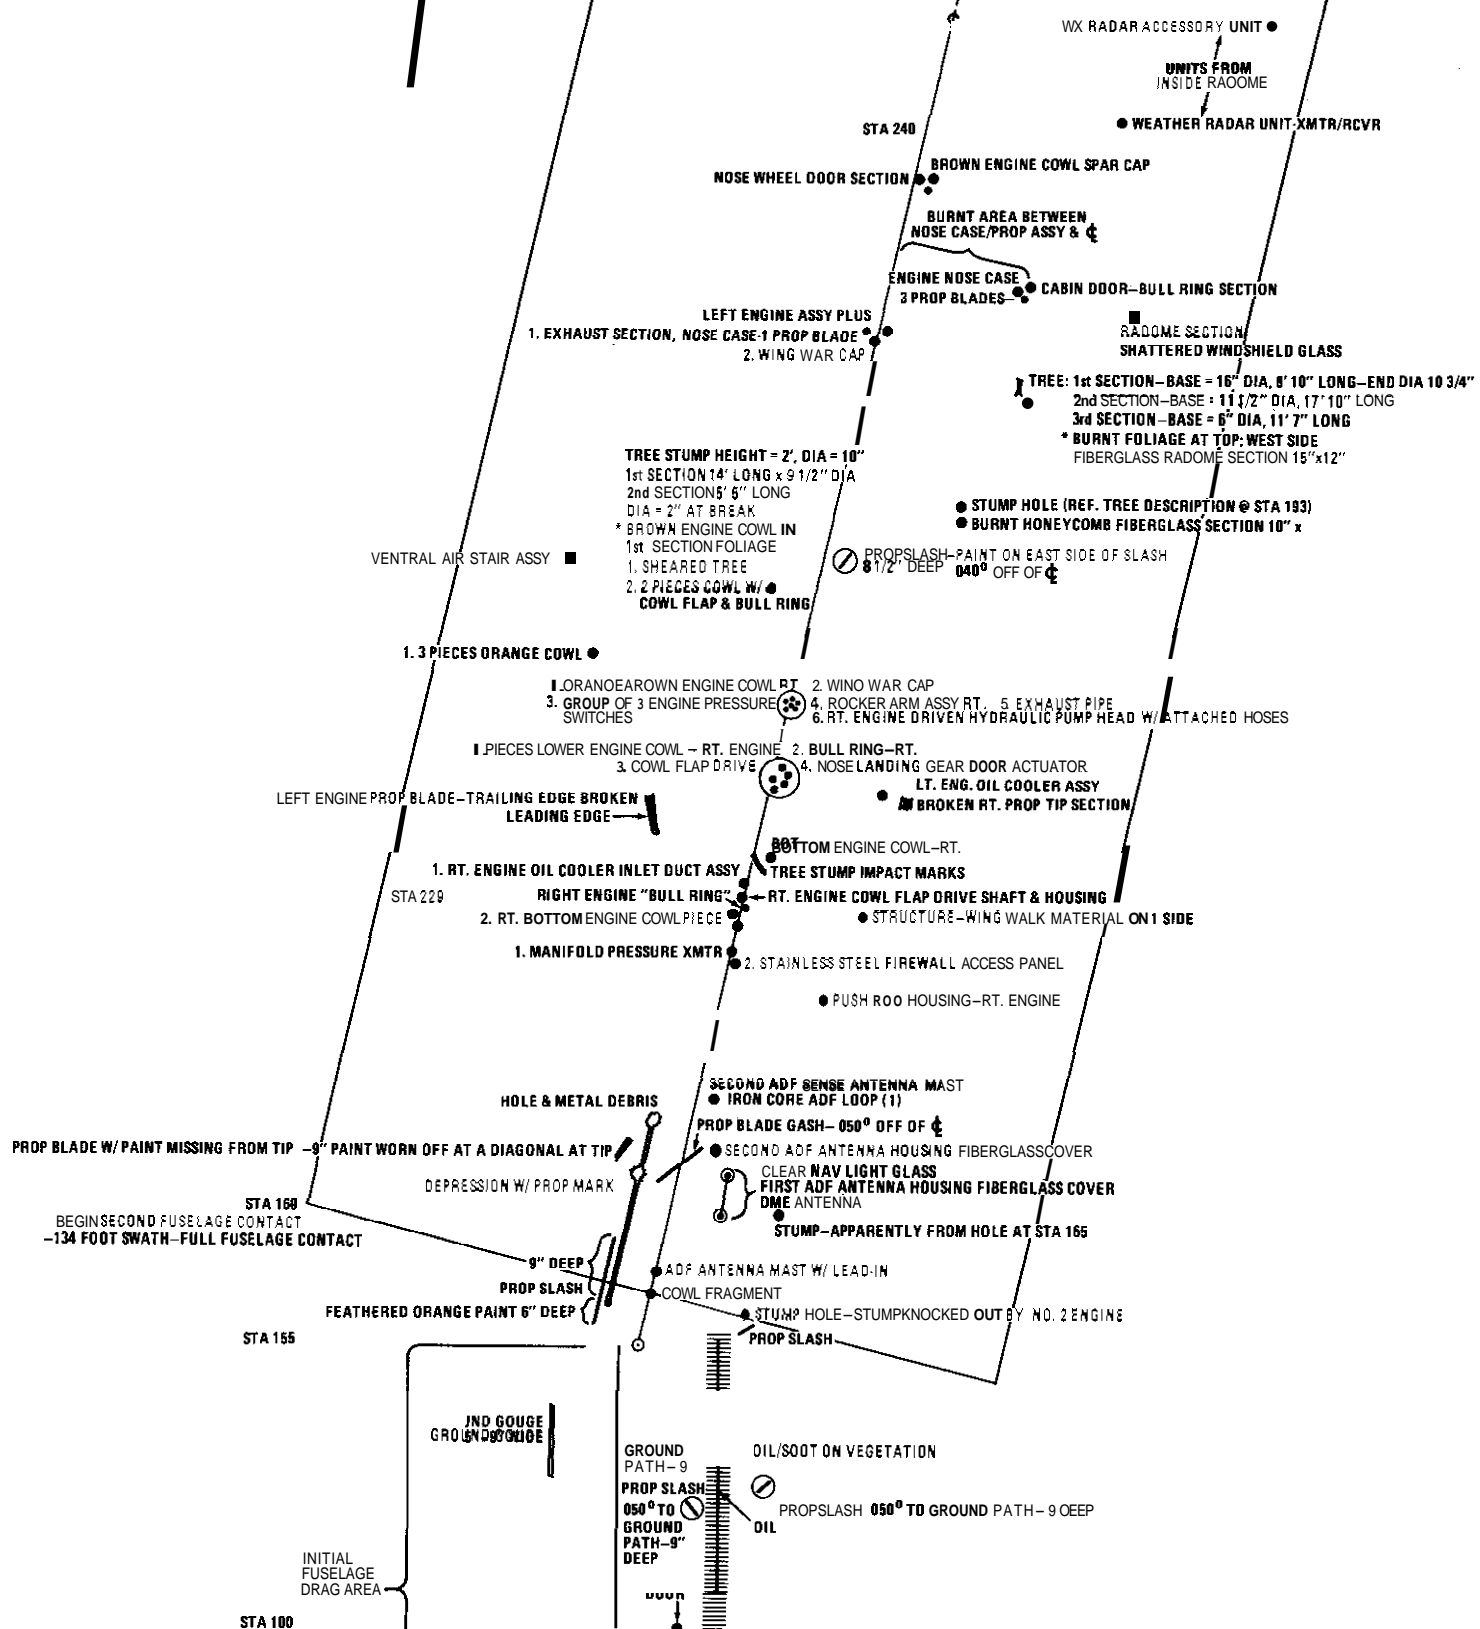
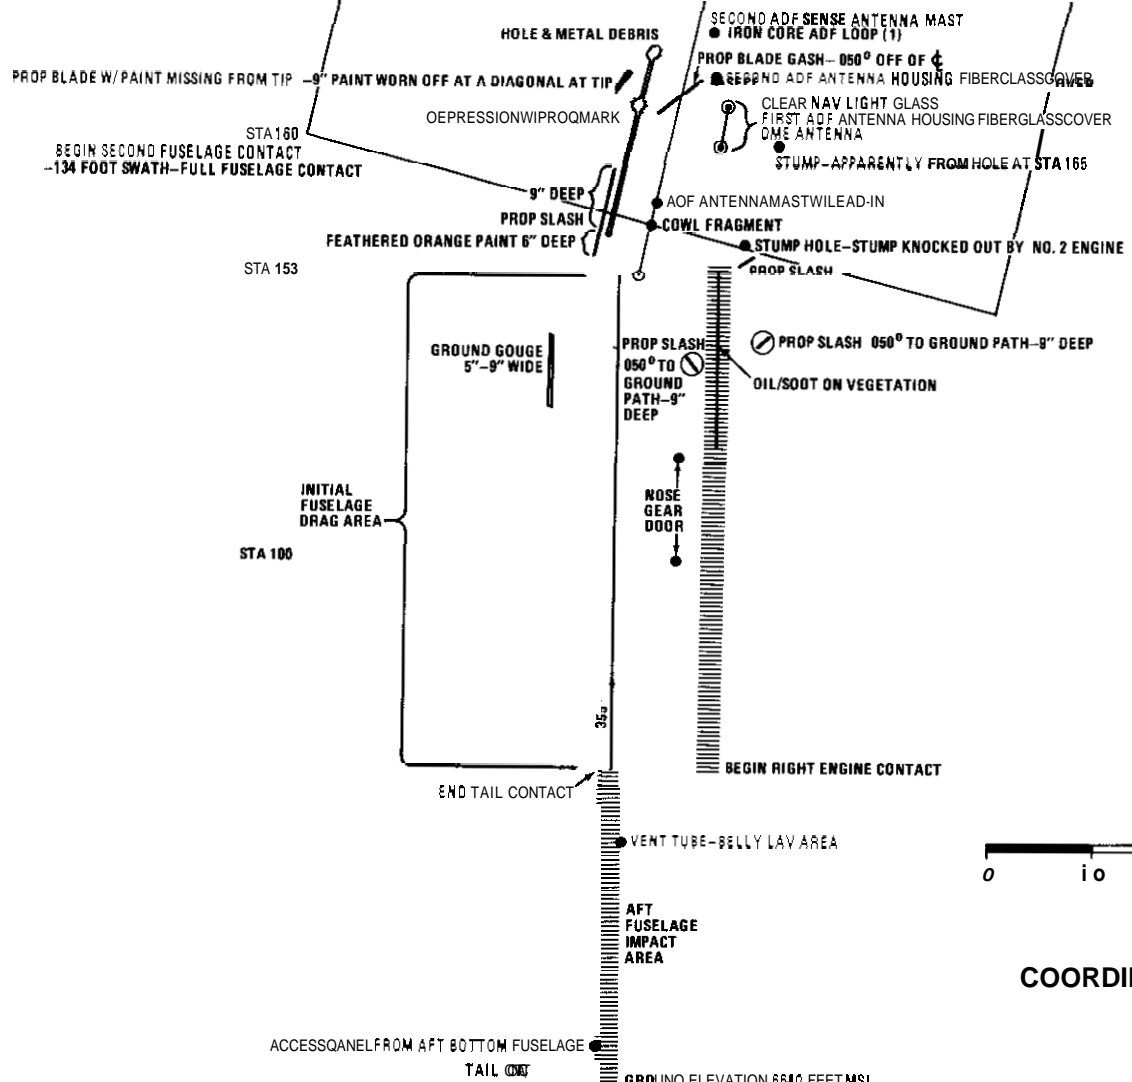
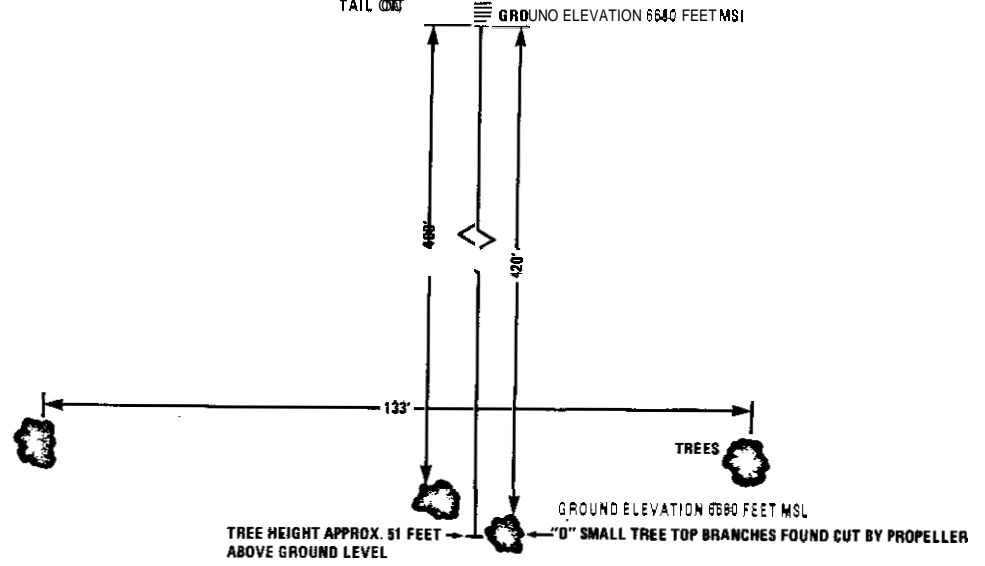
**APPENDIX D**  
**WRECKAGE DISTRIBUTION CHART**

The aircraft first struck the top of two trees at an elevation of about 6,731 ft while on a heading of  $330^\circ$ . Several broken and cut branches were found on the ground below the trees. The aircraft descended on a heading of  $355^\circ$  until the lower aft fuselage struck the ground at an elevation of 6,680 ft, 420 ft beyond the trees. The aircraft then slid along the ground and came to rest 434 ft beyond the first ground impact point. The aircraft came to rest oriented on a heading of  $070^\circ$  and at an elevation of 6,700 ft. The wreckage was confined to an area 434 ft long and 134 ft wide.

RADOME SECTION  
SHATTERED WINDSHIELD GLASS

TREE: 1st SECTION-BASE = 16" DIA, 8' 10" LONG-END DIA 10 3/4"  
2nd SECTION-BASE = 11 1/2" DIA, 17' 10" LONG

GROUND ELEVATION 6660 FEET MSL  
"D" SMALL TREE TOP BRANCHES FOUND CUT BY PROPELLER  
TREE HEIGHT APPROX. 51 FEET ABOVE GROUND LEVEL
