# NATIONAL TRANSPORTATION SAFETY BOARD

## AIRCRAFT ACCIDENT REPORT

SCENIC AIRLINES, INC.  
CESSNA 404, N2683S  
NEAR GRAND CANYON NATIONAL PARK AIRPORT  
TUSAYAN, ARIZONA  
JULY 21, 1980

NTSB-AAR-81-2

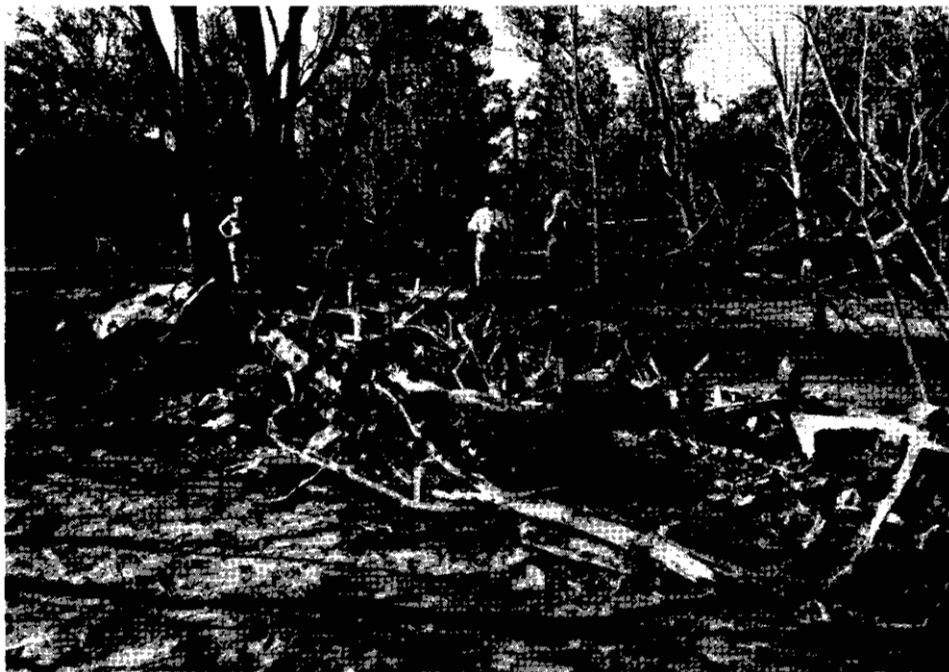
Small pieces of wing skin containing fuel tank sealant were found scattered in an area approximately 40 feet along the crash path from initial tree impact. Evidence of fire retardant slurry was found on tree foliage about 90 feet beyond initial tree impact and to a point 100 to 150 feet beyond the main wreckage. The burned area on either side of the aircraft's ground crash path showed evidence of fuel spillage. (See figures 1 and 2)

Figure 2.—Main wreckage.

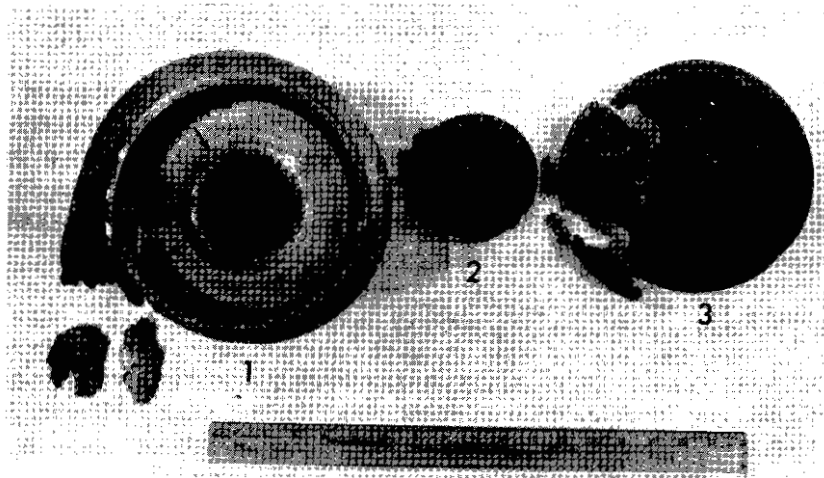
The left engine turbocharger compressor housing was welded to the backplate and had to be driven off with a hammer and chisel. The backplate and compressor wheel showed evidence of high heat exposure. Several compressor wheel blades rubbed the shroud and one blade tip had broken. The backplate was fractured during removal of the shaft. The compressor wheel nut appeared tight and was removed. The shaft was removed and the turbine journal showed normal bluing and coke deposits. The compressor journal was scratched slightly from abrasives in the oil. There was some coking at the piston ring at the turbine end. The thrust collar and thrust bearing were removed, and the antirotation pins were found intact and in place.

Figure 3.--Overall view of the cold section components of the turbocharger:

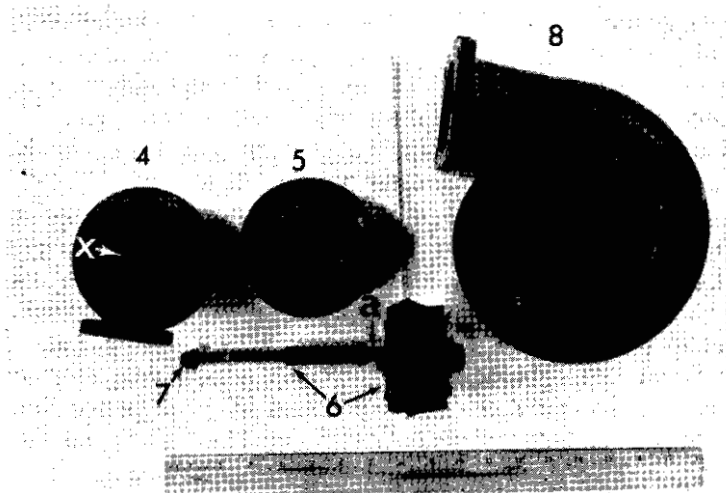
The left engine turbocharger was examined in detail by the powerplants group at Airesearch Manufacturing Company of the Garrett Corporation in Los Angeles, California. Disassembly of the turbine housing showed that **all** blades were uniformly damaged - about 3/4 inch of each blade was missing. The blade fractures were jagged in appearance and generally confined to the inducer area of each blade. There was slight rubbing and soot deposits inside the turbine housing. About one-half of the circumference of the turbine wheel shroud exhibited heat corrosion. **Four** 1/4- to 3/4-inch diameter holes were found in the shroud.

Figure 4.--Overall view of the hot section components of the turbocharger:

Metallurgical examination of the left engine turbocharger disclosed that it had seized suddenly but that the engine had continued to operate for some time following failure. There were hot gas erosion holes in one-half of the turbine wheel shroud and silhouette imprints of the turbine wheel blades on the housing. Both conditions indicated that hot exhaust gases impinged for **an** appreciable time on the turbine wheel while it was stationary. Further, metal transfer between the compressor impeller blades and housing **and** the turbine wheel blades **and** housing indicates that a severe imbalance of the turbine wheel and compressor existed within the turbocharger assembly. The wear on the center bearing and the deformation of the turbine wheel shaft, adjacent to the shaft fracture, are also consistent with an imbalance condition. Only a small portion of the fracture on the turbine shaft was clean or free of deposits; the remainder contained heavy, lead rich exhaust gas residues. The deposits indicated that the majority of the shaft fracture had been exposed to exhaust gases for some time. The discolored fracture surface exhibited cracking features which had originated at the bottom of the piston ring groove with fatigue crack propagation toward the inside diameter of the shaft. However, the crescents indicative of this type of cracking did not extend to the inside diameter. Thus, the final fracture probably occurred rapidly because of **an** overstress condition. **As** a result, the fracture was subjected to hot gases escaping through the turbine wheel shroud.

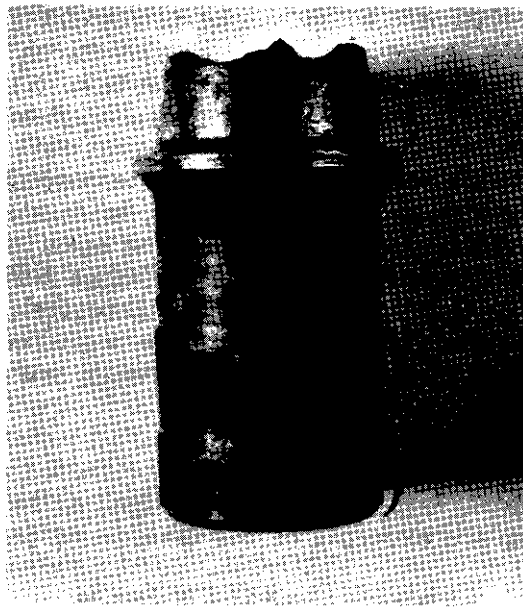
Additionally, the original exhaust valve guide removed from the No. 5 cylinder of the left engine showed evidence of extreme wear between the cylinder seat shoulder and fracture. It also showed considerable exhaust gas deposits on the outside diameter in areas not normally exposed to exhaust gases. There were exhaust gas residues on the fracture as well as on the inside diameter of the guide. Although the fracture surface exhibited some evidence of progressive cracking, positive identification of the failure mode was not determined because of the masking of the fracture surface by exhaust gas deposits and/or oxidation. (See figures 5 and 6.)

Figure 5.--Overall view of the fractured section of the exhaust valve guide (approximately X2).

Metallurgical examination of the upper portion of the exhaust valve guide showed a fracture characteristically similar to a fatigue break; however, deposits on the fracture surface prevented a positive determination of the failure mode. Scanning electron microscopic (SEM) examination of the barrel of the guide disclosed deposits primarily of lead and bromine, both of which are used extensively as fuel additives. The deposits were also found on the inside diameter of the guide, close to the fracture surface, and **all** over the outside of the barrel of the guide, past its shoulder. Extensive wear of the outside diameter of the shoulder and the fracture was indicative of the guide moving in the cylinder seat. These findings indicate that, following the fracture of the guide, the lower portion of the guide unseated itself, or broke apart, which allowed movement of the upper portion of the guide and passage of exhaust gases by the valve stem.

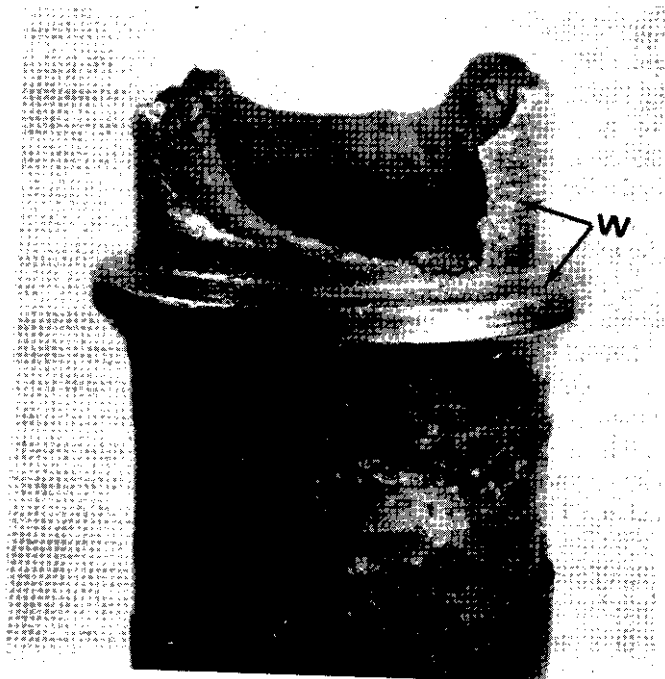
Figure 6.--Detail of valve guide showing orientation of fracture plane and surface detail of outside diameter (approximately X3).
