## AIRCRAFT ACCIDENT REPORT

**KELLOGG COMPANY** *TONY "THE TIGER" (CAPT.)*  
**AVIONS MARCEL DASSAULT BREGUET**  
**FALCON 10, N253K**  
**MEIGS FIELD**  
**CHICAGO, ILLINOIS**  
**JANUARY 30, 1980**

NTSB-AAR-81-6

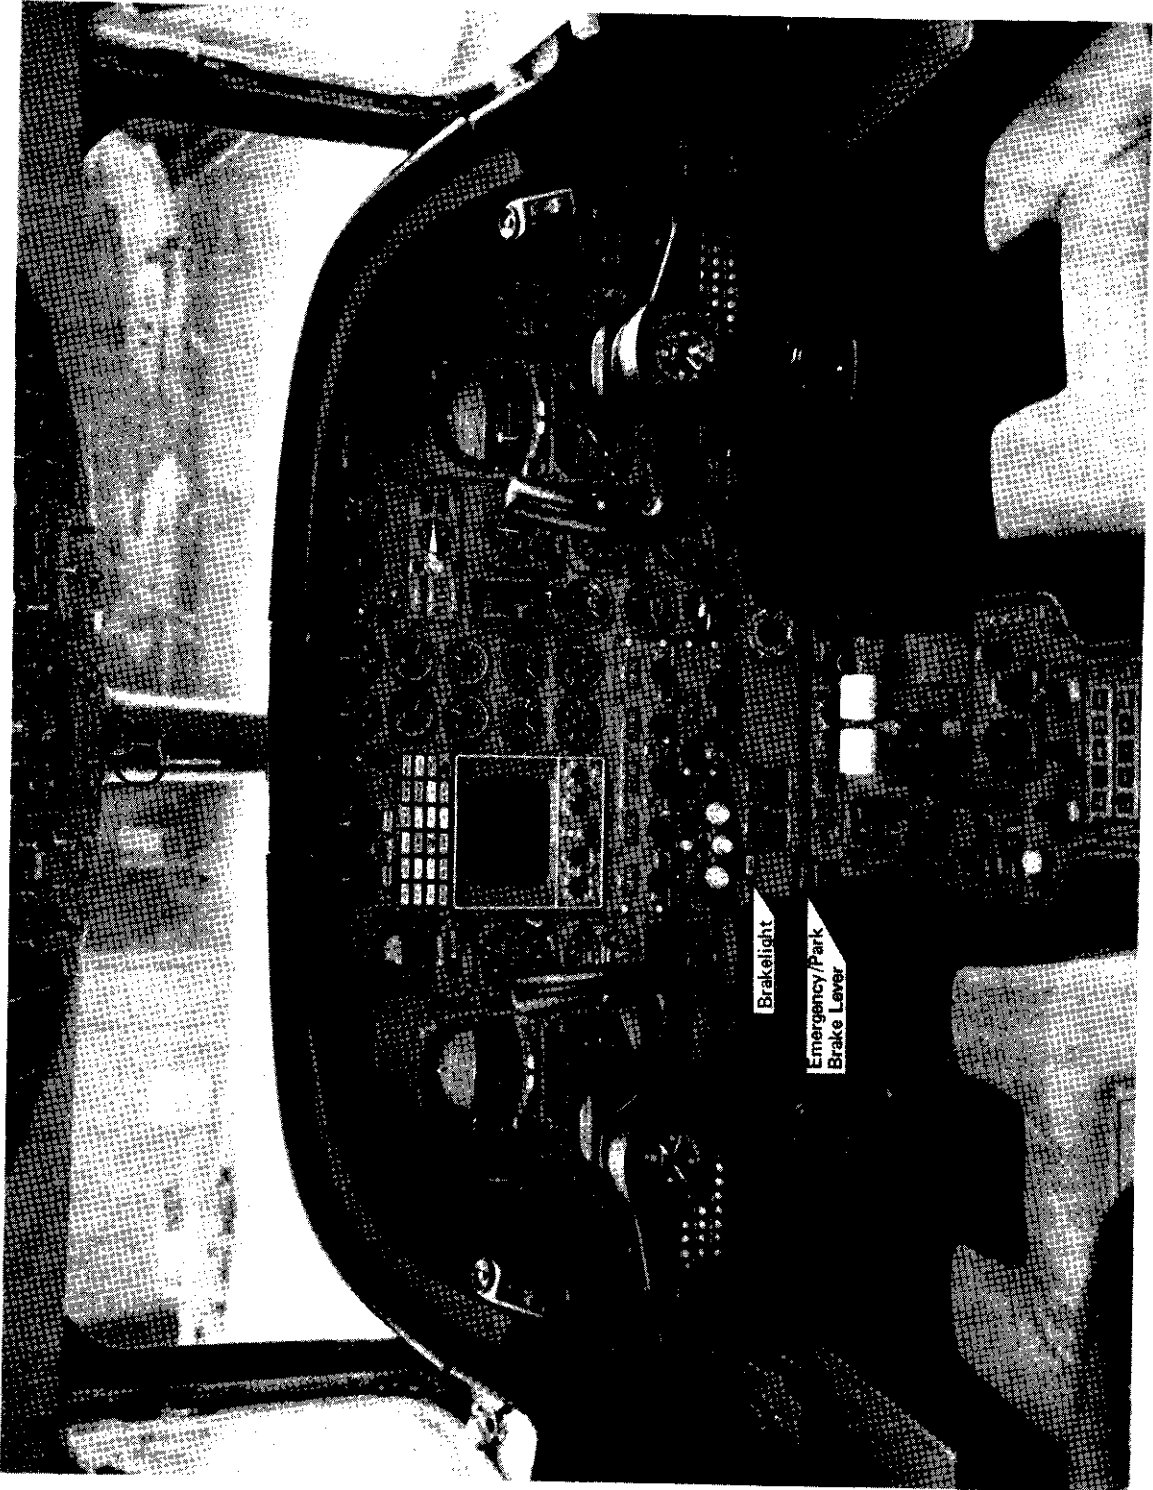
Figure 1.--

The Falcon 10 aircraft is equipped with an emergency/parking brake system, which operates from pressure supplied from the No. 2 hydraulic system directly to the wheel brakes through a proportional selector valve that is mounted in the lower left side of the nose section. Pressure to the emergency/park brake system is controlled by a lever which is located at the upper left corner of the center control pedestal, the lever is adjacent to the pilot's right knee. (See figure 1.)

Falcon 10 aircraft.
