AIRCRAFT INCIDENT REPORT

EASTERN AIRLINES
BOEING 727-25, N8140N
JOHN F. KENNEDY INTERNATIONAL AIRPORT
JAMAICA, NEW YORK
APRIL 8, 1981

NTSB-AAR-81-14

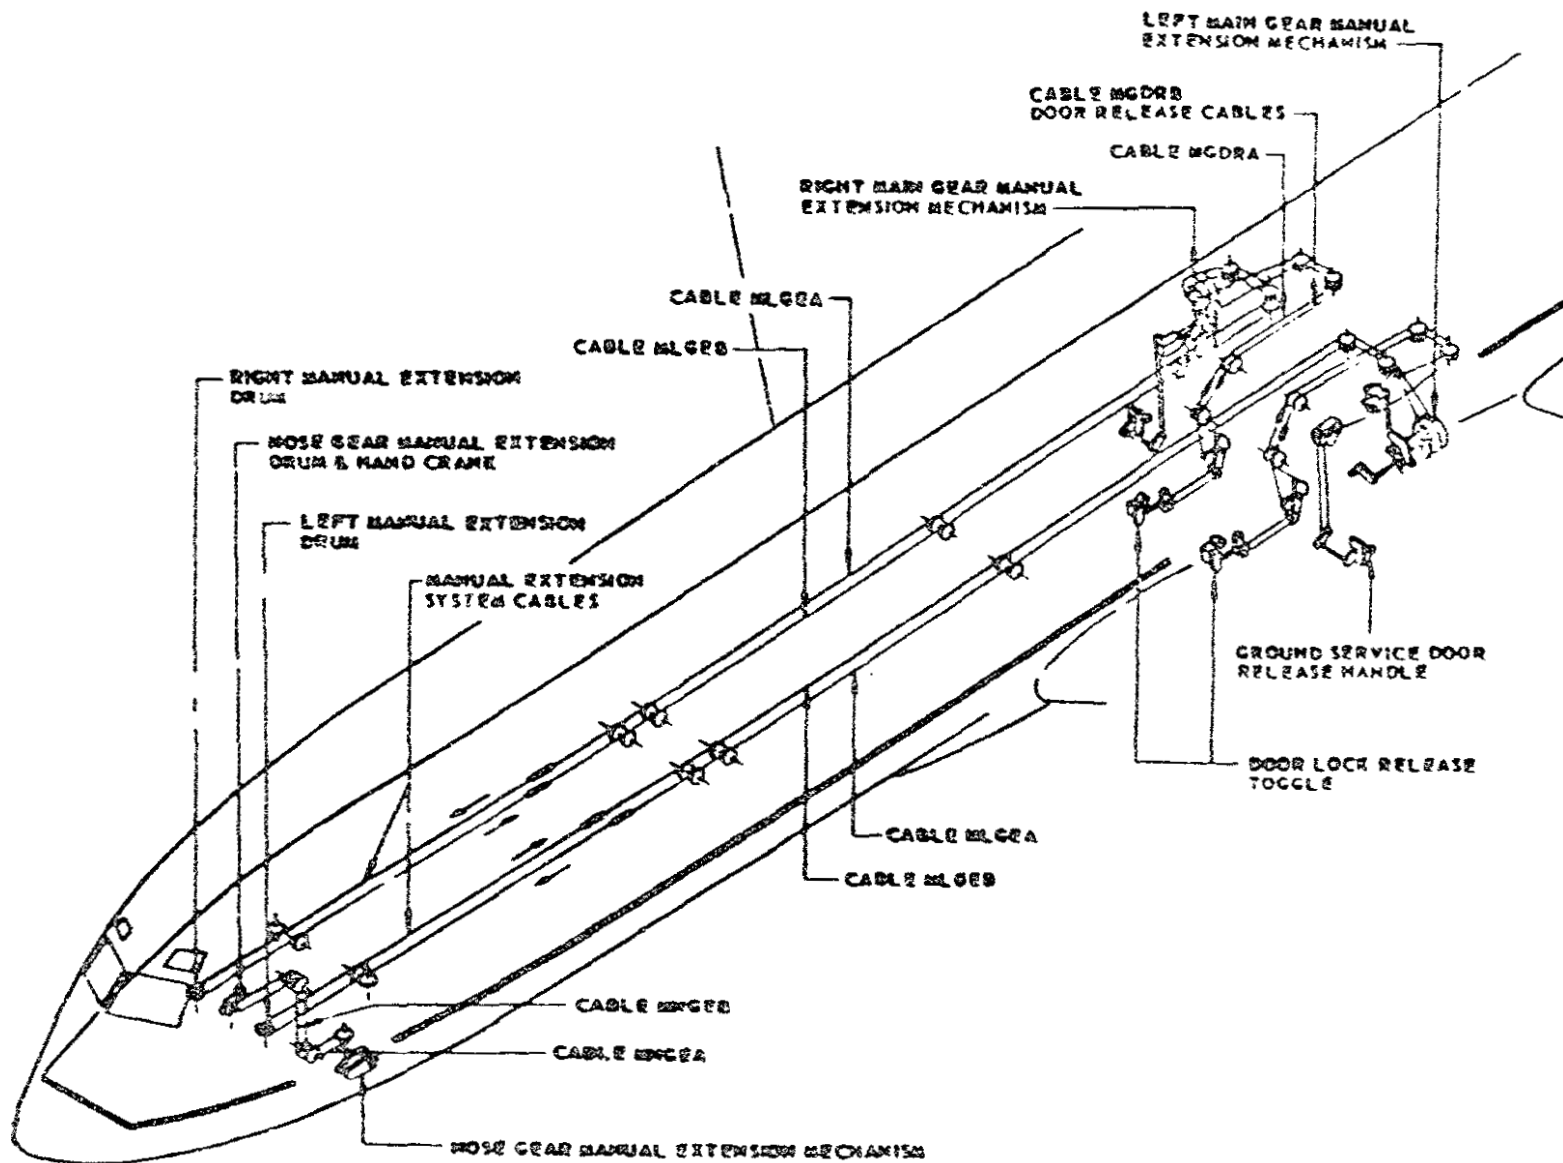
Figure 1.—Manual gear extension system.

The aircraft was lifted off the runway by cranes. Both inboard main landing gear doors were hanging by the attached actuators and sequencing push-pull rods. After the loose doors had been cleared, the nose and both main gears were extended manually by a Safety Board investigator and pinned in the down and locked position. (See figure 1.)

In normal manual operation, the handcrank must be rotated 3 turns clockwise (CW) to release the door uplock and gear uplock. When the door and gear fall free, the crank must be rotated 6 turns counterclockwise (CCW) to lock the gear down. When the aircraft was lifted from the runway, the Safety Board investigator rotated the left main gear manual extension handcrank in a clockwise direction to release the gear uplocks. The investigator said that he felt increasing resistance to rotation after about one turn, and after about 1 3/4 turns, he heard a "thud," the resistance eased, and the gear fell free from the retracted position. The crank rotated counterclockwise six turns without any resistance and the gear locked down normally.

After the aircraft was flown to Miami, the left main gear manual release system was functionally tested with the aircraft on jacks. It functioned normally with no unusual resistance to crank rotation. During the test, a scored and rubbed notch was found between two cable grooves on the cable drum. A worn and scored flat spot was found on the cylindrical cable guard above the drum. Based on the findings, tests were conducted to determine if the cable could move out of the groove and jam under the guard.

The tests were conducted with the gear down and locked and the inboard gear door removed. The gear uplock hook was placed in the locked position. The manual extension crank was rotated clockwise about 3 turns to unlock the hook, and force was continued in the same direction. The cable exiting the bottom side of the drum slackened slightly but not enough to allow it to move out of the groove.

The handcrank was rotated counterclockwise about 1 1/2 to 2 turns until the manual extension gearbox crank roller contacted the side strut cam. Resistance to the rotation of the handcrank increased, accompanied by slackening of the cable on the upper side of the drum, sufficiently to allow the cable to move out the groove and ride between the drum lands and the cable guard. When force on the handcrank was reduced, the cable tension caused the crank to spring back.
