AIRCRAFT ACCIDENT REPORT

SKY TRAIN AIR, INC.
GATES LEARJET 24, N44CJ
FELT, OKLAHOMA
OCTOBER 1, 1981

NTSB-AAR-82-4

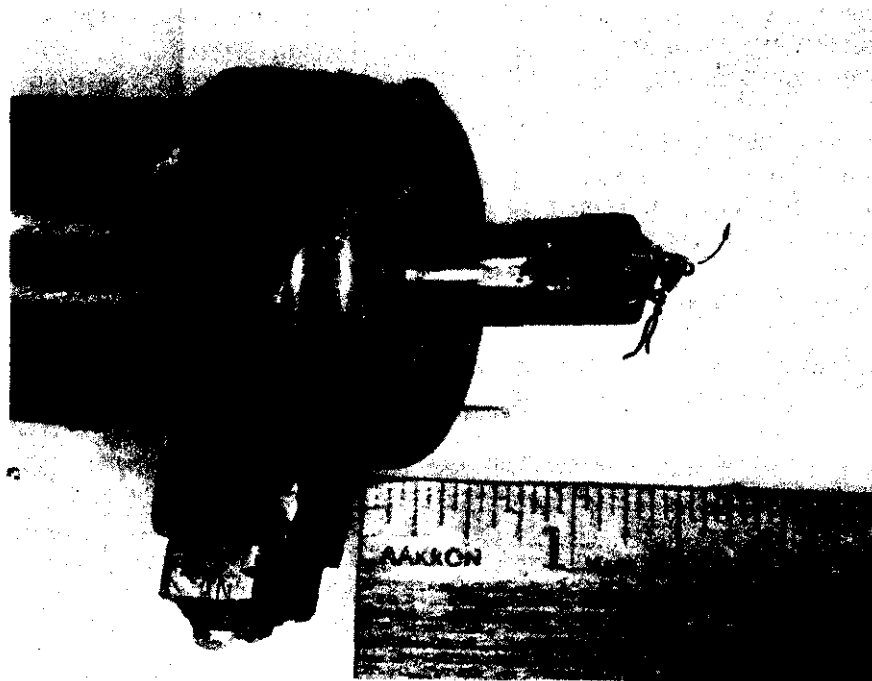
Examination of the wing spoiler actuator by the Safety Board's metallurgical laboratory disclosed that the piston rod-end broke from overload bending forces (figure 2). The actuator gland was driven sufficiently into the cylinder to shear the setscrew. Impact marks on the exterior of the actuator barrel (see figure 3) had deformed the inside wall of the barrel (see figure 4). The piston (see figure 5) was jammed within the distorted area 0.65 inch from its fully retracted position which indicates that the actuator piston had been moved by impact forces into the spoiler retract direction when the piston became jammed. The position in which it was jammed correlated with an extended spoiler deflection angle of 205. The deflection angle, in turn, corresponded to the position the spoiler would seek due to opposing air loads at an airspeed of 369 knots. This speed is 69 knots above the maximum airspeed (V_{mo}) for the aircraft. However, it was not possible to determine what portion of the distance that the piston had moved from the progressive forces associated with the impact breakup sequence.

Figure 2.—Closeup view of the piston rod end in position in the actuator.
Arrow indicates direction of bending of piston rod.

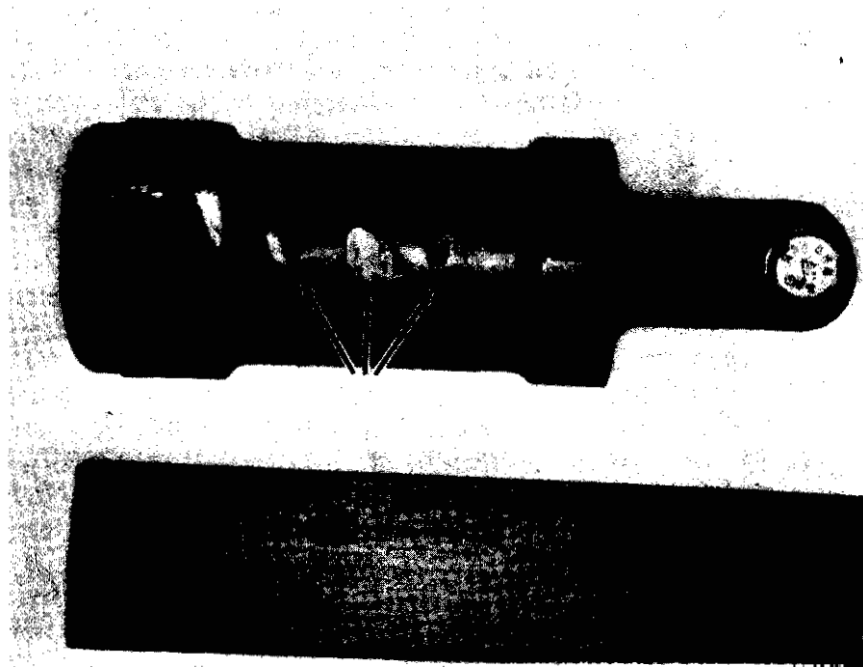
Figure 3.—Arrows indicate impact damage on the barrel.

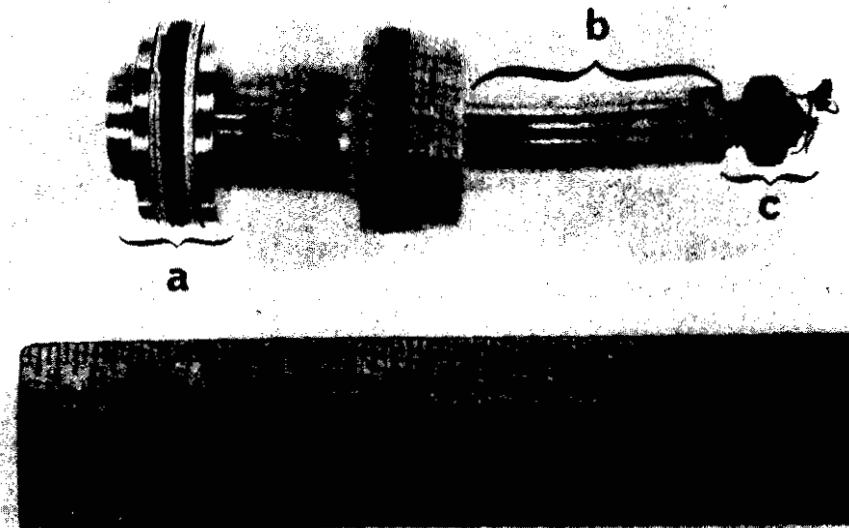
Figure 5.—View of (a) piston, (b) rod, and (c) rod end, after disassembly.
